FLYING LESSONS for December 15, 2011

suggested by this week's aircraft mishap reports

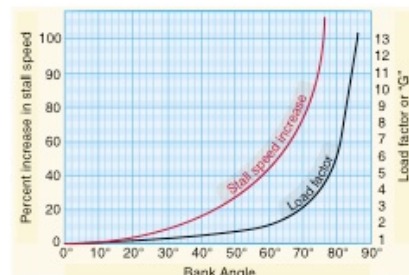
The aircraft appears to have been making a normal, VFR pattern entry, probably crossing midfield or on a crosswind leg (it's unclear where on the ground the videographer was located) to enter on a downwind for landing. The gear was up, and flaps appear to be up. There are popping noises on the video that may or may not be related to engine noise; international mishap reporting sources say the pilot was returning to the airport after reporting dual engine trouble.

Making the turn, the airplane enters a steep bank, as much as 60 degrees bank angle or more, while maintaining level flight. Very suddenly, the left wing drops, the right wing lifts, and the big twin snaps over into a steep spin from which there is no possible chance of recovery.

- Both engines may have failed completely (perhaps from misfueling; a piston Queen Air looks a lot like a turboprop King Air to an untrained fueler) and the pilot was gliding back in for a landing (engine noise in the video appears to refute this). Attempting to stretch the glide back to the runway by resisting the descent, the angle of attack was increasing. When rolling into a commercial-standards steep turn in nearly level flight, the stall speed increased by over 40% compared to wing-level, constant altitude flight. The inside wing stalled first (it will have a higher angle of attack in a steep turn) and the sudden imbalance of lift snapped the big twin over into a spin.

- One engine failed and the pilot, anxious to get the heavy twin back on the ground, was overzealous in the turn, precipitating the stall.
- Both engines were still developing at least some power and the pilot, anxious to get the heavy twin back on the ground, was overzealous in the turn, precipitating the stall.

- Both engines were developing at least some power, but at the very moment the pilot began a turn the engine on the inside of the turn failed; the pilot did not recognize the increase in roll and yaw that resulted and the aircraft did a V_{MC} roll into the ground.

1. Adhere to the standard instructors' admonition to keep bank angle shallow in the traffic pattern to preserve a margin between current airspeed and the airplane's stall speed adjusted for weight and level-bank-induced G load.

2. If you have any power remaining at all, be very cautious about your return to the airport. This is absolutely not the time to be using your steep-turn skills in the airport traffic pattern.

3. In a twin-engine airplane, be very attuned to bank angle and rate of turn. If the bank or turn rate suddenly changes, level the wings and hold a constant heading. It's almost impossible to use the "dead foot, dead engine" technique to identify a failed engine while turning. If the inside, "down" engine quits the rate of turn will increase and the nose will pitch down relative to the horizon. If the outside or "high" engine quits the airplane will feel as if it's trying to roll out of the turn.
