Agusta A119, Cracked Gleason Crown Gear, ATA 6320

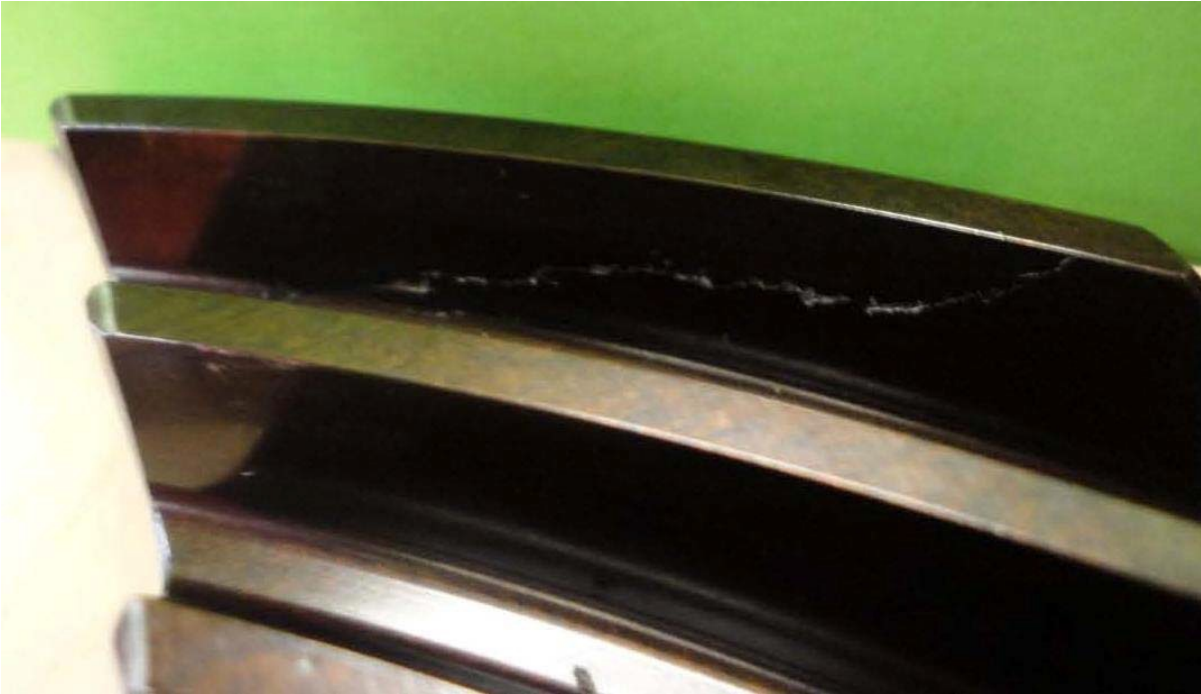
A quality control supervisor for this repair facility says, "During a 4800 hour overhaul inspection, the Gleason Crown gear was found to have a crack."

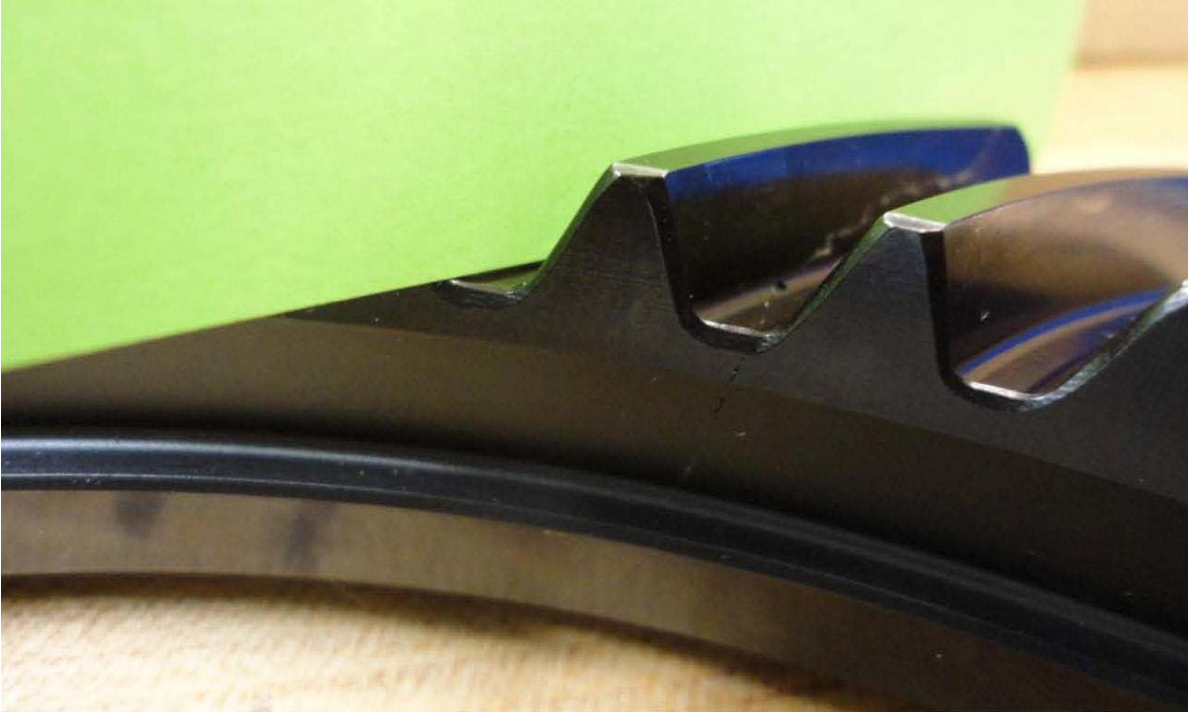
(Gleason Crown gear P/N: 109040307103; Main Gear Box Component P/N: 109040005103. A second such gear report is found in the SDRS database. Thanks for the photos—Ed.)

Part Total Time: 4,854.0 hours
