Lycoming O540, Failed Pushrod Shroud Springs, ATA 8530

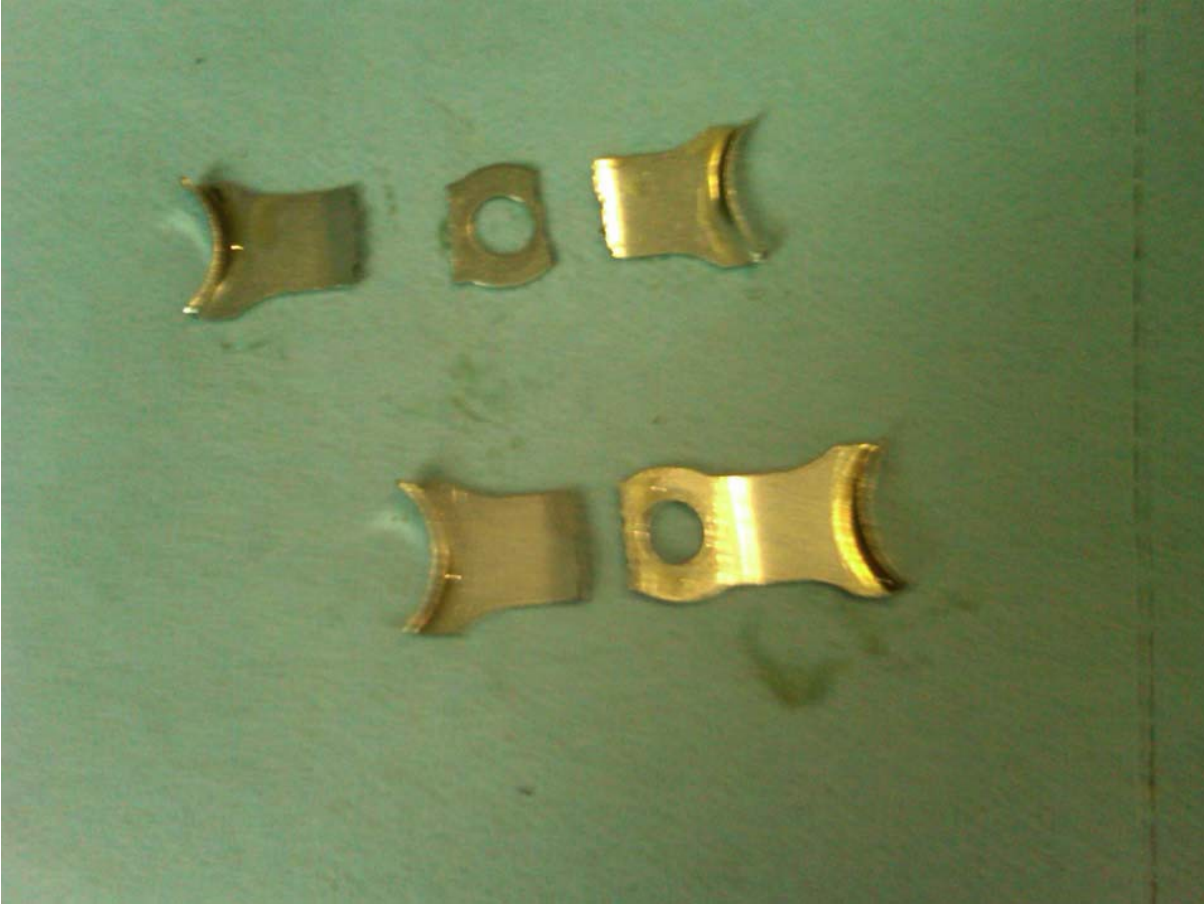
A technician states, "Tracing an oil leak, it was discovered the pushrod shroud tube retaining springs (SL14995) had failed on all six cylinders. The part failed by breaking into two or more fragments. This allowed the shroud to unseat from the head and leak oil. All six springs were replaced." *(There are eight similar reports in the SDRS database.)*
