Piper PA28-180, Failed Landing Gear Strut, ATA 3213

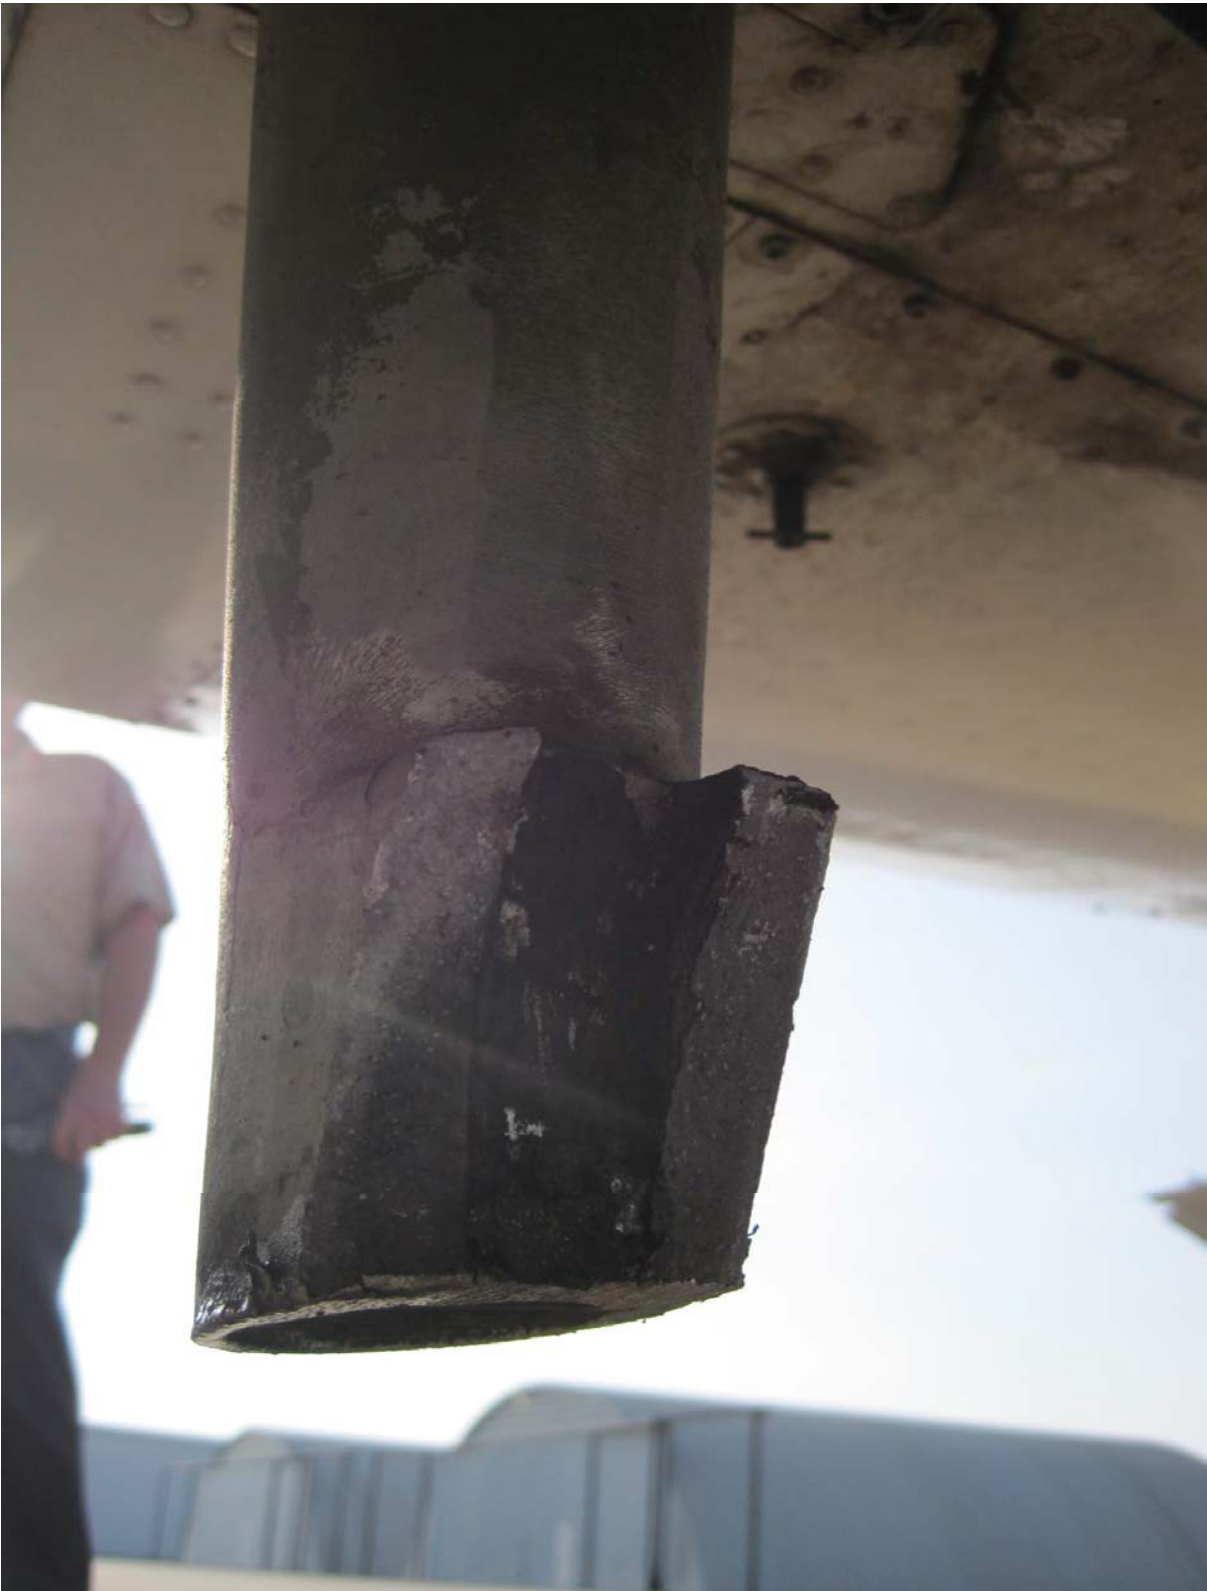
Piper PA28-180, Failed Landing Gear Strut, ATA 3213

A general aviation report states, "The right main landing gear lower strut fell off when the aircraft lifted off the runway at *(the airport)*. The student pilot flew to *(his destination)* and landed, resulting in damage to the upper landing gear strut *(P/N: 6531904)*. When the lower strut departed *(from the)* upper housing, it struck and damaged the flap skin.

"The right main landing gear upper torque link mounting ears broke off the cylinder, allowing the lower gear leg to fall out of the upper cylinder and depart the aircraft. This cast aluminum cylinder is original since 1972. The inboard ear appears to have been partially broken for some time. Once it broke all the way, the outboard ear could not support the twisting forces applied during normal turns, taxi, and torque during takeoff. I feel this led to the outboard ear breaking off, and on takeoff, the gear left the aircraft. This upper torque link attach point is covered with a fairing, preventing the pilot from seeing any defects during preflight." *(The SDRS database reflects this part number 22 times.)*
