Beechcraft B200, Bad Rivet Installation in Stabilizer Spar, ATA 5510

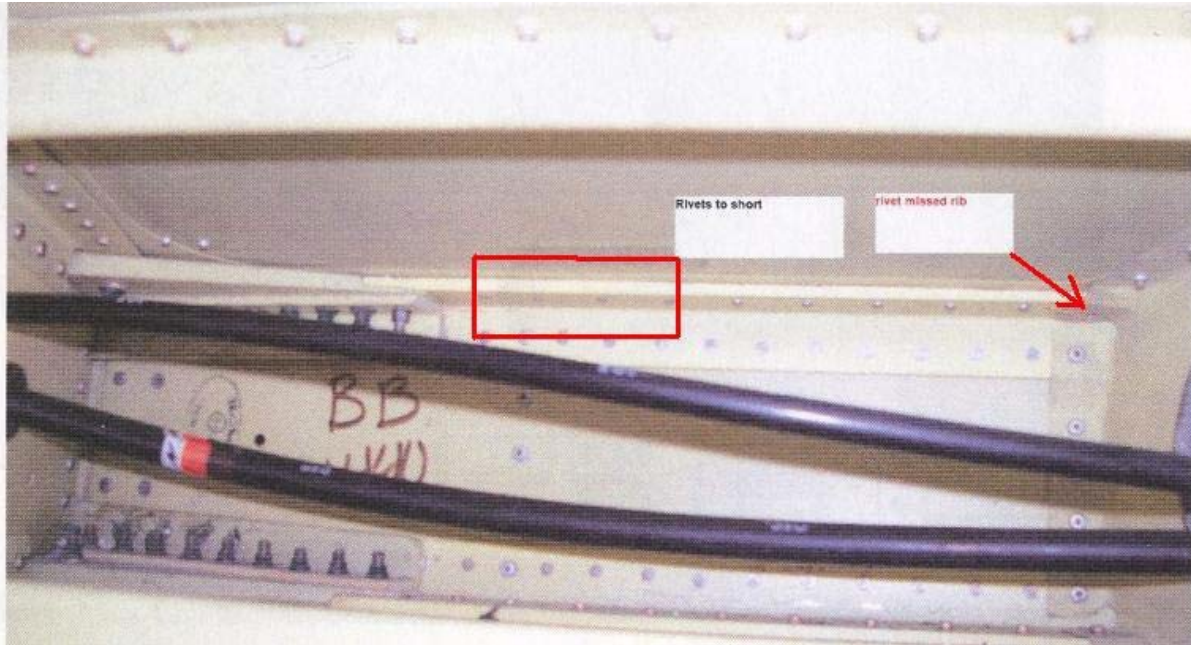
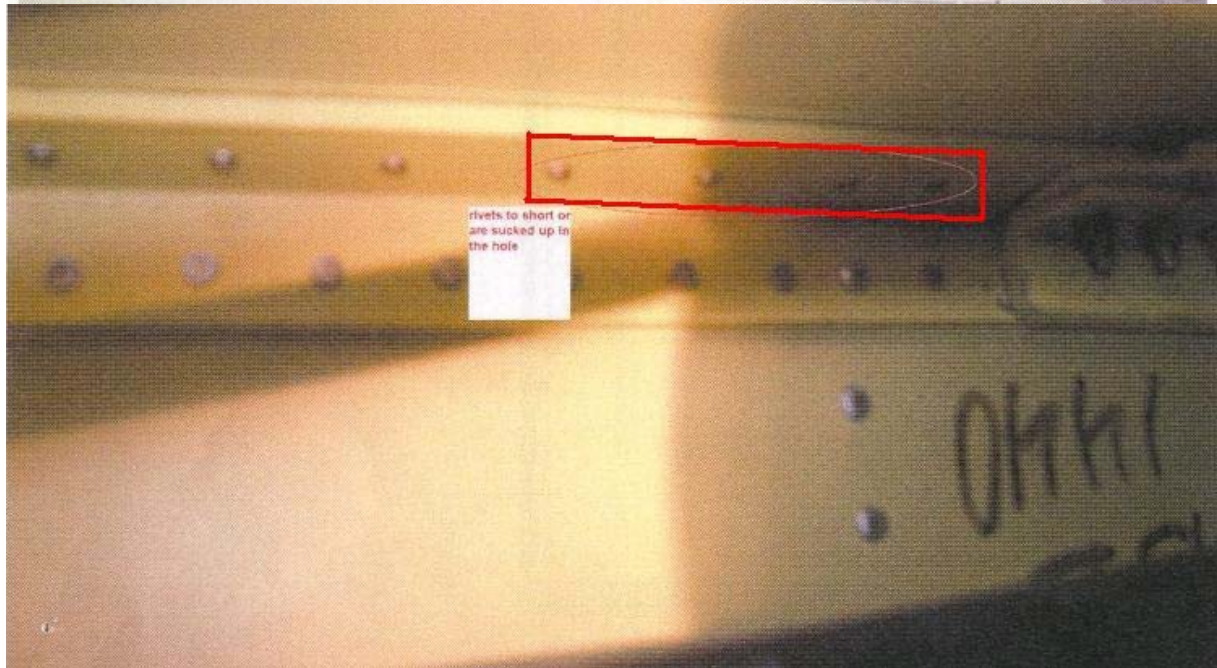
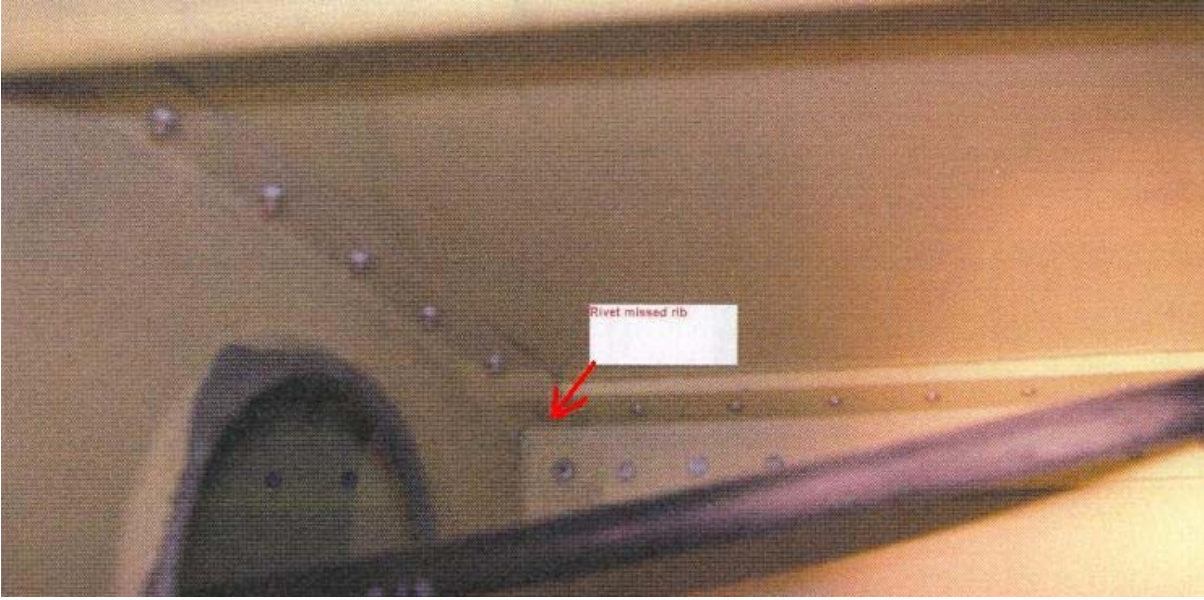
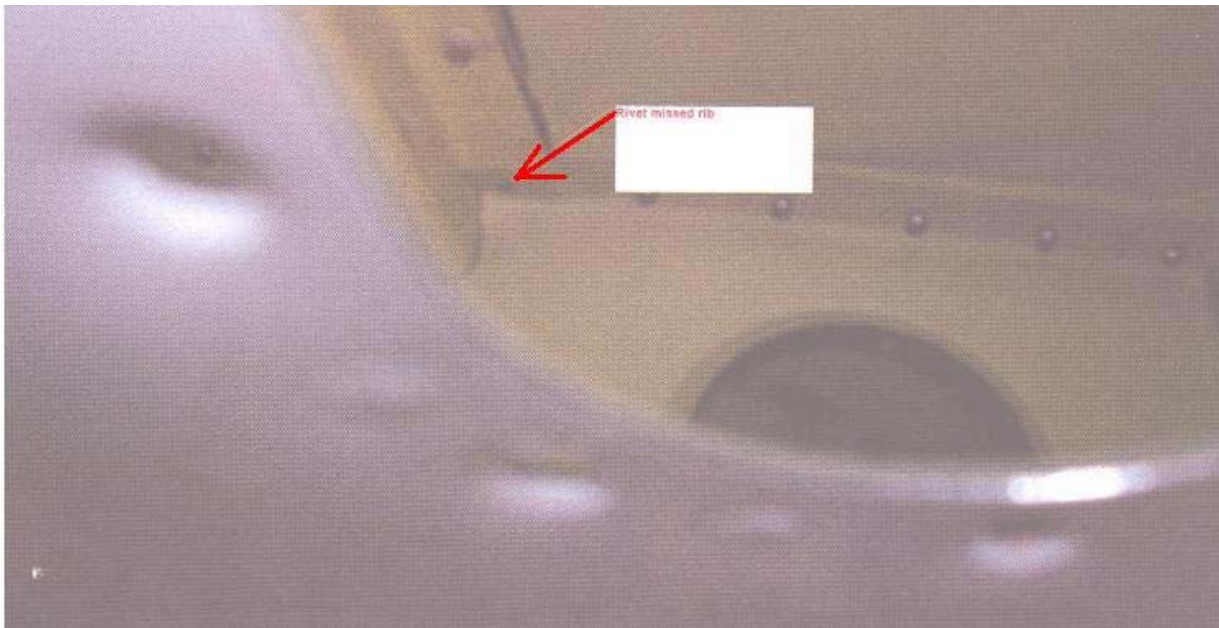
A submitter working on this corporate aircraft writes, "After complying with Service Bulletin 55-3835 'Installation of Empennage Inspection Access Panels' and the 'Horizontal and Vertical Stabilizer' inspection, we found the horizontal stabilizer forward spar and ribs not riveted correctly from the factory. Many rivets that go through the forward spar are too short, and where the rib and forward spar come together, the rivet misses the rib. We have found this same problem on other aircraft we have inspected."
