## **Piaggio P-180, Improper Elevator Installation, ATA na**

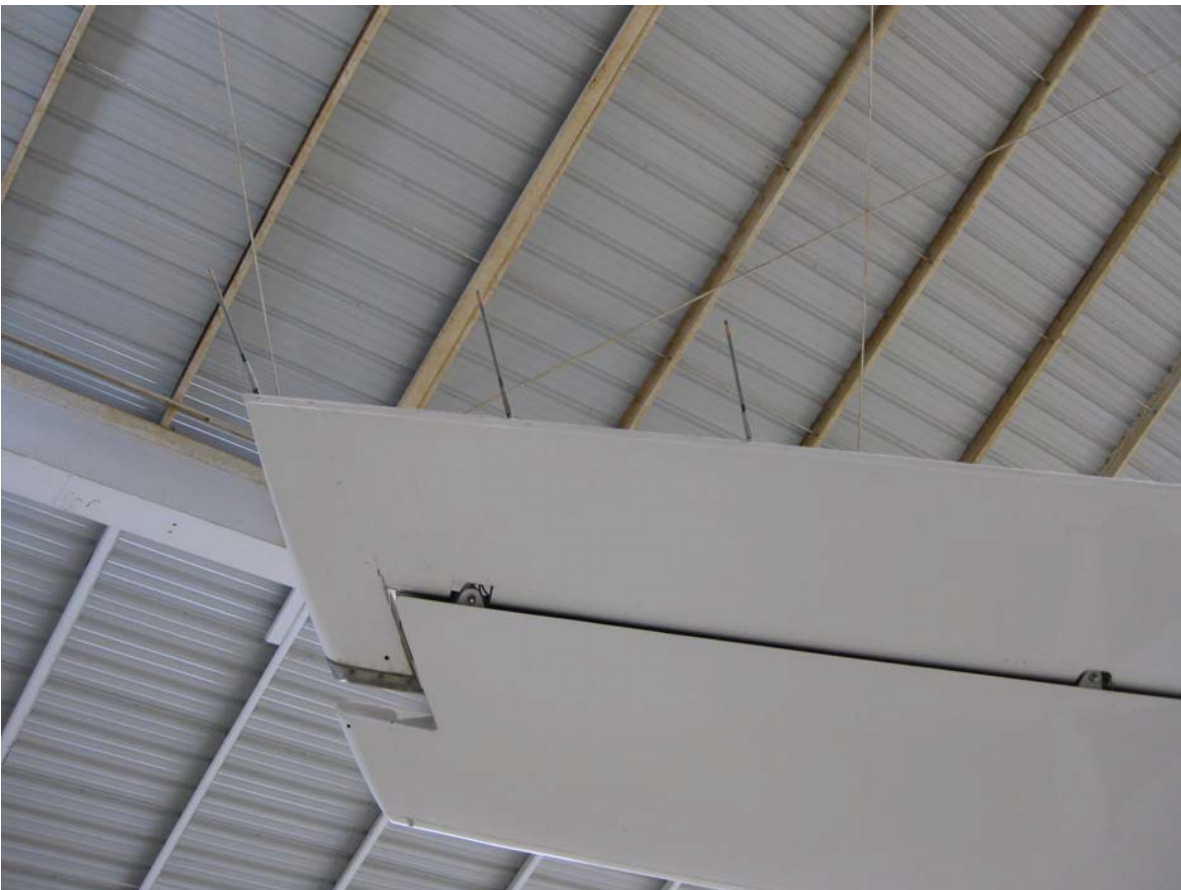
"The purpose of this Alerts article is to describe an event where the elevators on a Piaggio Aero P180 Avanti airplane were installed incorrectly. The R/H elevator was installed upside down on the left side of the airplane, and similarly, the L/H elevator was installed upside down on the right side of the airplane. The airplane was then rigged within acceptable limits per the AMM (aircraft maintenance manual). During flight, this reversed elevator installation greatly influenced elevator trim authority—additionally causing the airplane yoke to be in a noticeably different longitudinal position.

"A very simple way to ensure the correct elevator is installed on the proper side is to verify the location of the static wicks—they must be on the upper surface of the elevator. This fact is reflected in the additional note added to the P180 Avanti AMM."
