Piper PA28-180, Worn Fuel-select Valve, ATA 2823

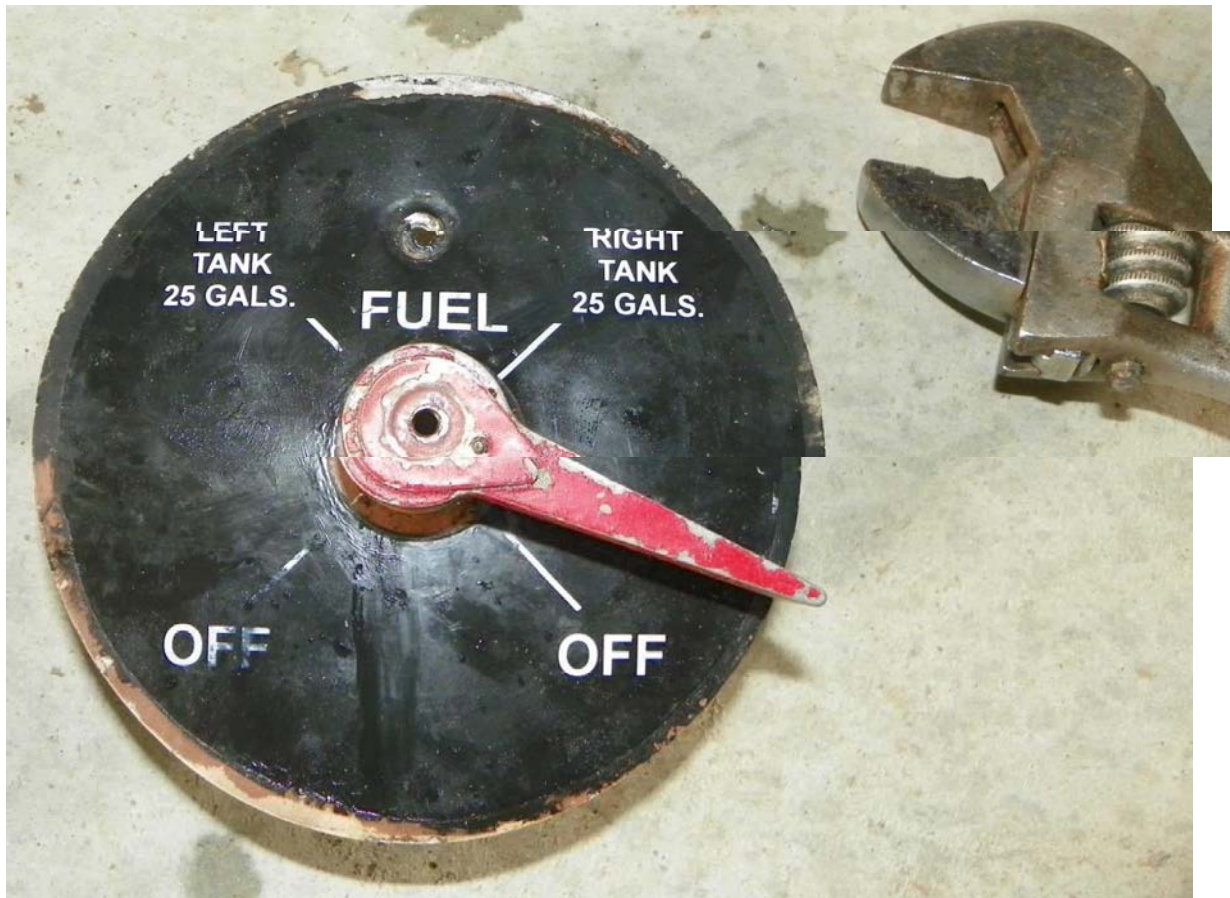
A general aviation mechanic writes, "When the fuel tank selector valve (P/N 756645) was rotated it was stiff to move, and the detents could not be felt at each position. A teardown showed the valve was very dirty inside, and the detent ring was worn. A review of Airworthiness Directives (AD's) and Service Bulletins (SB's) revealed two bulletins that directly involve problems with this valve. This defect (worn and dirty) led to improper fuel selection (position), greatly reducing fuel flow and causing stoppage of the engine.

"1. SB 0355: Fuel Selector Valve Lubrication. I was unable to locate a sign-off in the maintenance records of (compliance) with this bulletin.

"2. SB 0840: Fuel Selector Valve Cover Replacement. I was unable to locate a sign-off in the maintenance records of (compliance) with this bulletin. This bulletin deals directly with preventing the pilot from inadvertently moving the valve to the 'off' position. Piper considers this SB to be mandatory. No AD was found."
