## Piper PA28R200, Cracked Aileron Pulley Brackets, ATA 2710

A General Aviation submission states, "During an Annual Inspection, both the L/H and R/H lower support aileron pulley brackets were *(found)* cracked in the forward inboard radius mount *(flange)* at each wing rib. A piece of one of these pulley brackets was detached." *(Pulley bracket P/N: 67550000.)*

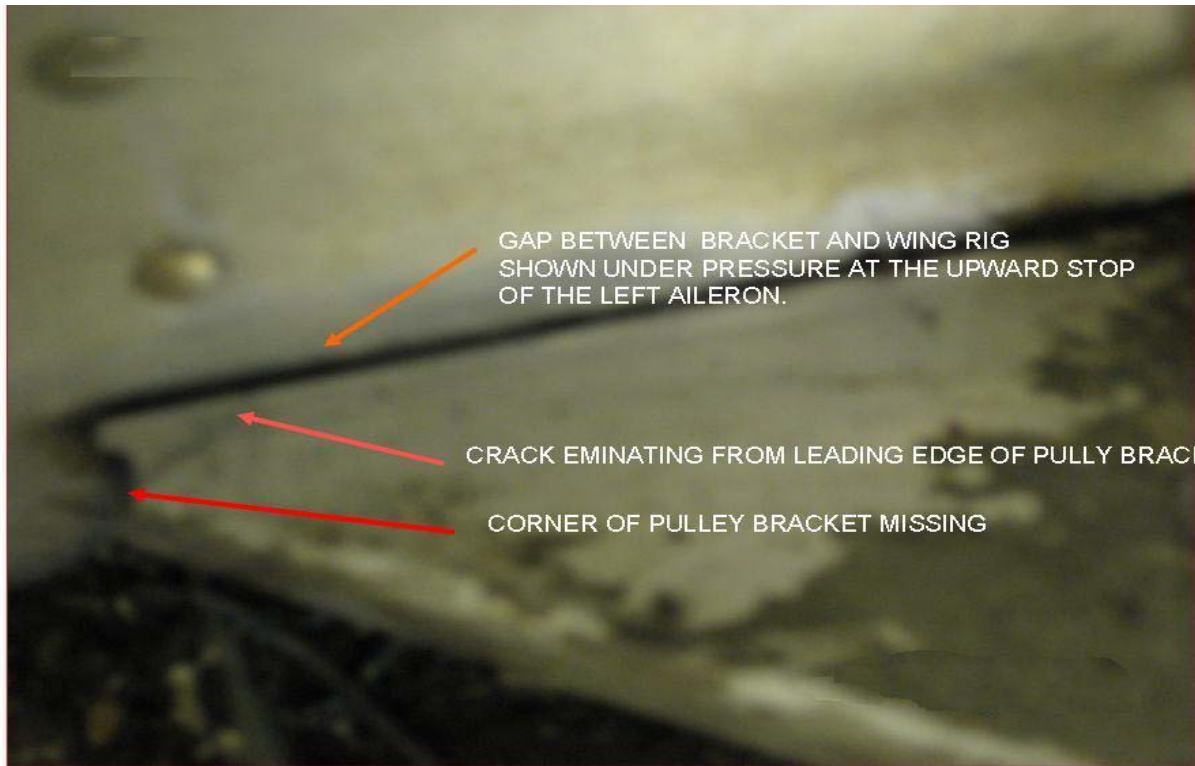
VIEW LOOKING INBD AT L/H WING LOWER AILERON PULLEY BRACKET ATTACHED TO THE L/H MAIN WING RIB.  
\* (NOTICE A PIECE OF THE BRACKET MISSING WITH GAP AT WING RIB). THE SEVERITY OF THE DEFECT WAS ACHIEVED BY ADDING UPWARD PRESSURE TO THE TRAVEL STOP WITH THE TRAILING EDGE OF AIRLERON.

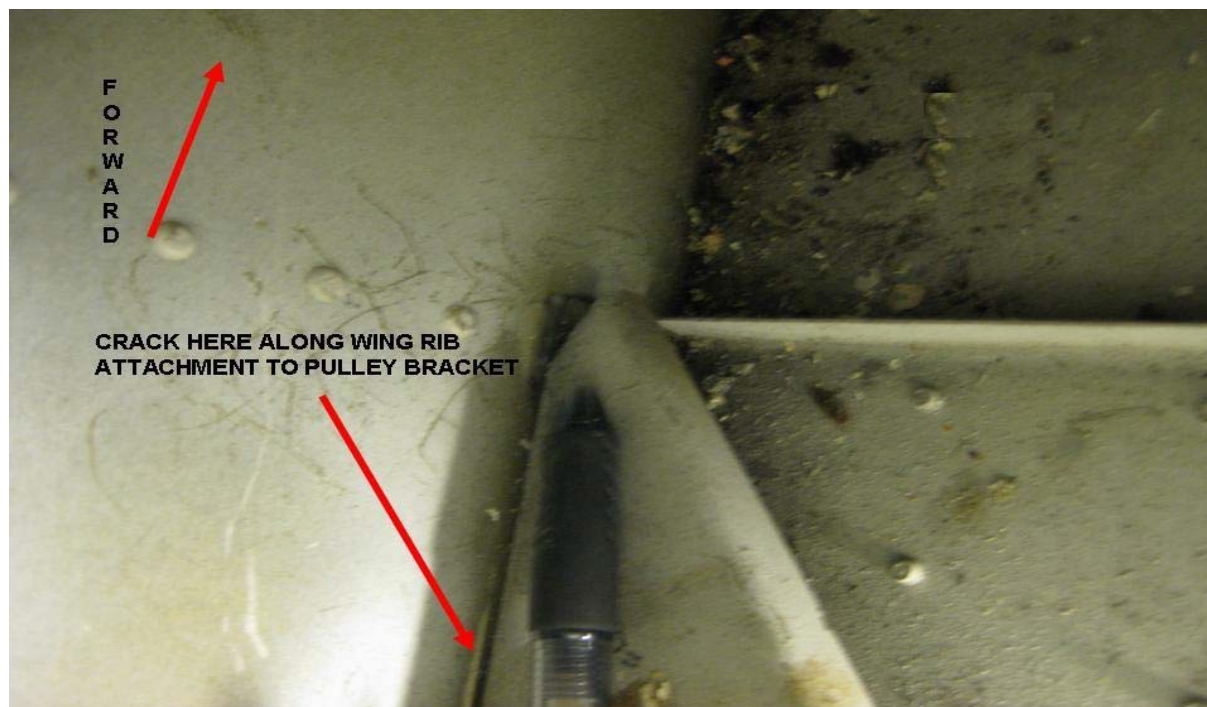
**"VIEW LOOKING DOWN ON RIGHT HAND WING FORWARD CORNER OF LOWER PULLEY BRACKET"**  
**NOTE\*- THE CRACK WAS MORE EVIDENT WITH UPWARD PRESSURE ADDED TO THE TRAILING**  
**EDGE OF THE AIRLERON.**
