Piper PA31-350, Electrical Power Failure, ATA 2432

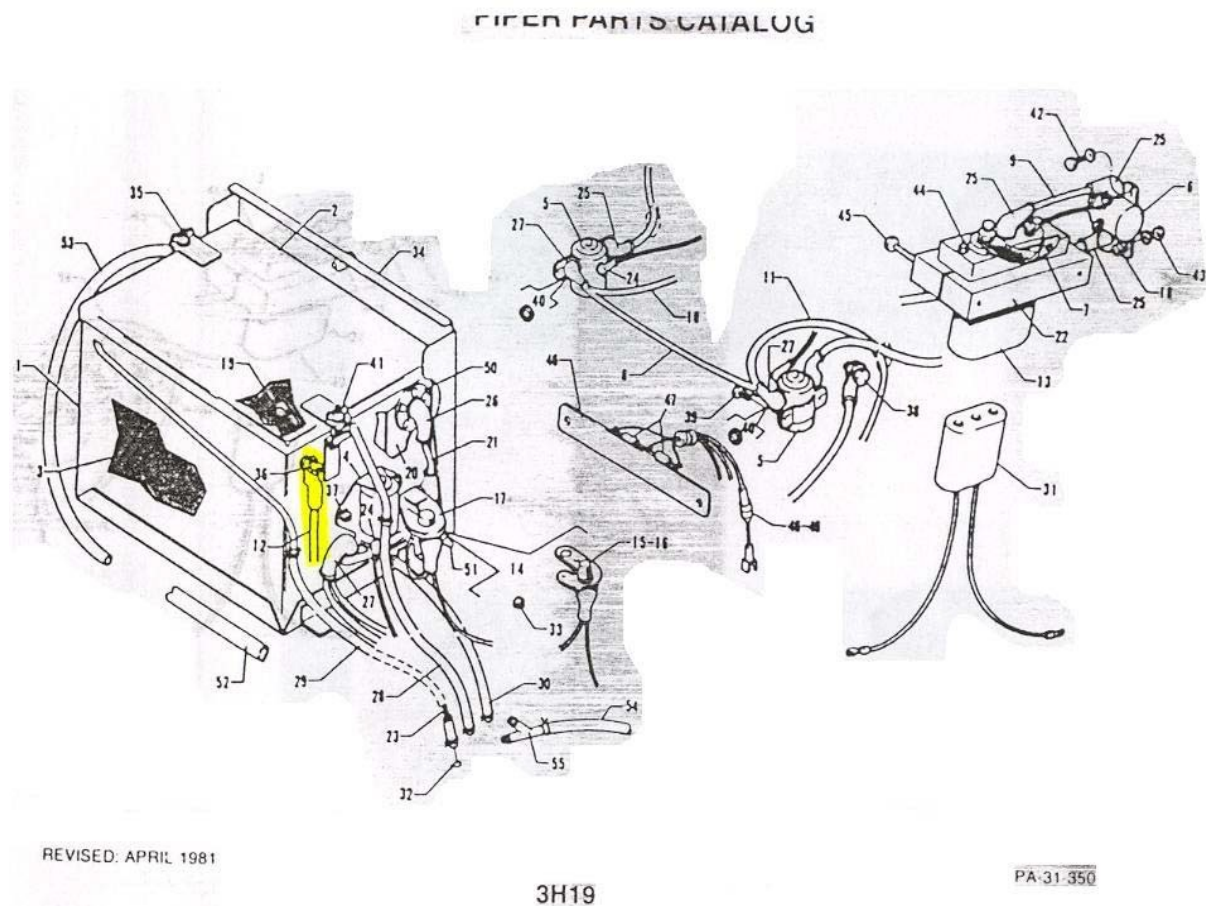
Figure 1 Piper Parts Catalog

Another FAA inspector writes, "Loose battery cables led to a complete loss of electrical power while in flight—IFR flight level 13,000 feet. Loose cables (P/N 80009-04) caused the loss of the aircraft battery (power). When the alternators were unable to carry the load, it resulted in a total electrical loss."
