Piper PA34-200, Cracked Nose Gear Trunnion, ATA 3222

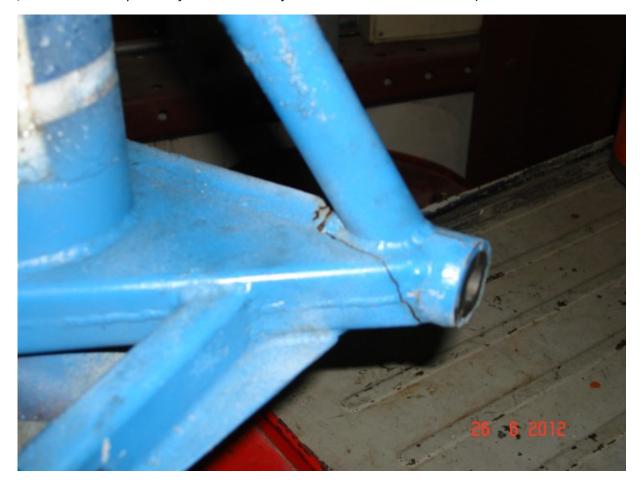
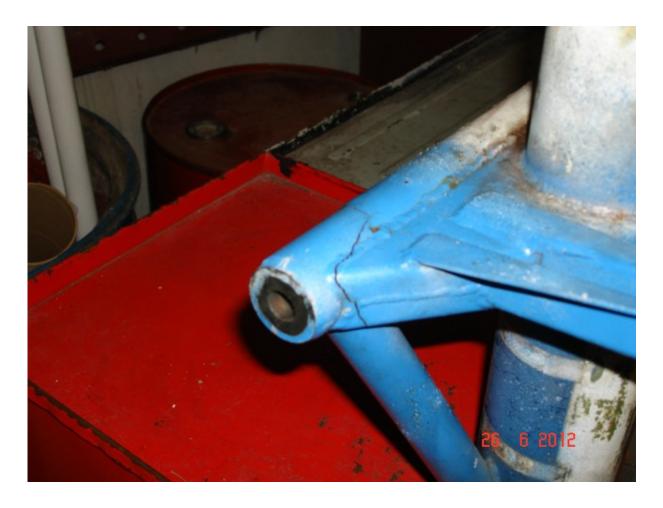
A repair station mechanic states, "(During) an Annual inspection, (I) found the right pivot point of the nose gear trunnion cracked (at the point...) where the trunnion is welded to the pivot bolt housing." (Trunnion

P/N: 9572300. This part is referenced at least four times in the SDRS database.)

Part total Time: 4,547.0 Hours
