Piper PA44_180, Throttle Cable Separation, ATA 7603

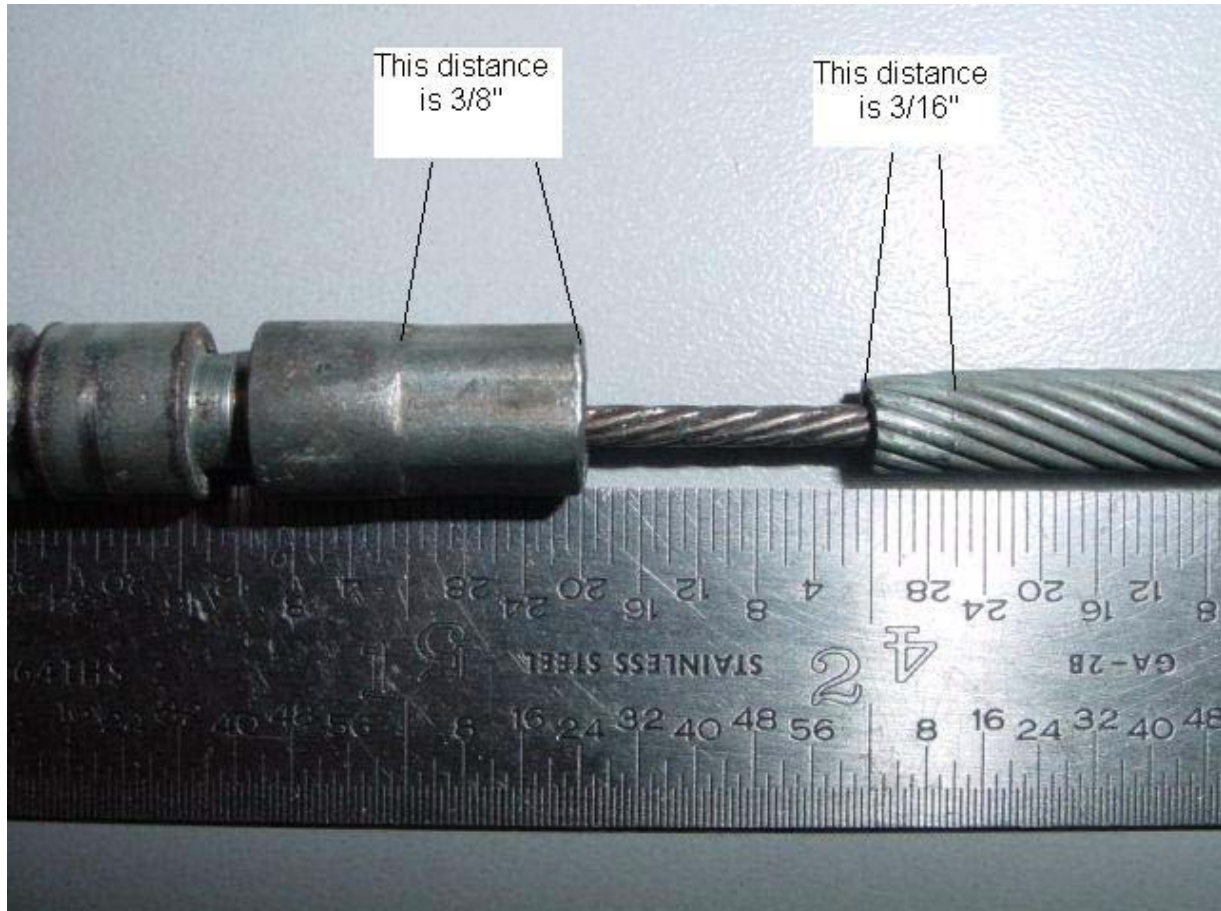
"During climb out and around 600-700 AGL (above ground level)," says this submitter, "the instructor pilot reduced the R/H throttle to idle to simulate engine failure. The student pilot simulated feathering the R/H propeller—and when attempting to set zero thrust, the instructor discovered there was no thrust available. The R/H engine was secured, and emergency declared, and an uneventful landing performed. Upon inspection of the R/H engine (*we found*) the engine end of the swaged portion of the throttle cable had failed, allowing only the cable housing to move when the throttle lever in the cockpit was (*actuated*). Further inspection of the failed swaged area leads me to conclude that during initial assembly of this particular throttle cable (*P/N 554528*) the cable housing had not been inserted into the cable end far enough before the end was swaged onto the cable housing."

Part Total Time: 1,051.0 Hours
