Piper PA31-350, Cracked Main Gear Fittings, ATA 3211

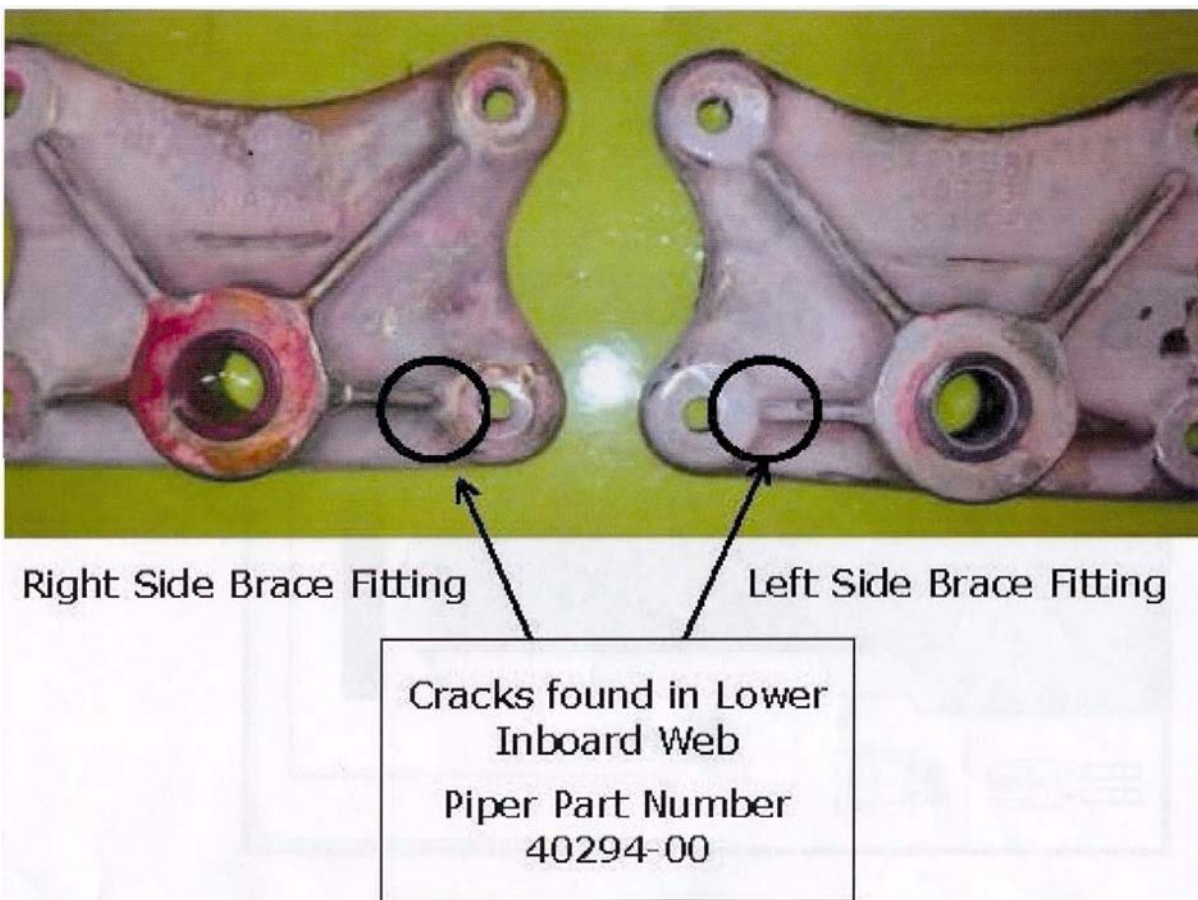
Cracks in the Aft Main Gear Side Brace Fitting Assembly (P/N 40294-00). The Aging Aircraft Lab at the National Institute for Aviation Research (NIAR) in Wichita, Kansas recently produced a report titled, 'The Aging Airplane Study: Piper Navajo Chieftain.' Based on their findings, we initiated a dye penetrant inspection program on the forward and aft main gear Side Brace fitting assemblies on our Piper Chieftain Navajo fleet. The inspection of our aircraft revealed several of the aft fitting assemblies on both the left and right landing gear have cracks located in the lower inboard web of the Side Brace (Piper P/N 40294-00). As a result of finding these cracks, we have added a 1,000-hour Special Inspection to our PA31-350 AAIP (*Aging Airplane Inspection Program*) to monitor and replace any assemblies exhibiting the cracking found in the fitting assemblies. It is interesting to note these cracks have only been found in the aft assemblies on our aircraft."
