## **Bell 430, Cracked Tail Rotor Blade, ATA 6410**

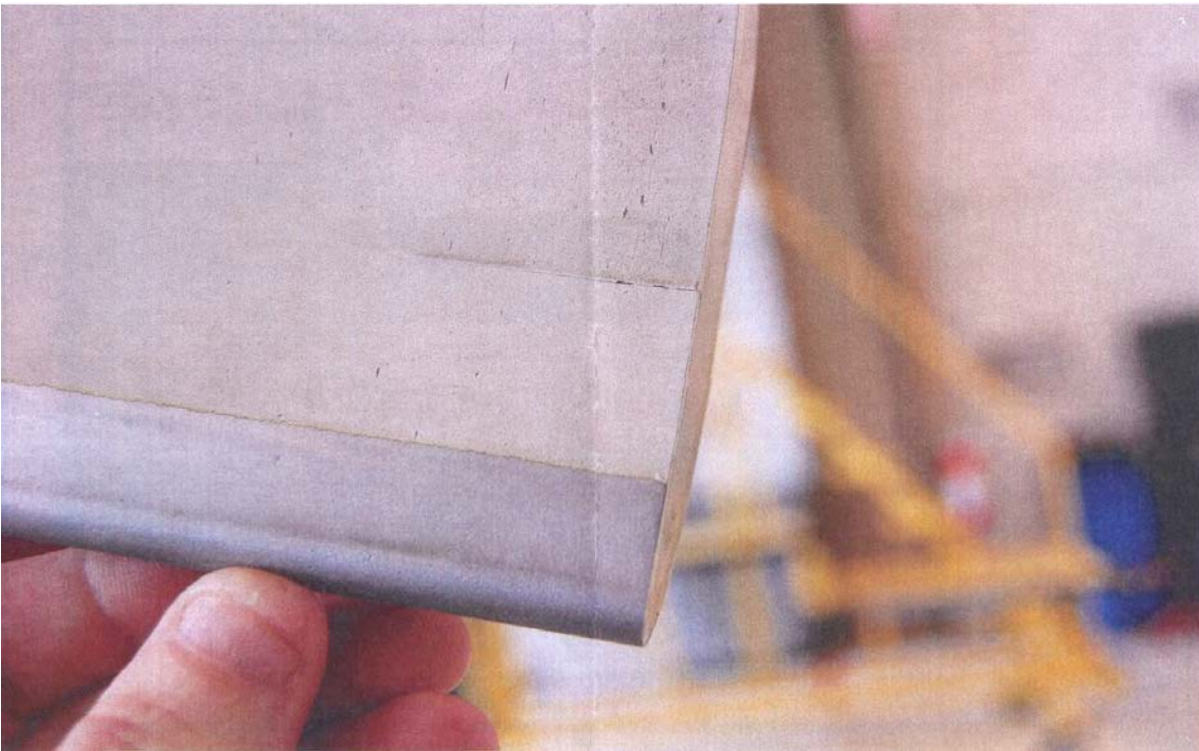
A chief inspector for a repair station states, "This aircraft was flown to our facility and the operator reported '...de-bonding of the tail rotor blade leading edge—at the tip of the blade.' Upon further investigation of the blade, it was discovered that the root end of the blade had cracked and the skin was separated from the blade end. Photographs are included with this report. Information has also been submitted to Bell Helicopter Textron, product support engineering. Probable cause is unknown at this time. This aircraft is operated under Part 135 compliance." (*Tail rotor blade P/N: 222-016-001-131. Tail rotor hub and blade P/N: 222-012-701-125. Photos list as tip views 1-3, then root view 1. Quite dramatic; thanks for the photo effort—Ed.*)

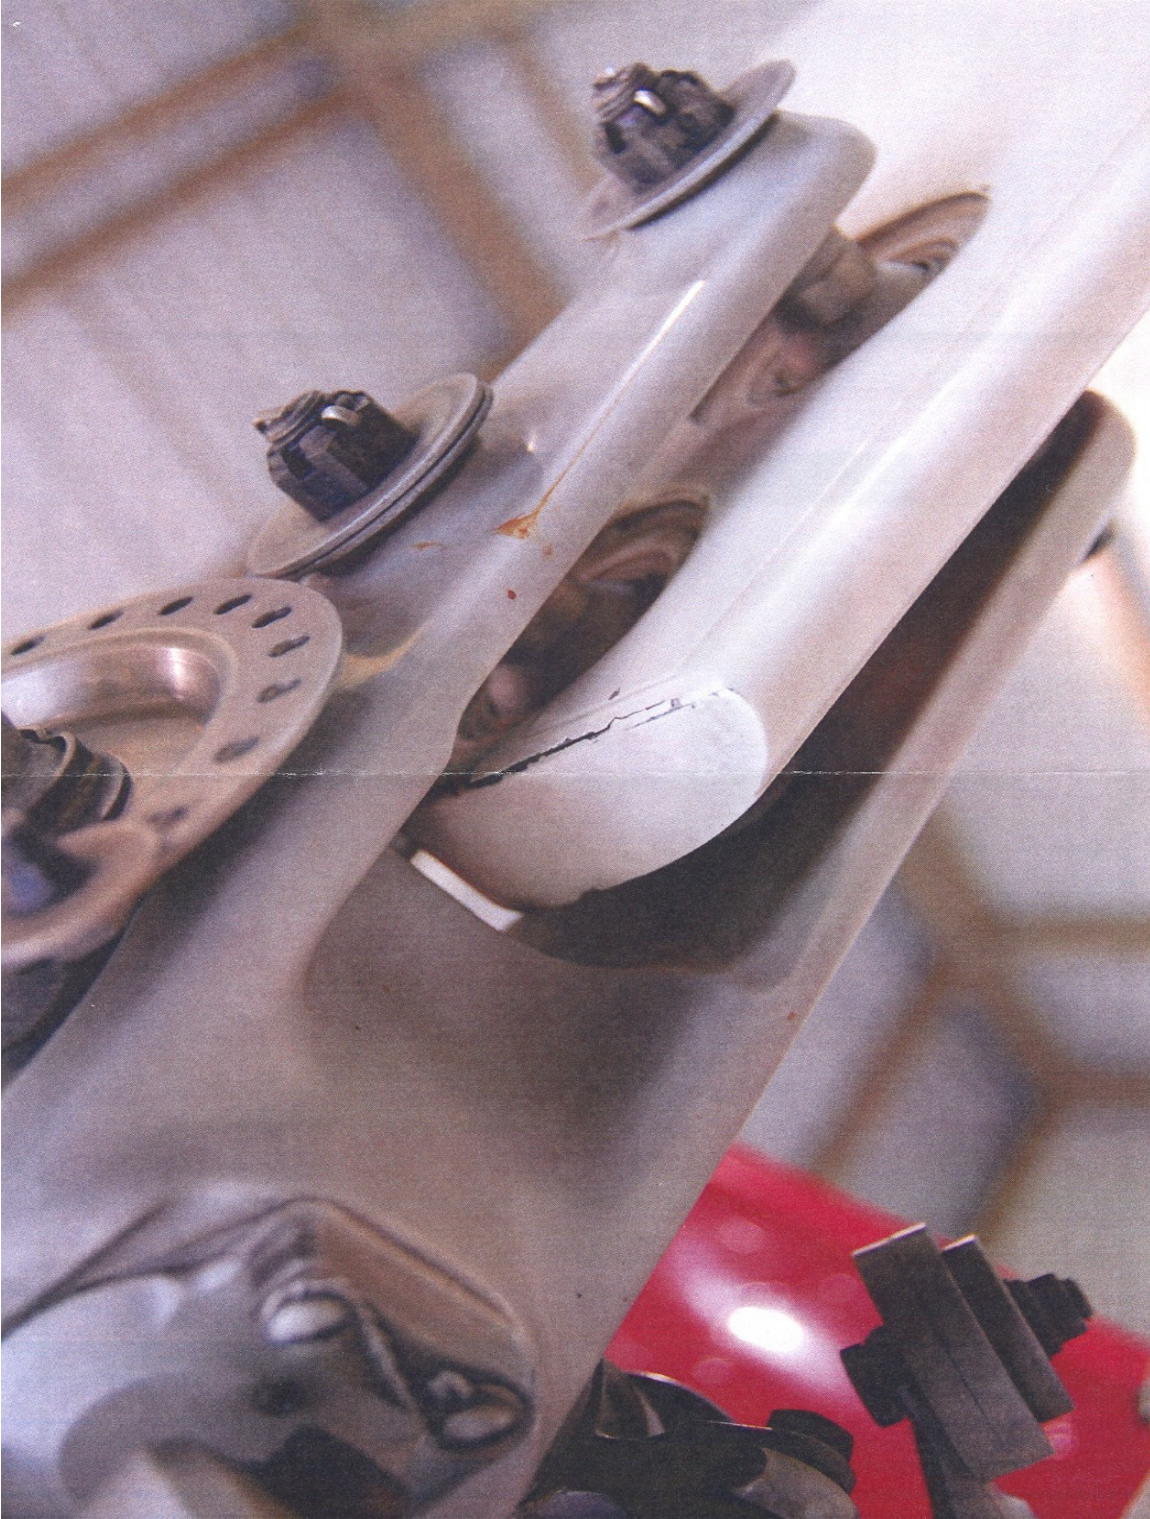
**Bell 430, Cracked Tail Rotor Blade, ATA 6410**

Part Total Time: 1,404.6 hours
