## F. Atlee Dodge, Muffler Shroud, Poorly Positioned Shroud, ATA 2140

*(The following description references a Lycoming O-360-C4P bolted to a Cub Crafter CC18-180).*

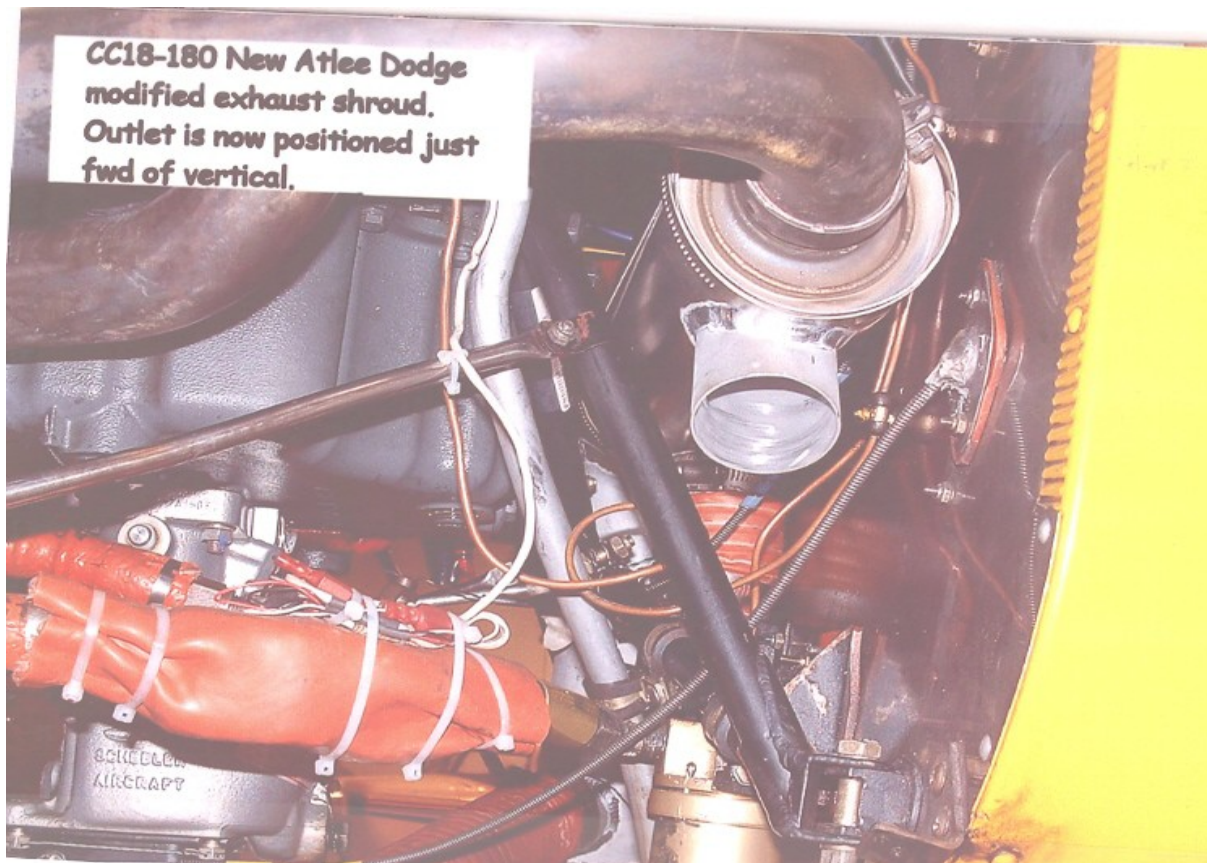
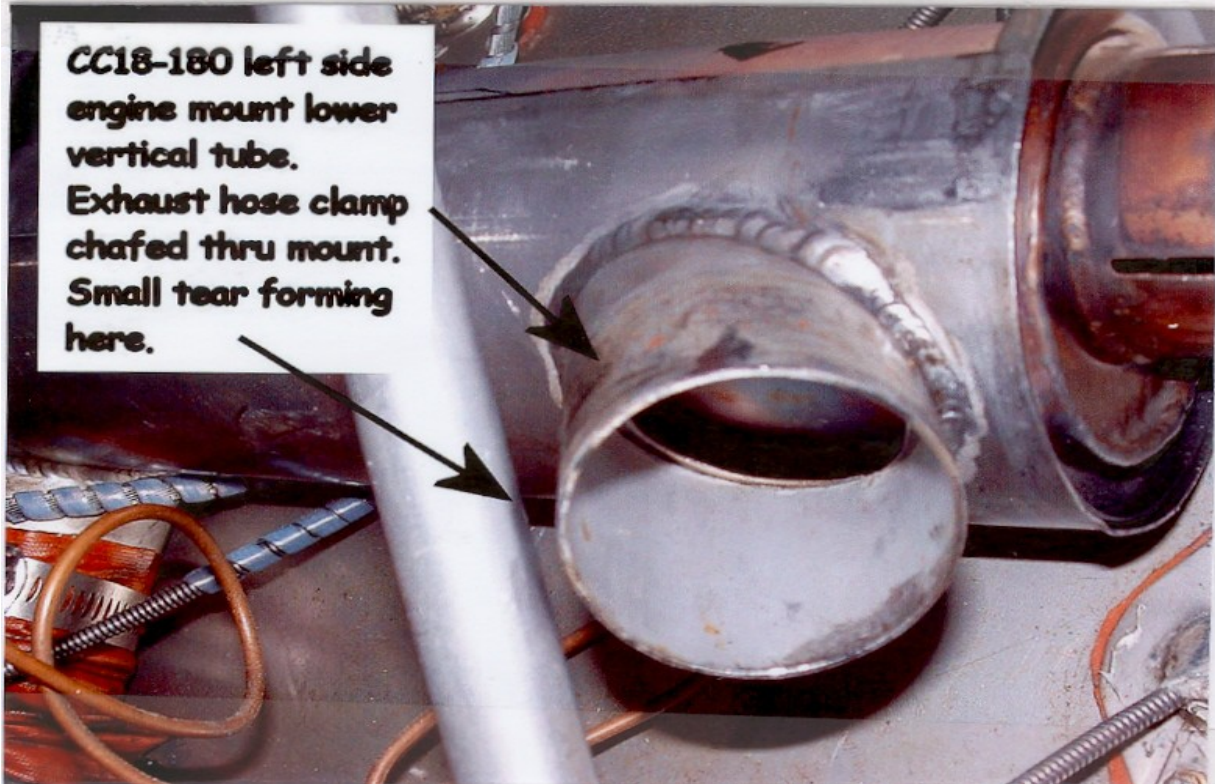
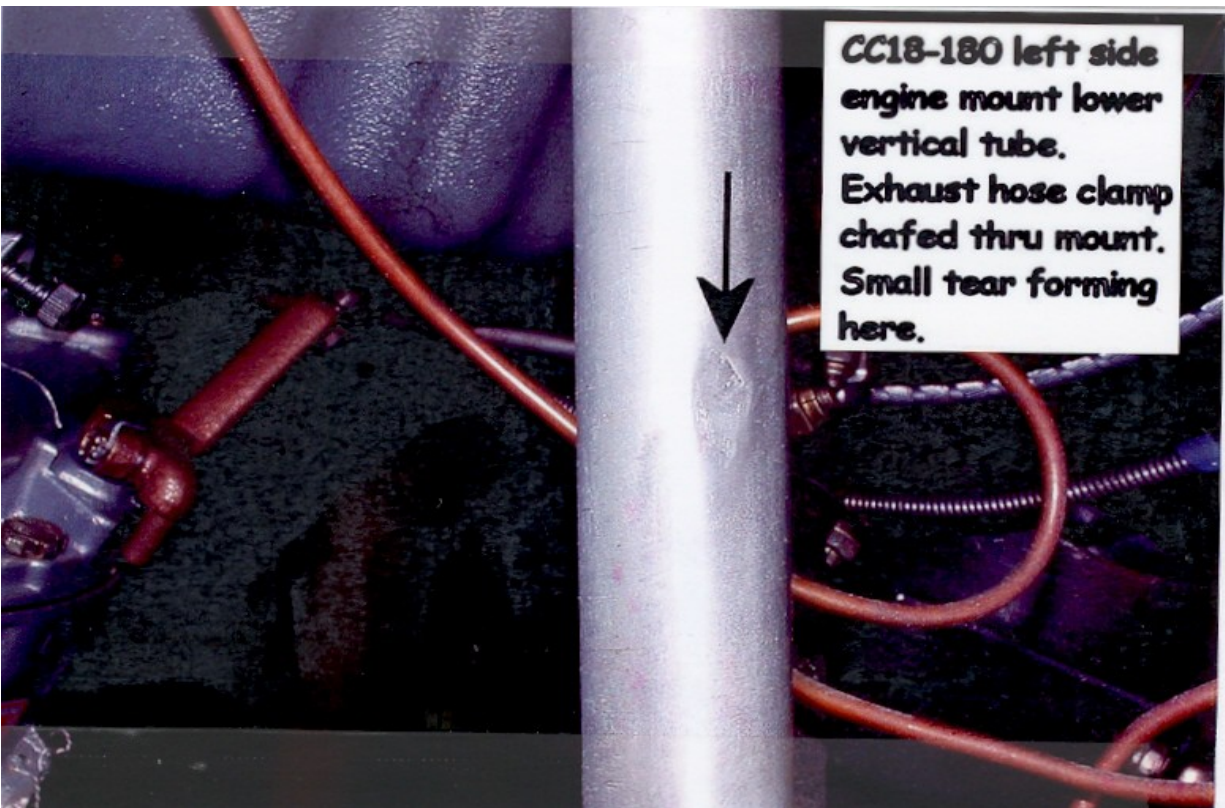
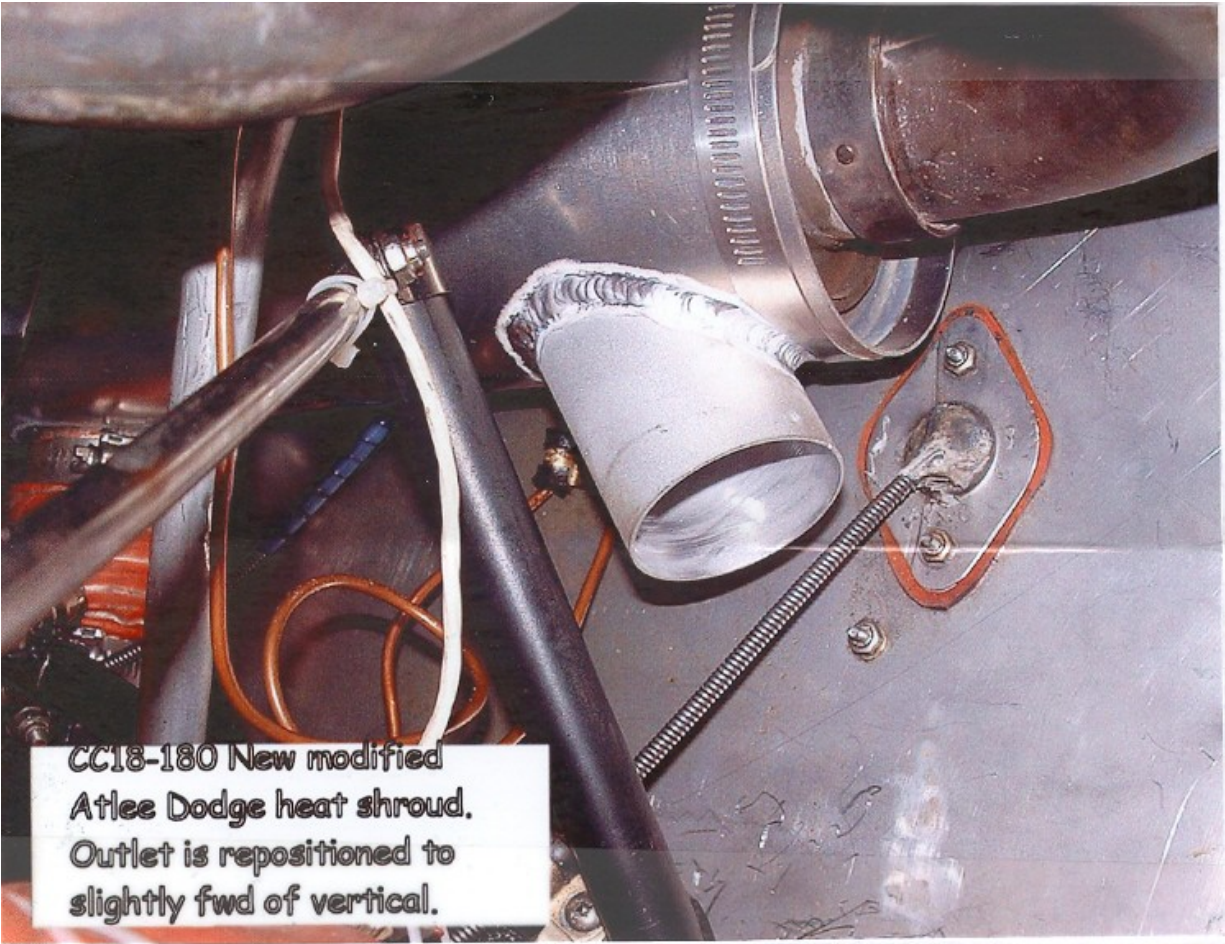
An aviation inspector says, "I removed the aircraft muffler (Atlee Dodge P/N 3241) to perform the muffler inspection and found the hose clamp on the muffler shroud's left cabin heat inlet port had worn a notch through the engine mount's lower left vertical support tubing (Univait P/N 12351-15). A small crack had formed in the top of the notch in the tubing. There was insufficient clearance between the heat shroud and the engine mount, and the shroud hose clamp would vibrate against the mount when the engine was running. When viewed from the left side of the aircraft the original inlet was clocked at about the 8:00 position. We fabricated a new shroud with the inlet clocked at *(approximately)* the 6:15 position, and now there is ample clearance. Refer to the attached pictures for reference. I would recommend checking all CC18-180's for this issue, and replace the shroud with a modified shroud. This shroud had worn the hole in the *(engine)* mount within 1400 hours total time."
