Lycoming TIO540SER, Broken Fuel Line, ATA 7310

(This report references a Piper PA310350 aircraft.)

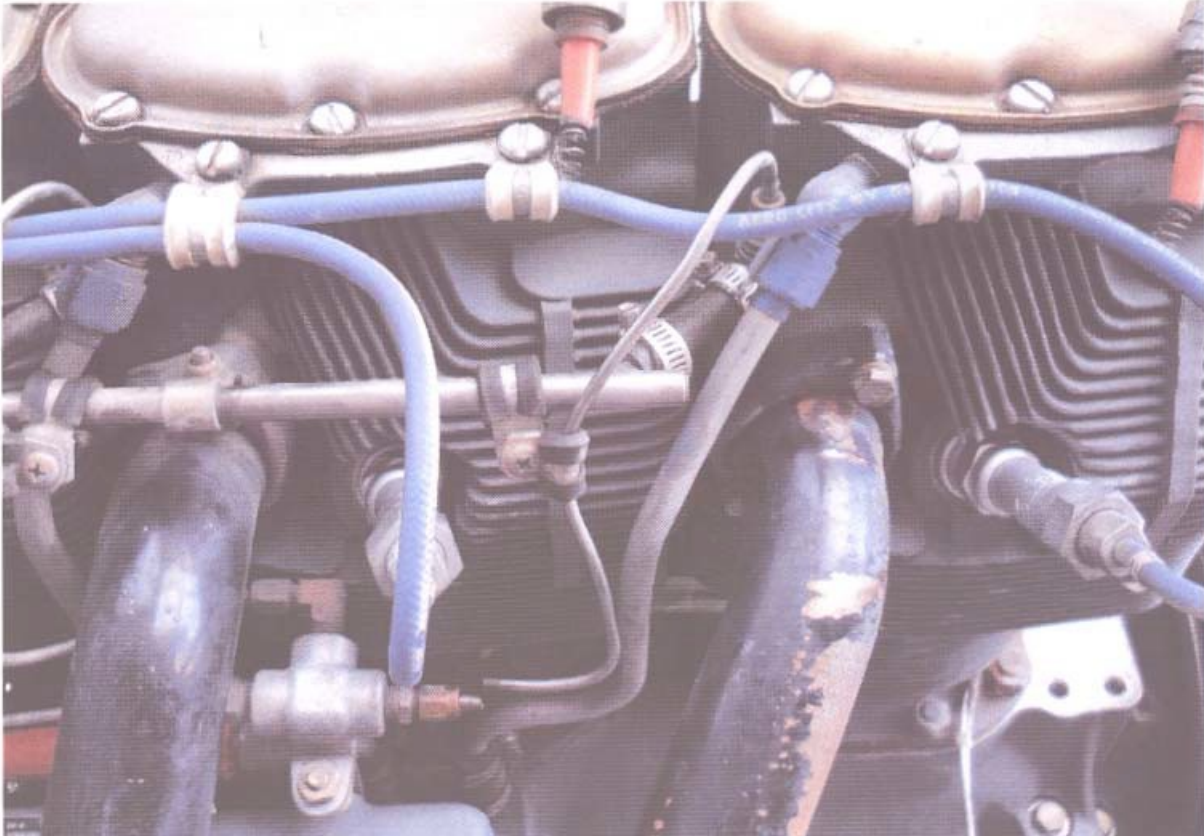
This general aviation report reads, "On departure the pilot reported all engine indications were normal prior to rotation. Climbing out of 4,000 feet the right engine lost power. The pilot proceeded with the 'engine out' procedures—determining the right engine was only producing 30 inches of manifold pressure with 8 PSI fuel flow. The pilot returned to (base) and landed without incident." "Maintenance inspected the right engine and found the number one, cylinder injection line broken. AD2011-26-04 was last complied with in May (2012). The aircraft was last inspected 67.7 hours previous to the total time (20,555.3 hours). No defects were found during the inspection."

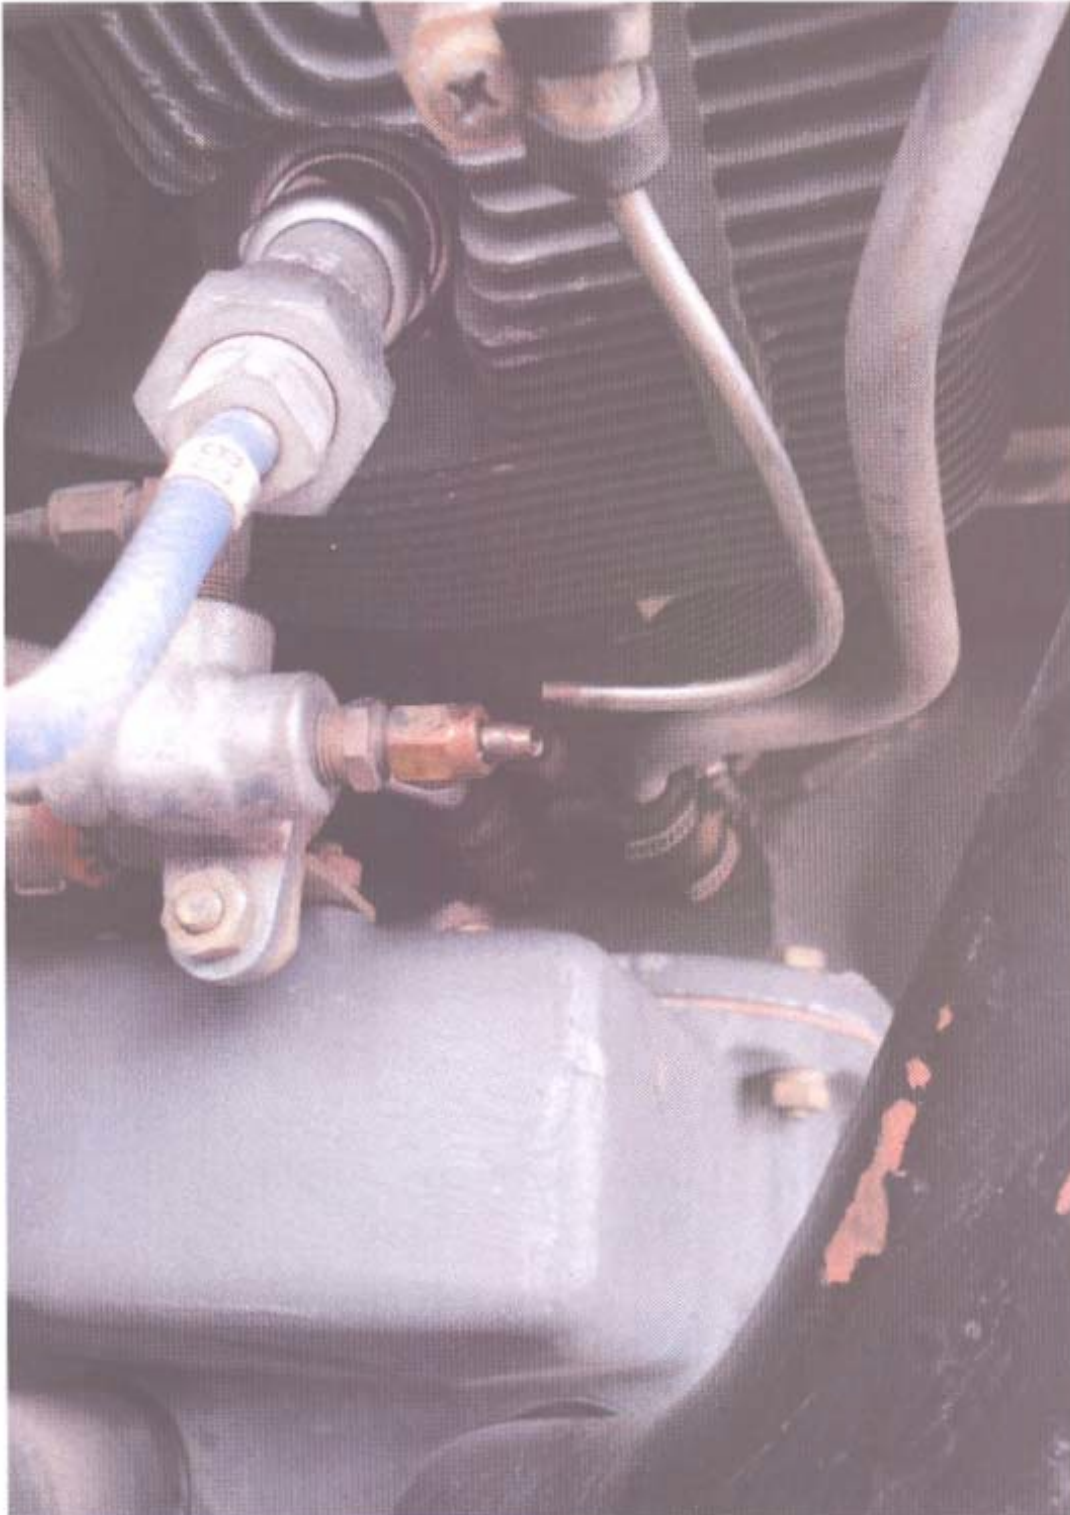
Lycoming TIO540SER, Broken Fuel Line, ATA 7310

(Fuel Line P/N: LW120980100. Nine of these part numbers can be found in the SDRS database.)

Part Total Time: 20,555.3 hours
