Turbomeca, Arrius 2B2, Cracked Guide Vane(s), ATA 7250

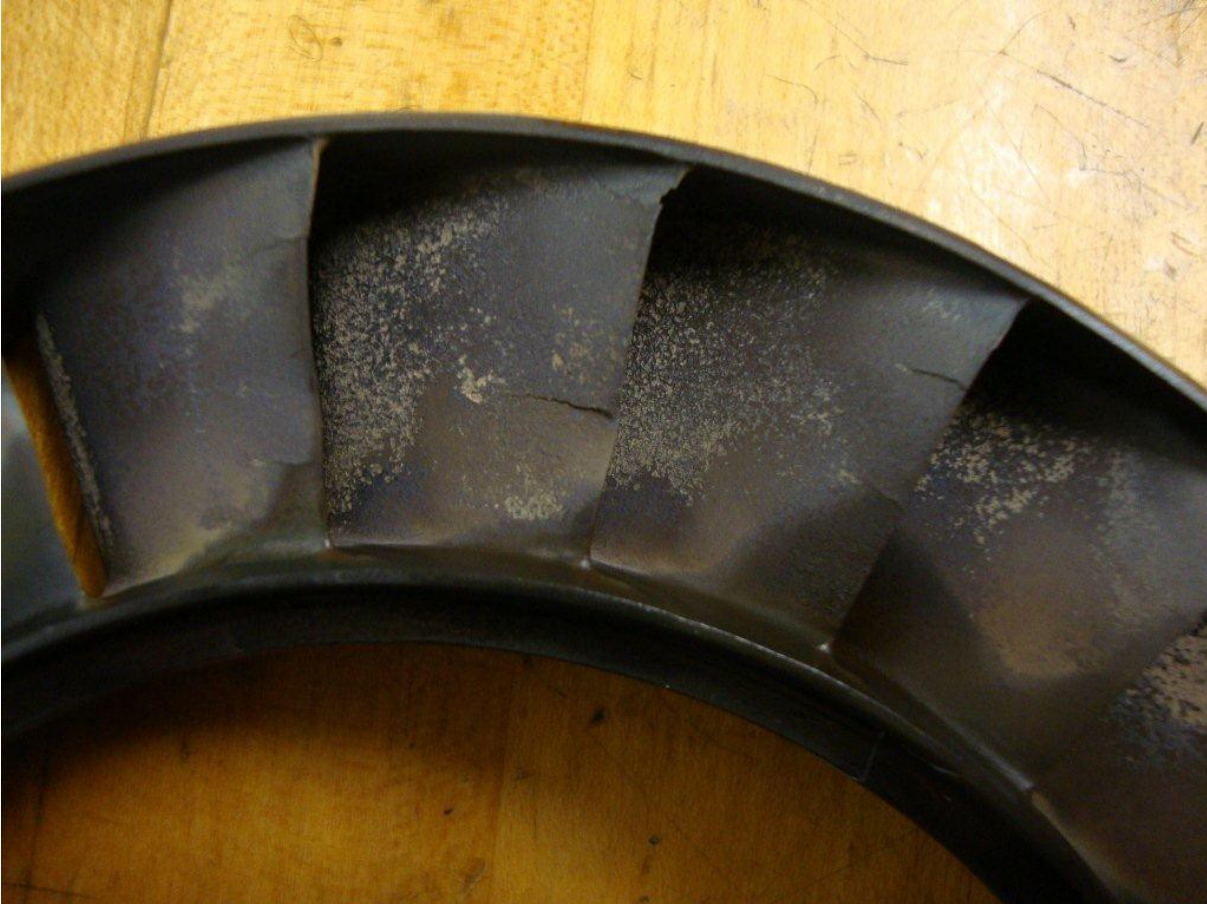
A technician for a corporate operation says, "While performing disassembly of this engine for a rear bearing oil pipe leak, (I) found damage to the following components, including: a PT nozzle guide vane cracked (HP segment, assembly P/N 0319217910); an HP nozzle guide vane cracked (P/N 0319218310); the flame tube cracked (P/N 031917850); Diffuser with FOD (P/N 0319210050; and the T-4 harness broken. All of these parts are being replaced." *(Additional listed parts: Module 2 P/N: 70EM027070 with cracked guide vane P/N 1319411580.)*

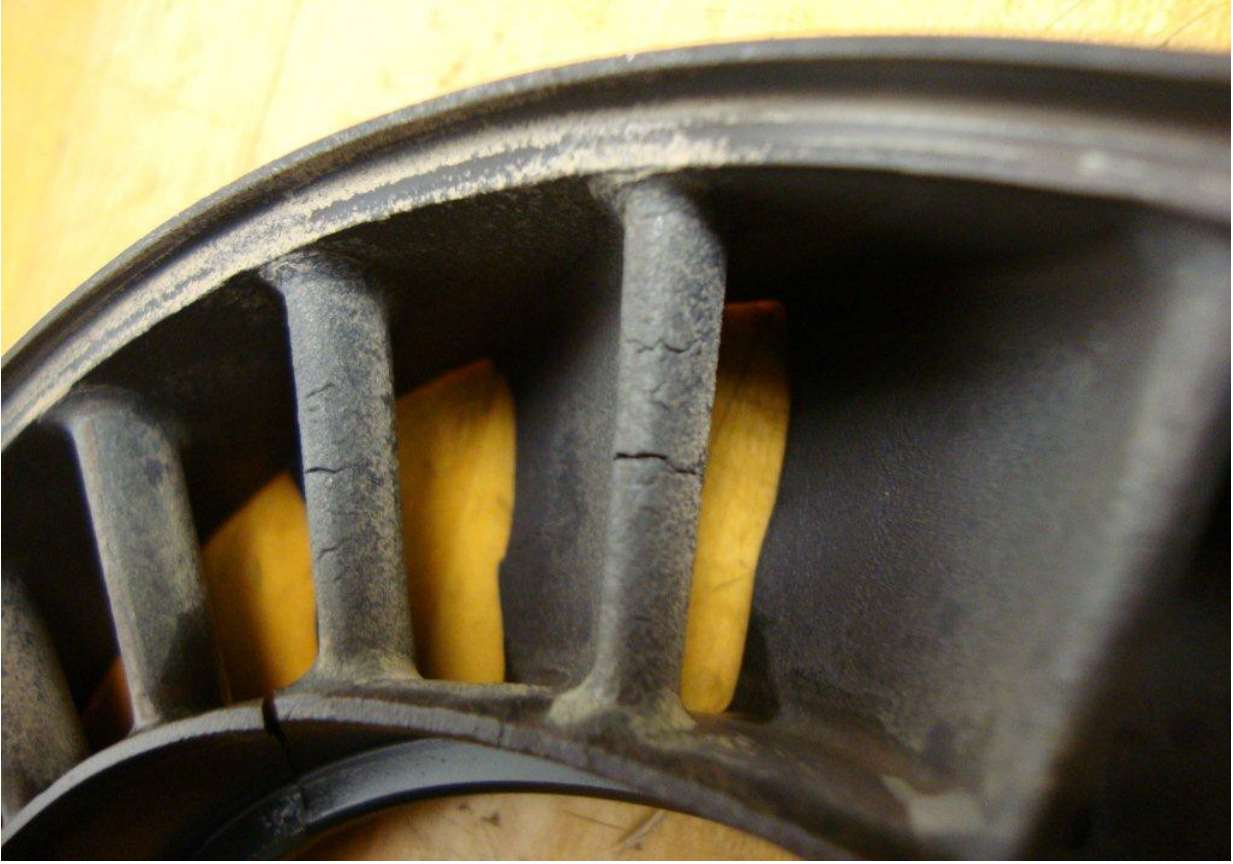
Turbomeca, Arrius 2B2, Cracked Guide Vane(s), ATA 7250

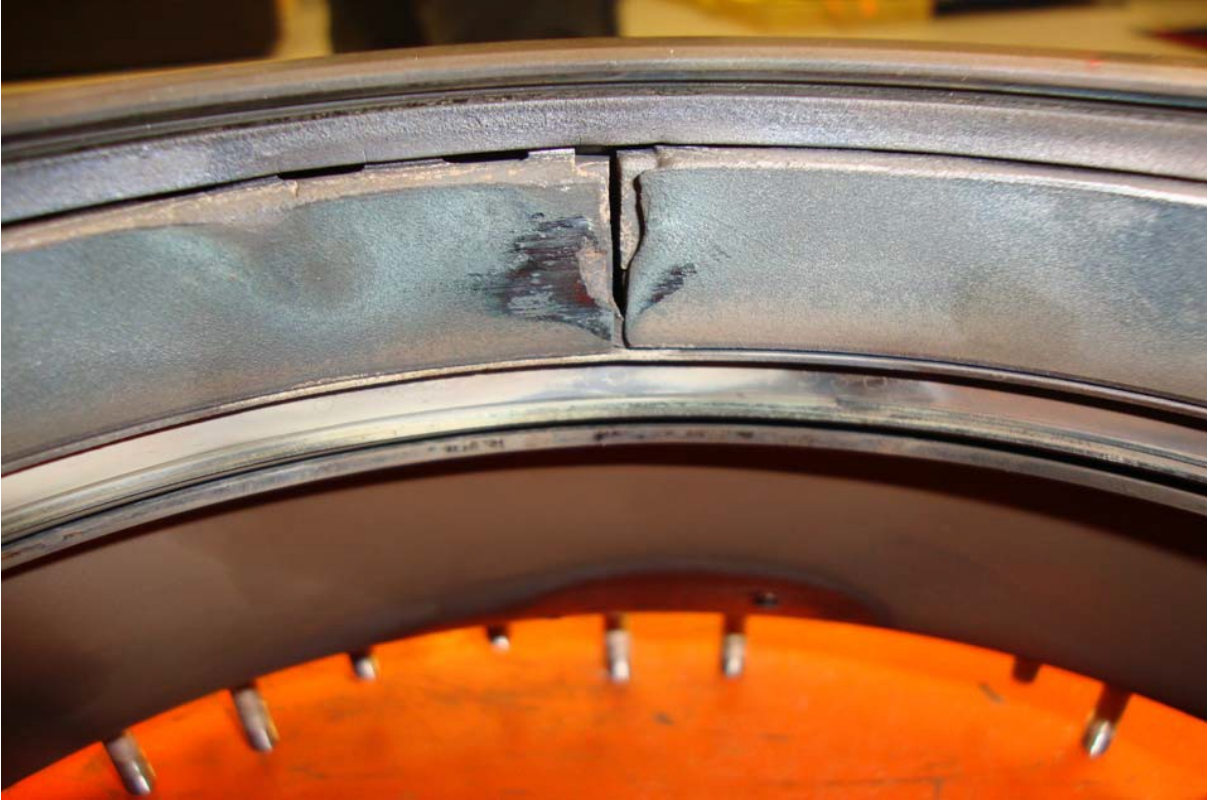
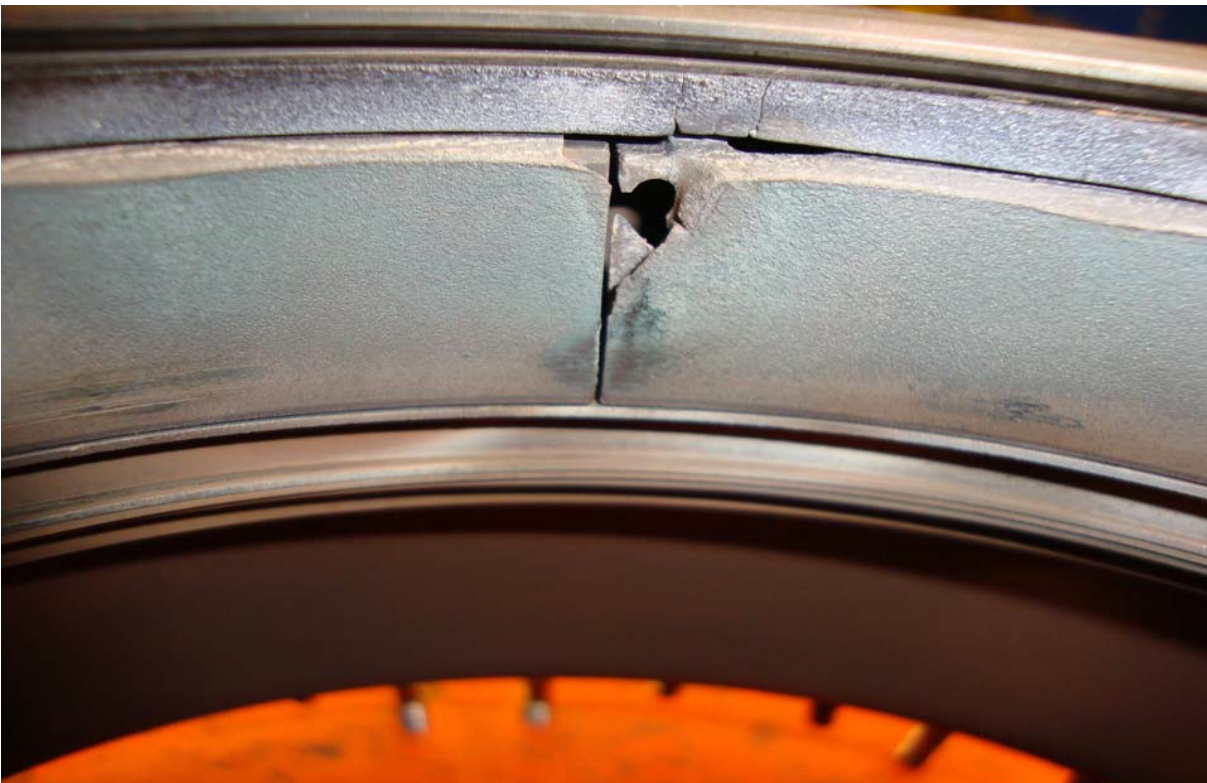
Turbomeca, Arrius 2B2, Cracked Guide Vane(s), ATA 7250

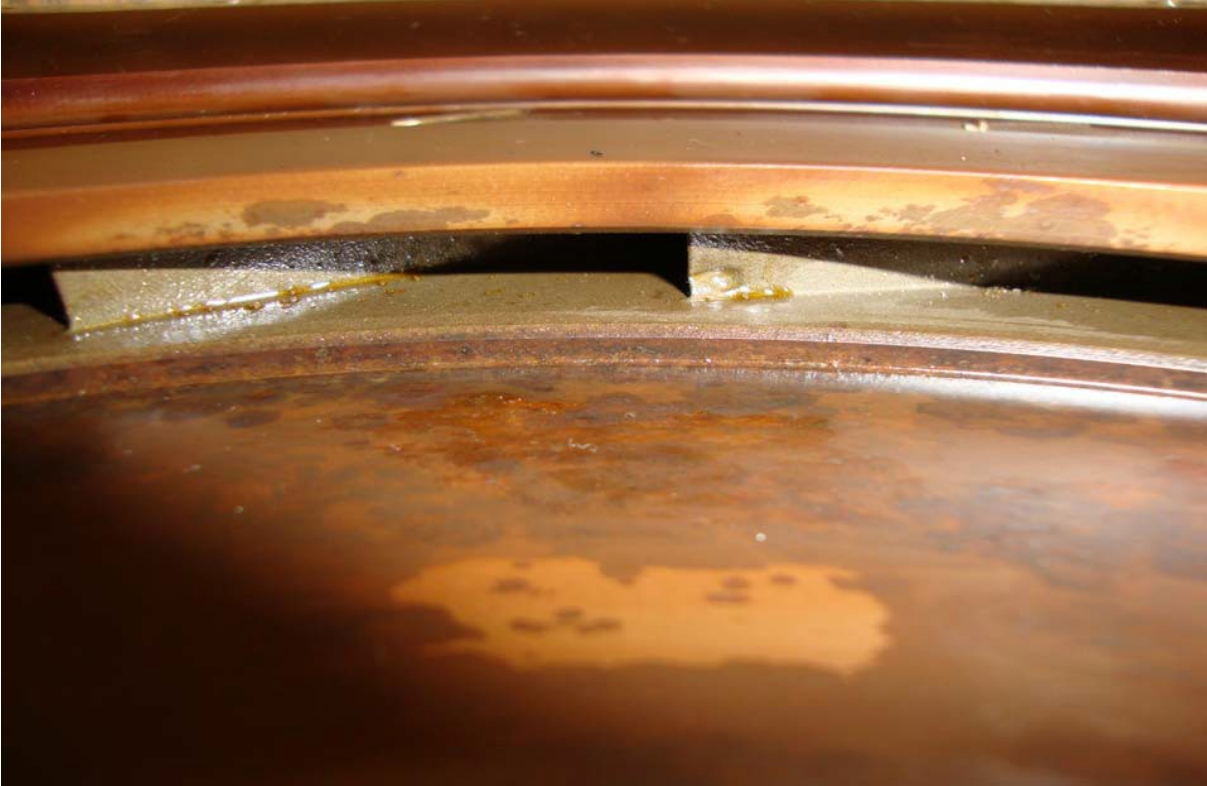
Turbomeca, Arrius 2B2, Cracked Guide Vane(s), ATA 7250
