Cessna Alternator P/N 99105923, Brush Failure, ATA 2434

(This report references a Cessna T206H aircraft with a Lycoming TIO540AJ1A engine.)

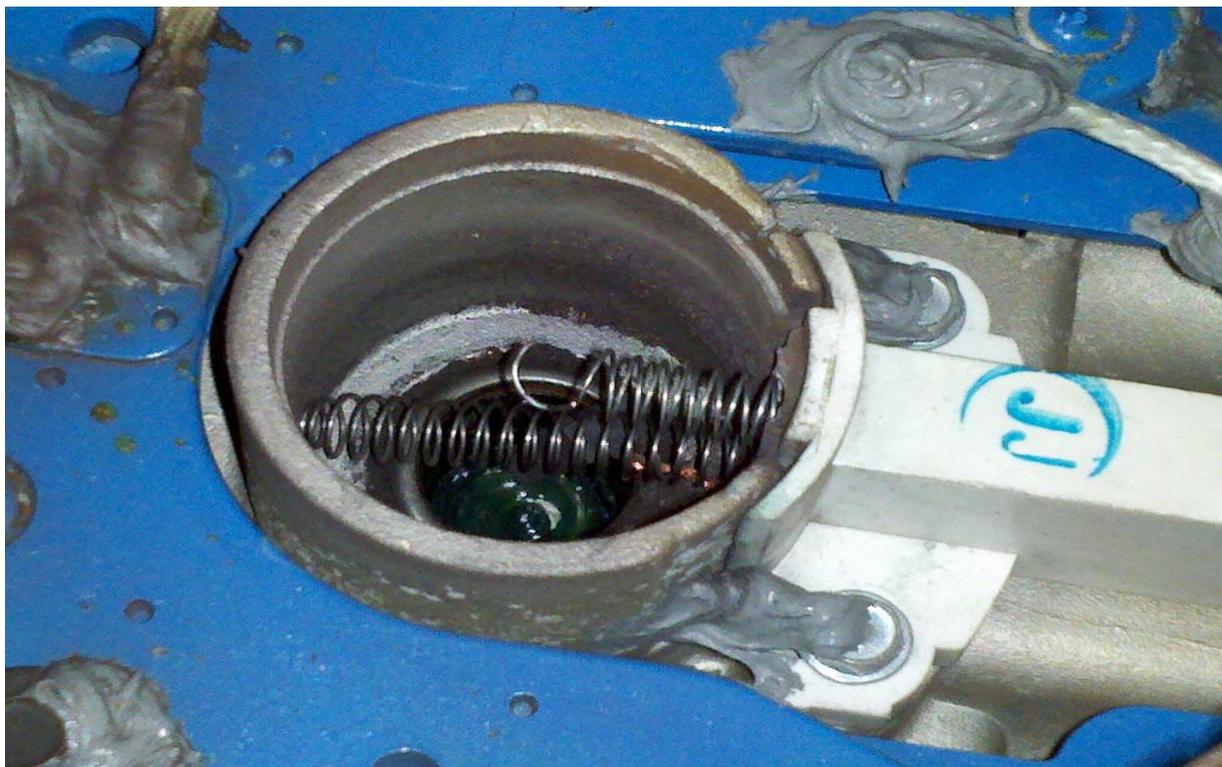
"The alternator was disassembled—found the ground brush (to be) 0.375 inches long. The field brush was completely disintegrated, with the spring contacting the slip ring. This alternator is only available from the manufacturer. There are no known third party overhaul facilities. The aircraft manufacturer service documents provide no service or parts data. There are no aircraft manufacturer inspection protocols beyond external security checks. Brush and/or slip ring inspection can only be accomplished by disassembly of the case.

"I suggest a re-design to permit proper periodic inspection the brushes, make service and overhaul data available, and/or improve quality. Neither 'operation to failure' or 'periodic mandatory alternator replacement' is (acceptable)."
