## Pratt & Whitney PW610F, Coked Combustion Line, ATA 7250

*(This engine report references an Eclipse EA500 business jet aircraft.)*

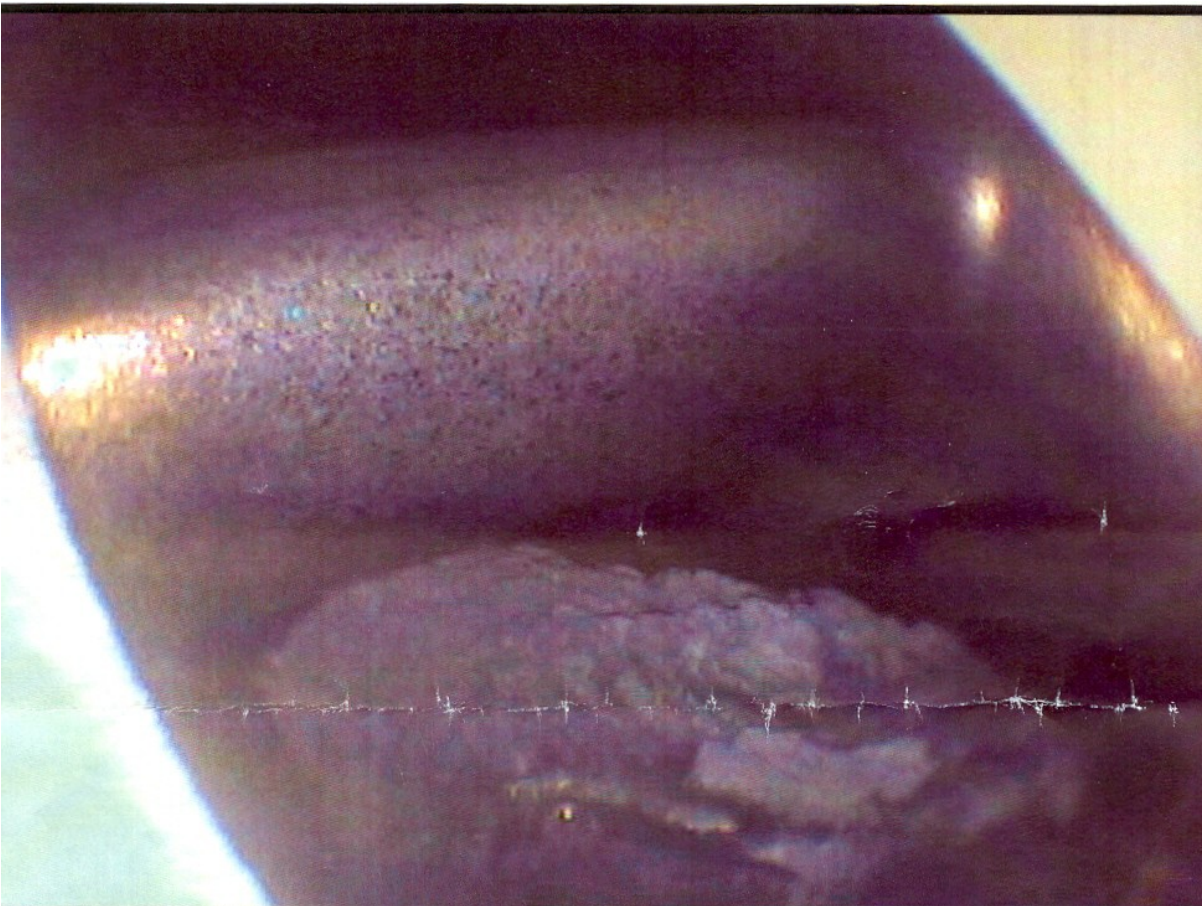
An FAA inspector writes, "*(This aircraft) developed a problem with the left engine temperature running high, followed by a 'left engine exceed' CAS (Crew Alerting System) message. The pilot reduced power on that engine hoping to reduce its temperature—but the temperature continued to climb. The engine was shut down, and then he notified (the destination's ATC) Air Traffic Control center. The aircraft was flying at FL 370 (flight level 37,000) when the call was made. The (flight) was diverted to an (alternate) airport due to the loss of the left engine, landing without incident.*" *(Here the engine was replaced by Pratt and Whitney.)*

"Airworthiness Directive AD 2008-24-07 limits this aircraft to FL 370—higher altitudes cause this aircraft engine to quickly produce hard carbon buildup (coking)."

*(Given the aircraft was operating within its altitude parameters, what caused the coking? Answer: Since this defect report submission early last year, AD 2008-24-07 has been superseded by AD 2011-06-06, lowering the maximum operating altitude to 30,000 feet. Reference:*

*Only one paper-scanned photo survived multiple e-mail transmissions sufficiently well to show some of the coke (carbon) buildup on what appears to be the turbine's rotor or stator—Ed.)*
