## **Sky-Tec Starter: C24SF3, Shorted Commutator, ATA 2434**

(This report references Cirrus SR20 aircraft with a Continental IO360ES engine.)

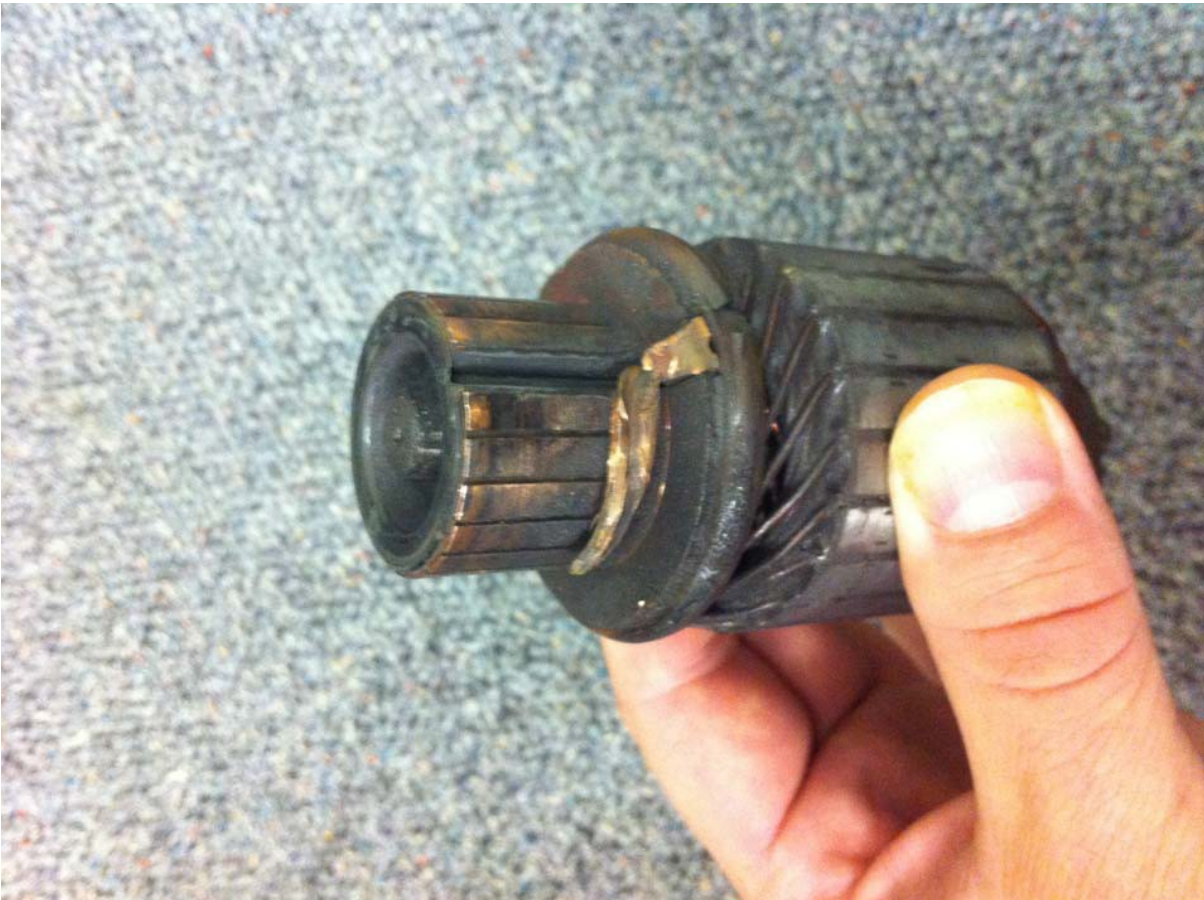
"After start up, the crew noted the R/H IFD (instrument flight display) went blank," says this repair station mechanic. "The maintenance crew suspected a bad battery (low voltage), so they installed a new battery. When the negative wire was installed, a large spark (was generated). The 'Battery NO. 1' relay was found to be stuck. After replacing the relay and the battery, the engine would not start. The starter was replaced, and during run up all conditions were normal. IFD data was downloaded and reviewed, and the starter disassembled. The maintenance crew determined a dead short-to-ground caused by a section of the commutator coming loose had caused Battery NO. 1 to rapidly discharge, causing the relay to stick in the closed position. (My) recommendation to flight crews is to monitor the systems page on the IFD (after start up) to determine proper battery discharge/charge rate and bus voltages."
