Slick Magneto 6310, Failed Contact Points, (2) ATA 7414

(This defect occurred on a Beech A36 aircraft.)

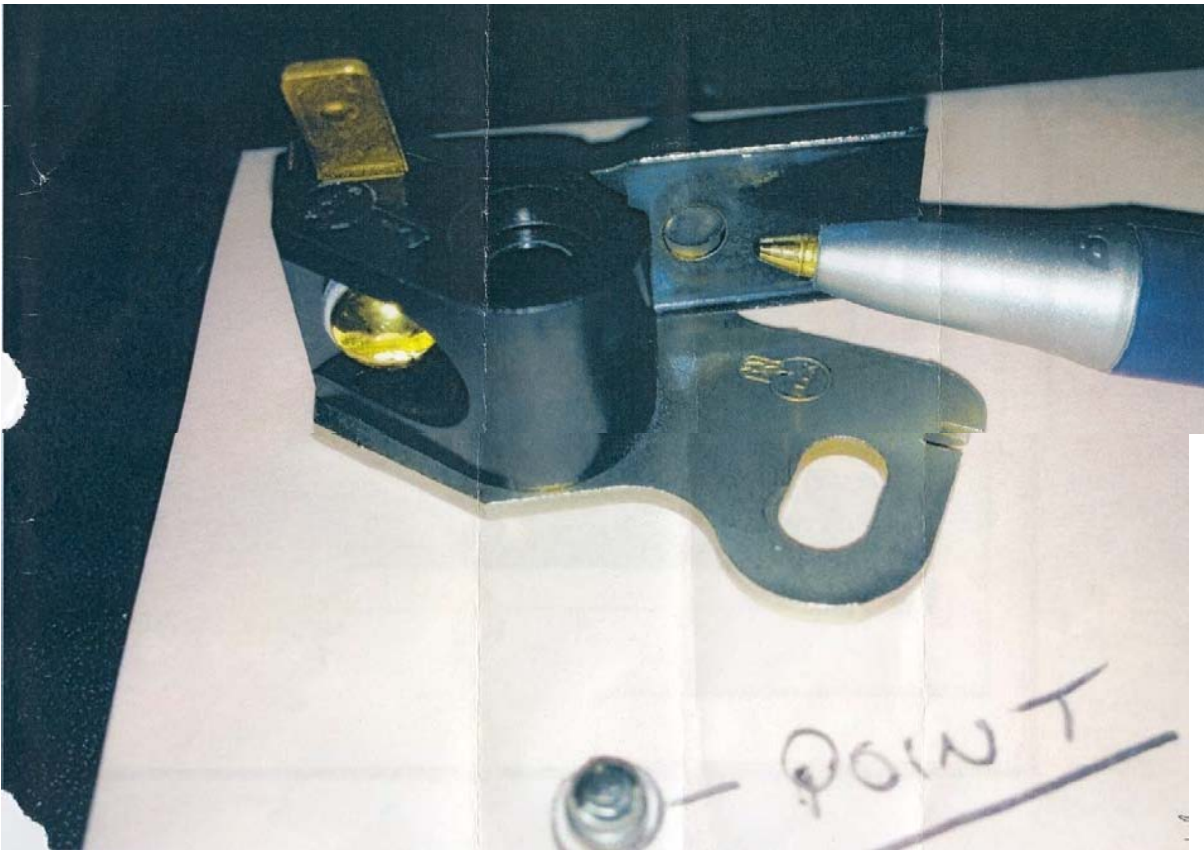
A repair station mechanic describes this failure. "This engine was running rough—when the magneto switch was moved to the R/H magneto position the engine would stall. (I) performed a run-up to verify the discrepancy. The magneto was removed from the engine and disassembled far enough to find the contact assembly's (P/N M3081) arm was missing the contact point. Further inspection found the missing point—it was removed from the magneto. (I) reassembled the magneto with a new contact assembly IAW the Component Maintenance Manual. Engine run-up was then performed with no defects noted. I suspect an improper crimp of the contact point to the arm (at the time of manufacture as the cause of this failure)."
