Slick Magneto 4330, Broken Impulse Coupling, ATA 7414

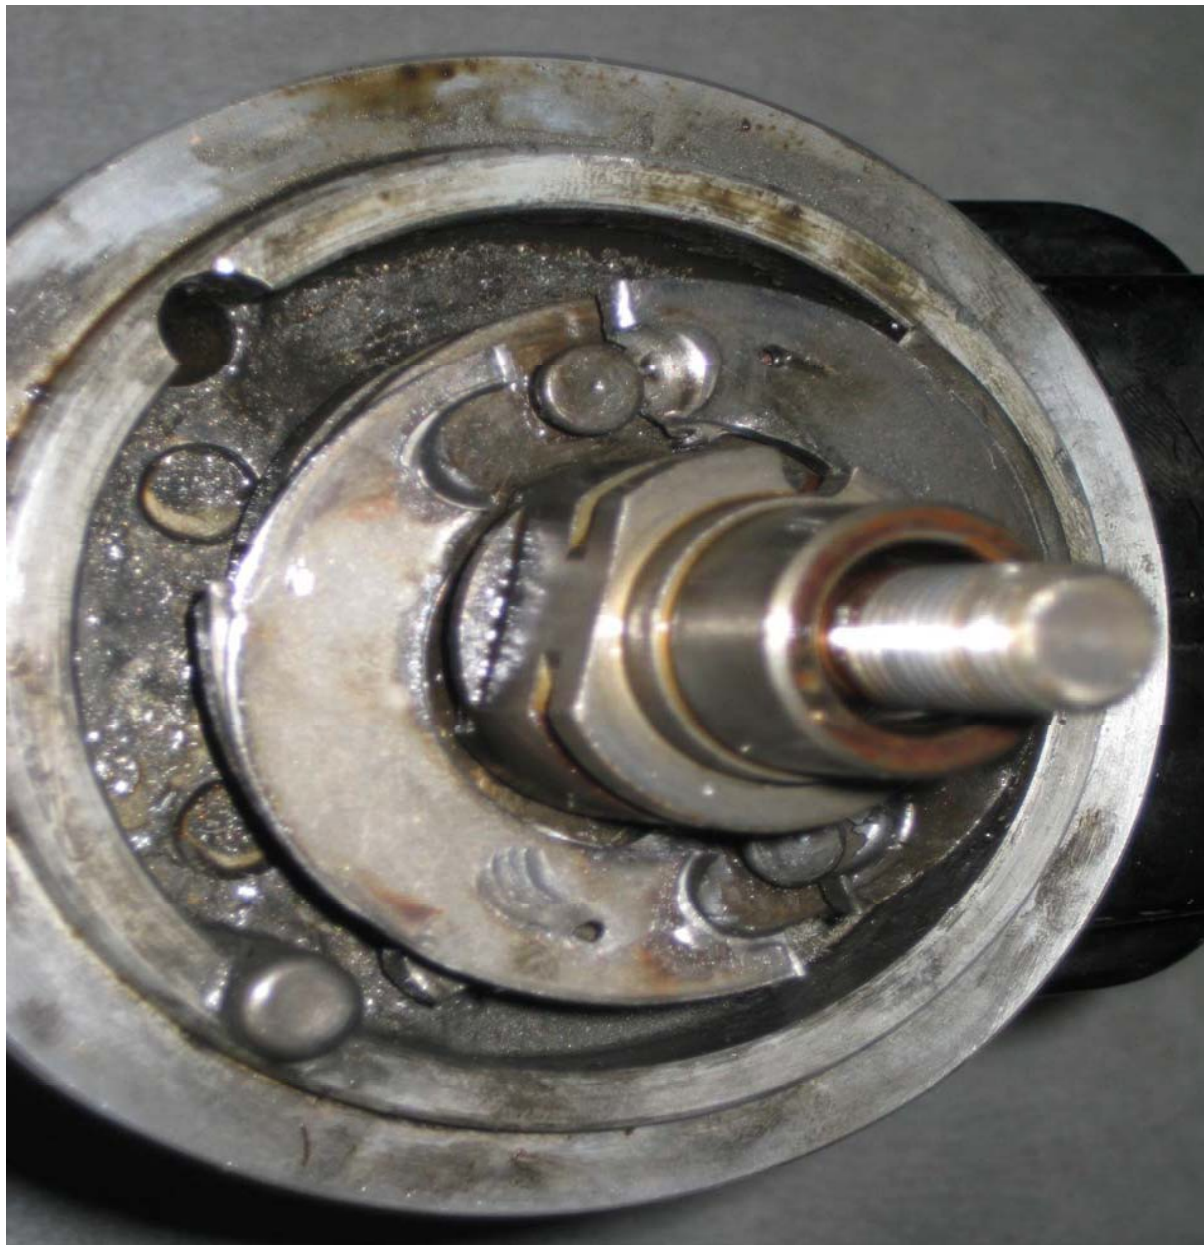
A general aviation submission states, "The L/H magneto on the R/H engine cut out while running the engine. After removing the magneto, (we) noticed the impulse coupling hub spacer had *(pulled)* away from the rivets and split into two pieces." (*Component number M3068. Next photo vertically compressed—Ed.*)

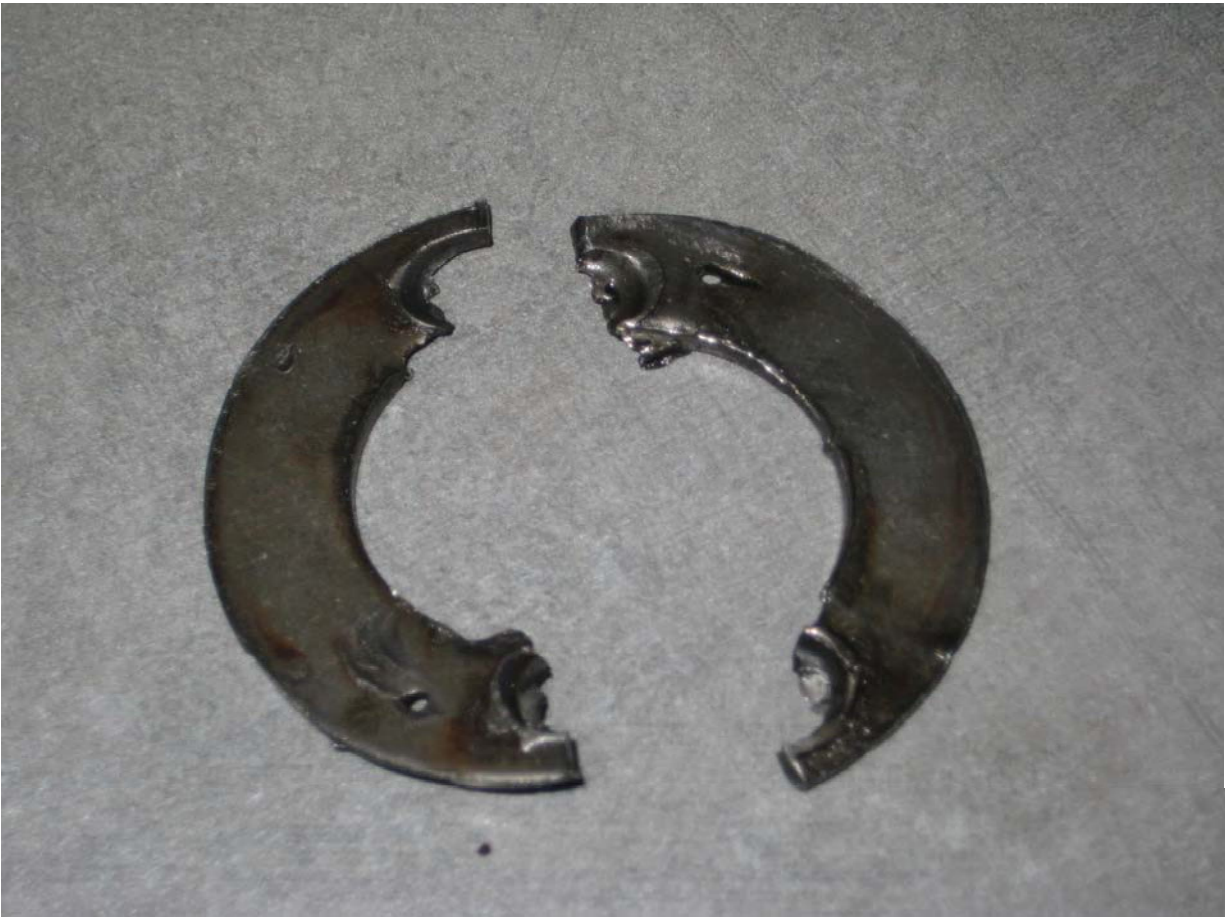
Slick Magneto 4330, Broken Impulse Coupling, ATA 7414

Part Total Time: 977.0 Hours
