## **Rotax 912ULS, Failed Crankshaft Connecting Rod, ATA 8520**

December 2010 AC 43-16A

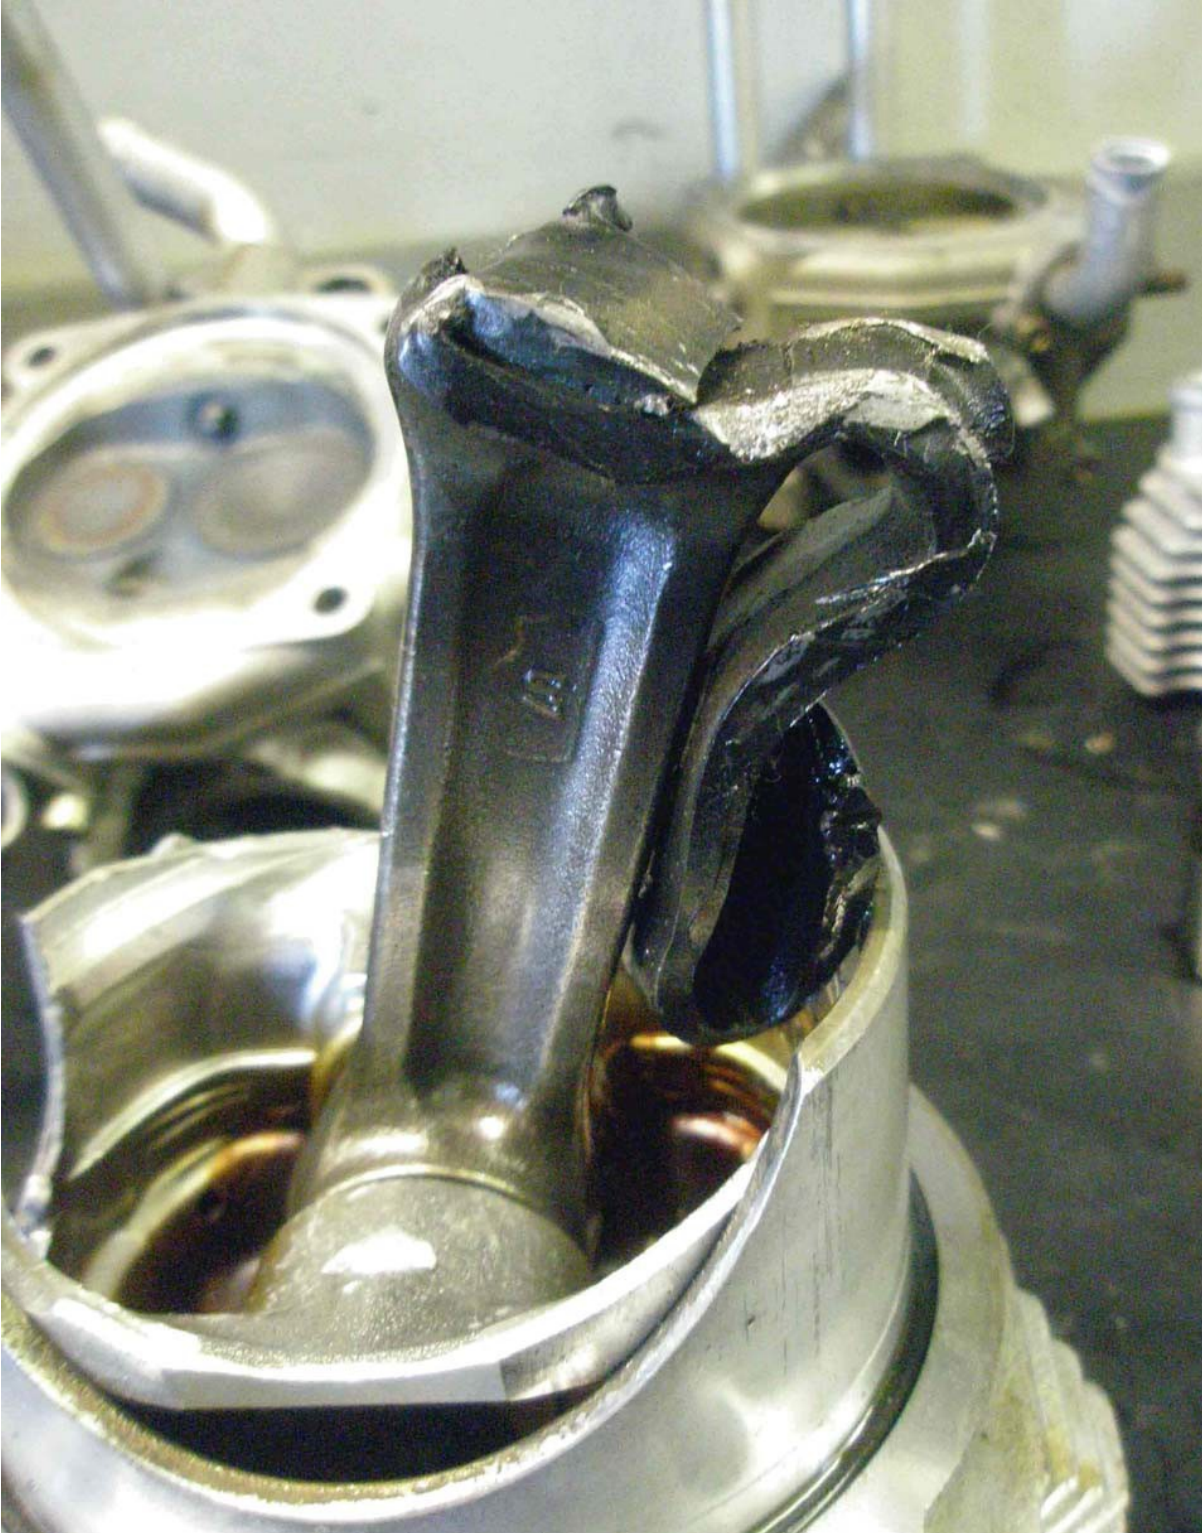
**Rotax 912ULS, Failed Crankshaft Connecting Rod, ATA 8520**

A repair station submission says, "The number three crankshaft rod failed in flight, knocking a hole in the crankcase. The engine remained running and the pilot was able to return the aircraft to the airport. One quart of oil was remaining in the oil tank.

A supplier/repair station performed a tear-down inspection and was unable to determine a conclusive cause for this engine failure" (P/N: 888164).

Part total Time: 607 Hours
