Beech 95B-55, Corroded Fuel Pressure Line

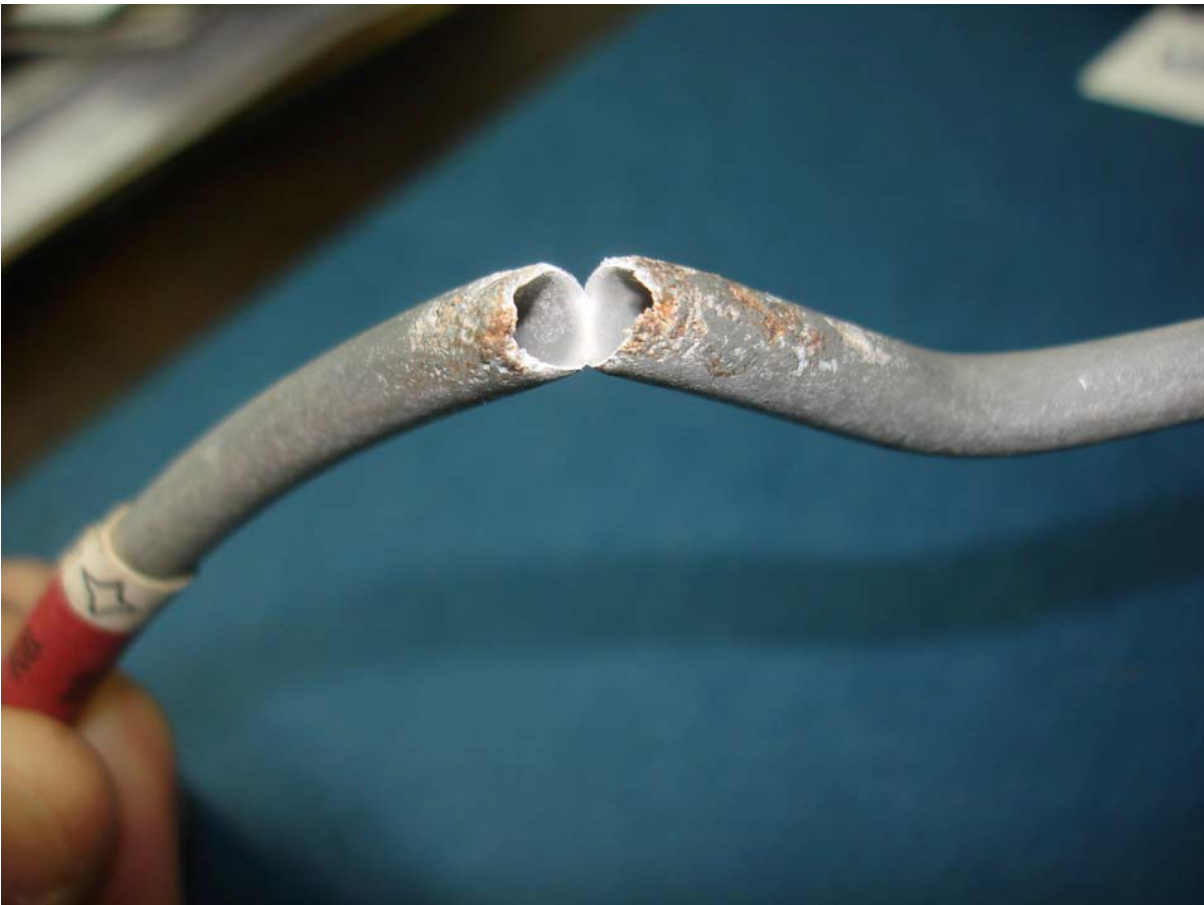
A general aviation submission states, "I was motivated to access and closely inspect the right fuel-flow, pressure gauge line where it crosses the CEET type defrost duct because it looked like they may be contacting each other. I was concerned about chafing or corrosion. The upper right side area behind the instrument panel is very difficult to inspect. It is not accessible from above, or at arm's length from below. The line crosses above the duct. I almost gave up inspecting this area closely, but ultimately I found extensive corrosion at the point of contact. After the line was removed, I saw a slight bending pressure cracked the area wide open and that the corrosion had actually penetrated to the inside of the line; however, the line was not leaking up to this point in time. If a leak started, the only way to stop it would be to shut down the right engine.

I strongly recommend careful, intense inspection of all lines in the vicinity of any CAT or CEET type duct, as these are notorious for causing corrosion or chafing. This particular instance is, of course, model specific and is sufficiently serious to demand attention. This particular aircraft has very little corrosion overall, but this fuel line defect was definitely caused by the ducting.

Part Total Time: 3,000 hours
