## **Beechcraft C90GTX, Failed Nose Wheel Steering, ATA 3250**

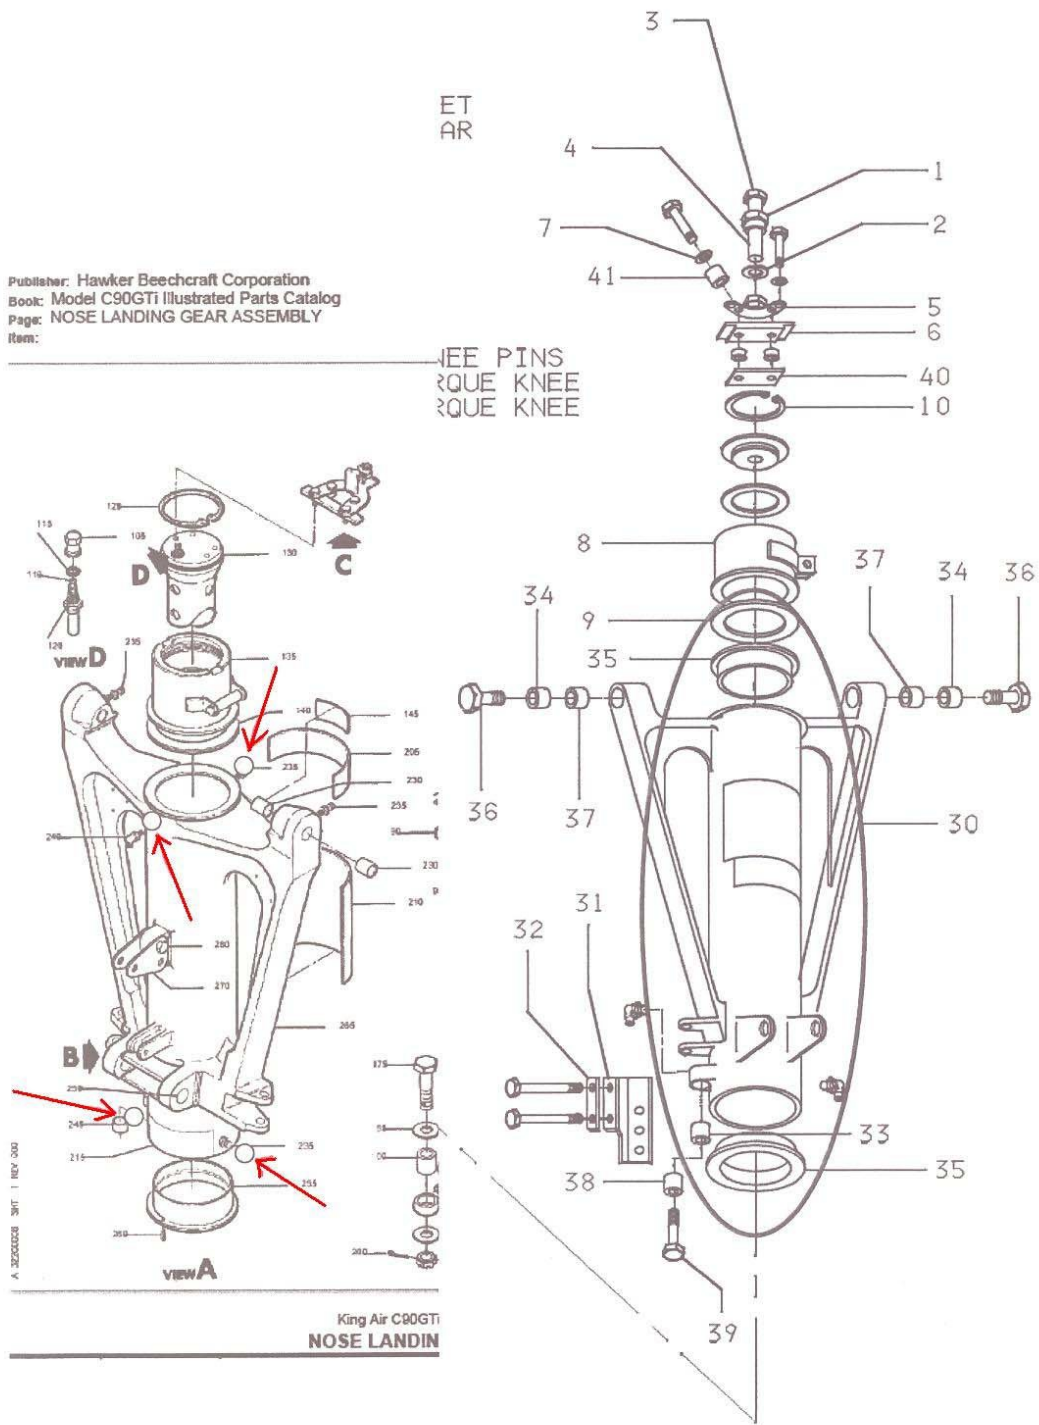
Publisher: Hawker Beechcraft Corporation  
 Book: Model C90GTX Illustrated Parts Catalog  
 Page: NOSE LANDING GEAR ASSEMBLY  
 Item:

A repair station technician states, "Coming from the taxi holding bay, the aircraft went out on the runway, the nose wheel steering was deemed to be inoperative. Investigation and inspection performed by maintenance found a lack of grease on the steering brace (P/N 101-820024-15). No other findings or problems were found on the steering assembly. After grease application, operational and functional tests performed smoothly.

Recommendation: the steering brace must be greased with the aircraft both on and off jacks to guarantee full lubrication.
