Piaggio P180, Burned Wiper Relays, ATA 3040

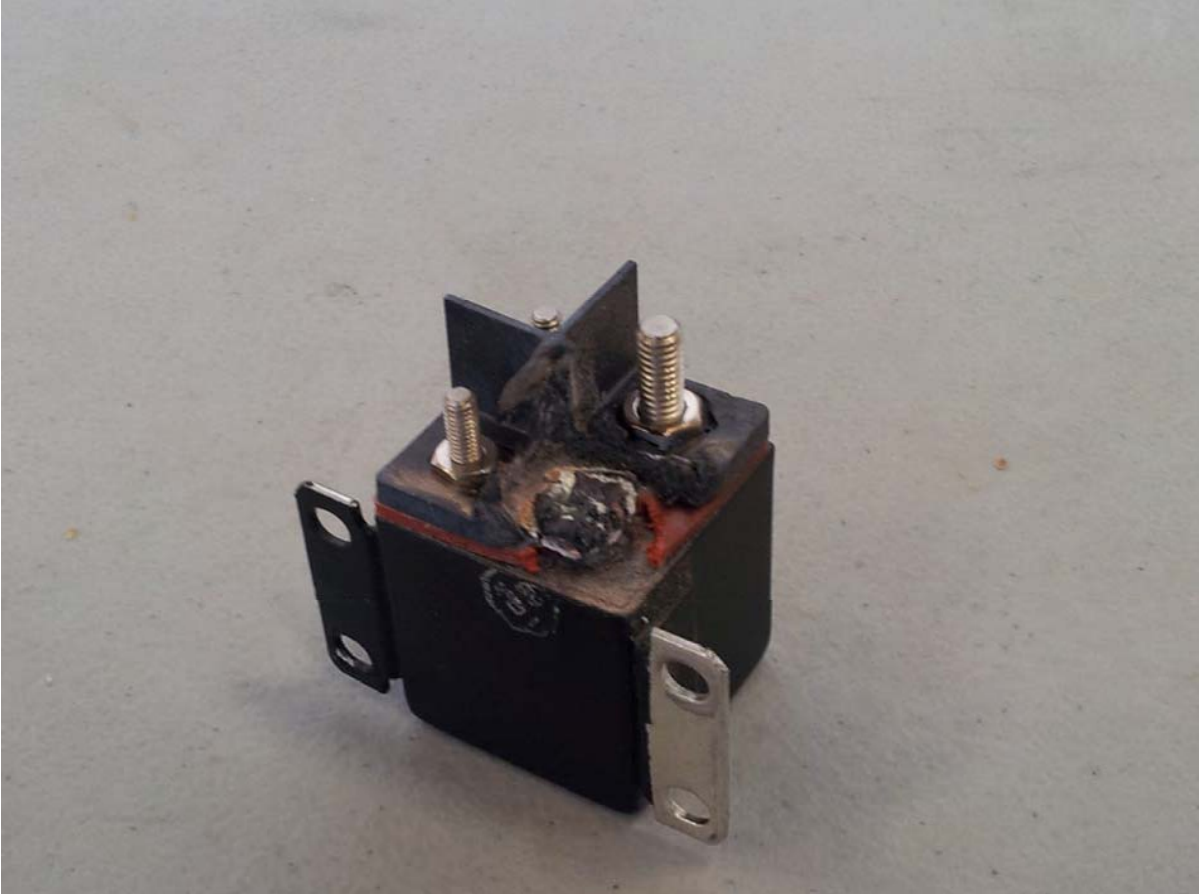
"Windshield anti-ice was found with inoperative sections during a 'B' check," says a technician. He found relays K59 and K6—with power terminals connecting wiring to the windshield—arced and burned, causing complete separation of the terminal from the relay. This condition could also possibly cause smoke in the cockpit.

Relay P/N: M20J5N

Part Total Time: 1,693.0 Hours
