Cessna 750, Bent Speed Brake Push Pushrod, ATA 2701

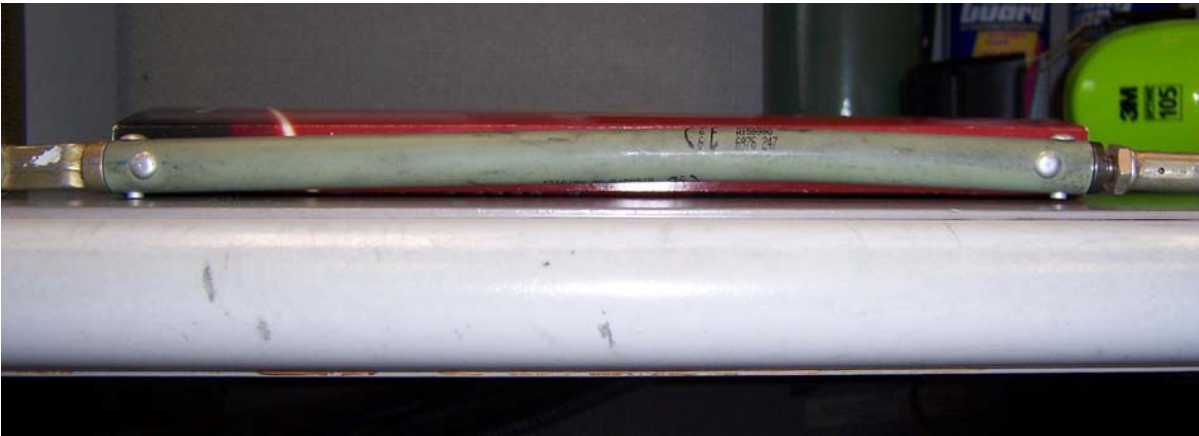
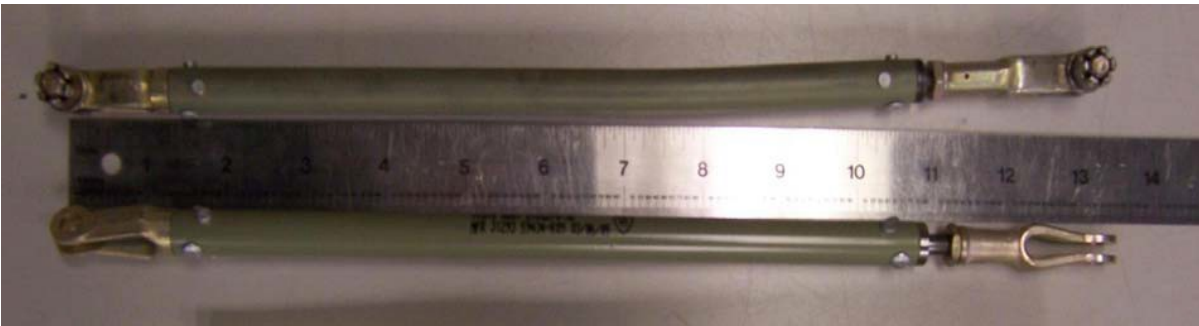
"When deploying speed brakes, the handle must be continuously held in position or the air load will stow the panels," says a corporate defect report. "A visual inspection revealed the speed brake pushrod to be installed upside down and bent—causing it to rub against the thrust reverser solenoid and preventing full travel of the speed brake handle. It was confirmed with Cessna Engineering that the pushrod should be installed with adjustable end up—and the rod should be straight, not bent. The pushrod was replaced with new (P/N 6760270-36). Operational checks were satisfactory."
