Piper PA17, Worn Landing Gear Mount Holes, ATA 3211

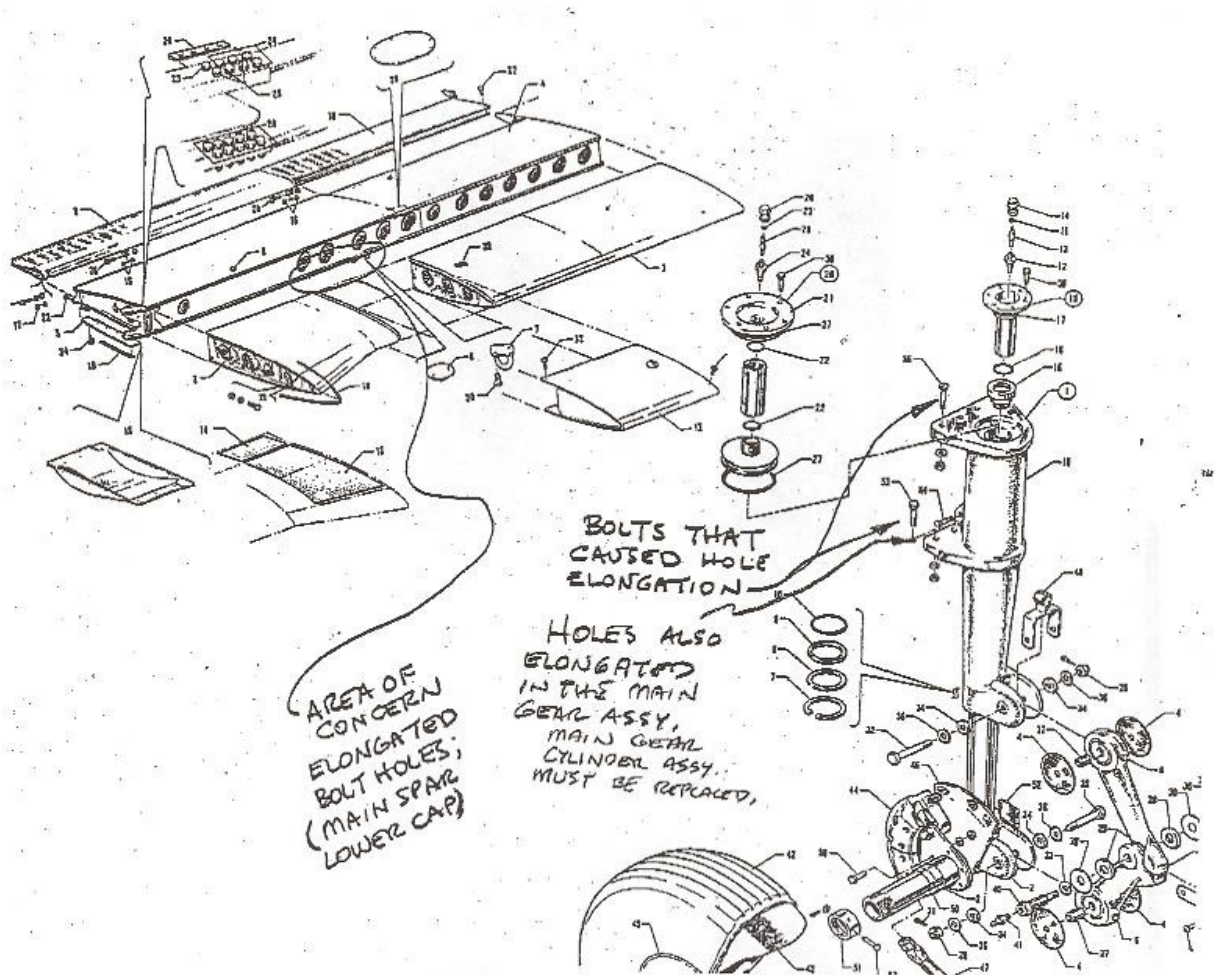
A Designated Airworthiness Representative (DAR) for a repair station describes the following defect. "During an annual inspection of the L/H main landing gear cylinder assembly (P/N 65319-04), it was found loose in the main wing spar. The L/H main landing gear was removed for further inspection of the main wing spar assembly's gear attaching bolt holes and attach points. Close inspection of the wing spar showed the lower four bolt holes were elongated. The holes in the landing gear cylinder were also found elongated; (apparently, all the bolts were 'shanked-out,' leaving the assembly loose for some time.)

The aircraft wing spar was repaired; and, the L/H main landing gear cylinder was replaced with a later model cylinder assembly from Piper (since the original part was no longer available). The submitter recommended close inspection of landing gear attach points during all inspections."
