## Piper PA32-300, Cracked Rudder Bar, ATA 2720

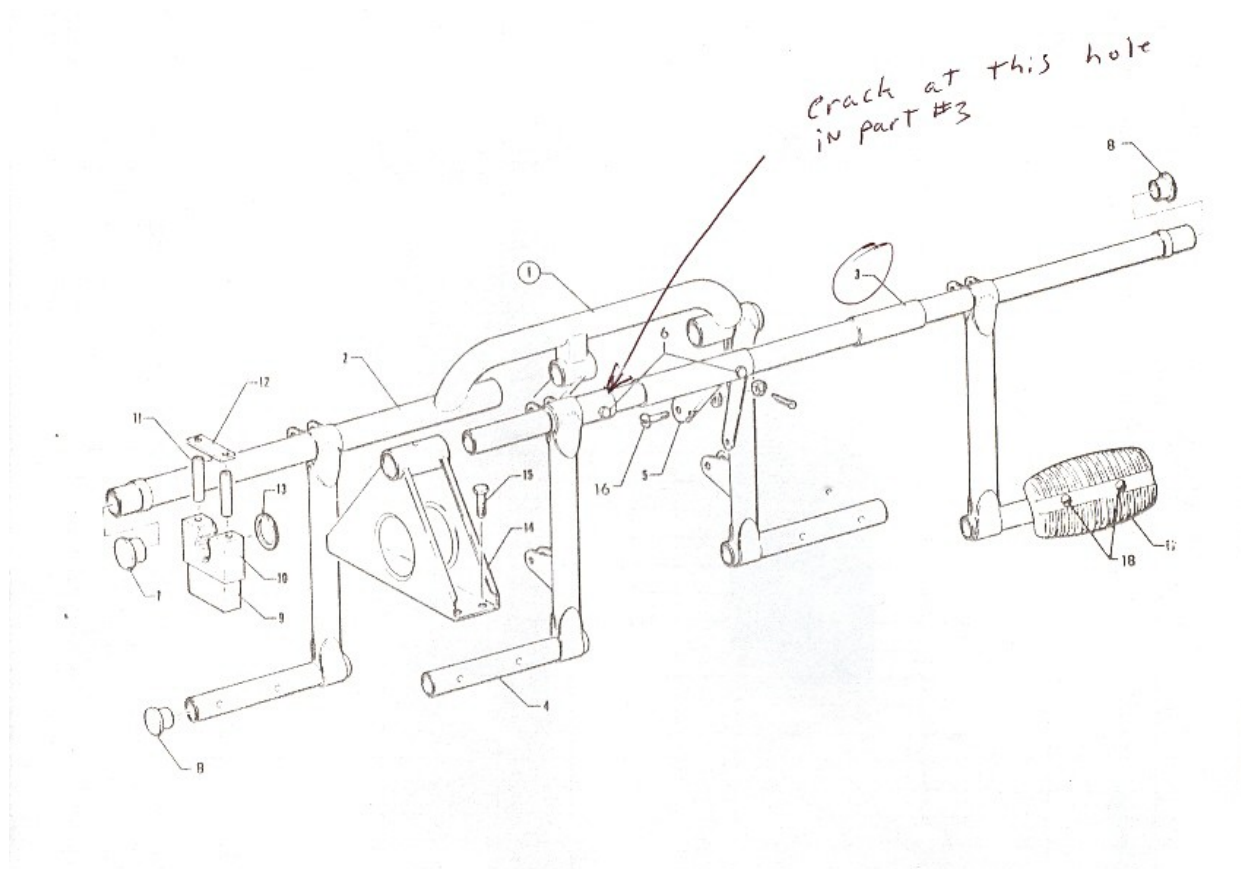
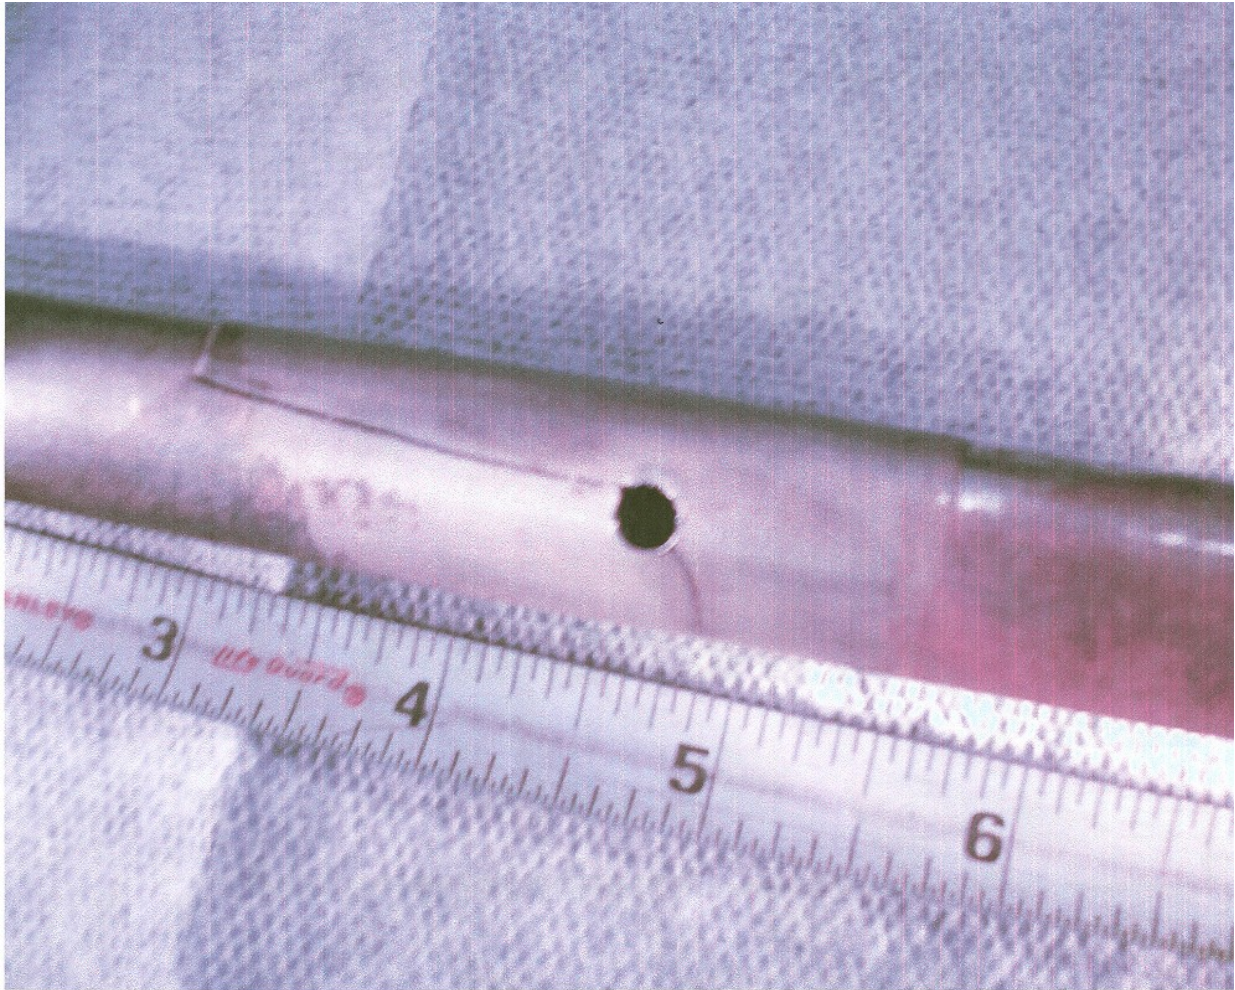
**Piper PA32-300, Cracked Rudder Bar, ATA 2720**

A technician for a commuter service states, "Upon removal and disassembly of the rudder pedal assembly (P/N 63419-02), a crack was found approximately two inches long, extending out from the center bolt through-hole.

The Technician found two other assemblies cracked in the same area. These cracks might be caused by a steering pressures applied while turning on the ground. All of these effected aircraft had more than 10,000 hours total time. Other aircraft inspected (for example, the Cherokee 6) also had elongated bolt holes.

Part Total Time: 17,018.3 hours.

This part can be inspected only by removing it from the aircraft, which is a time-consuming endeavor. The technician suggested arbitrary replacement of this part at or about 10,000 hours.
