## **Rockwell 695A, Steering Actuator Bolt Failure, ATA 3251**

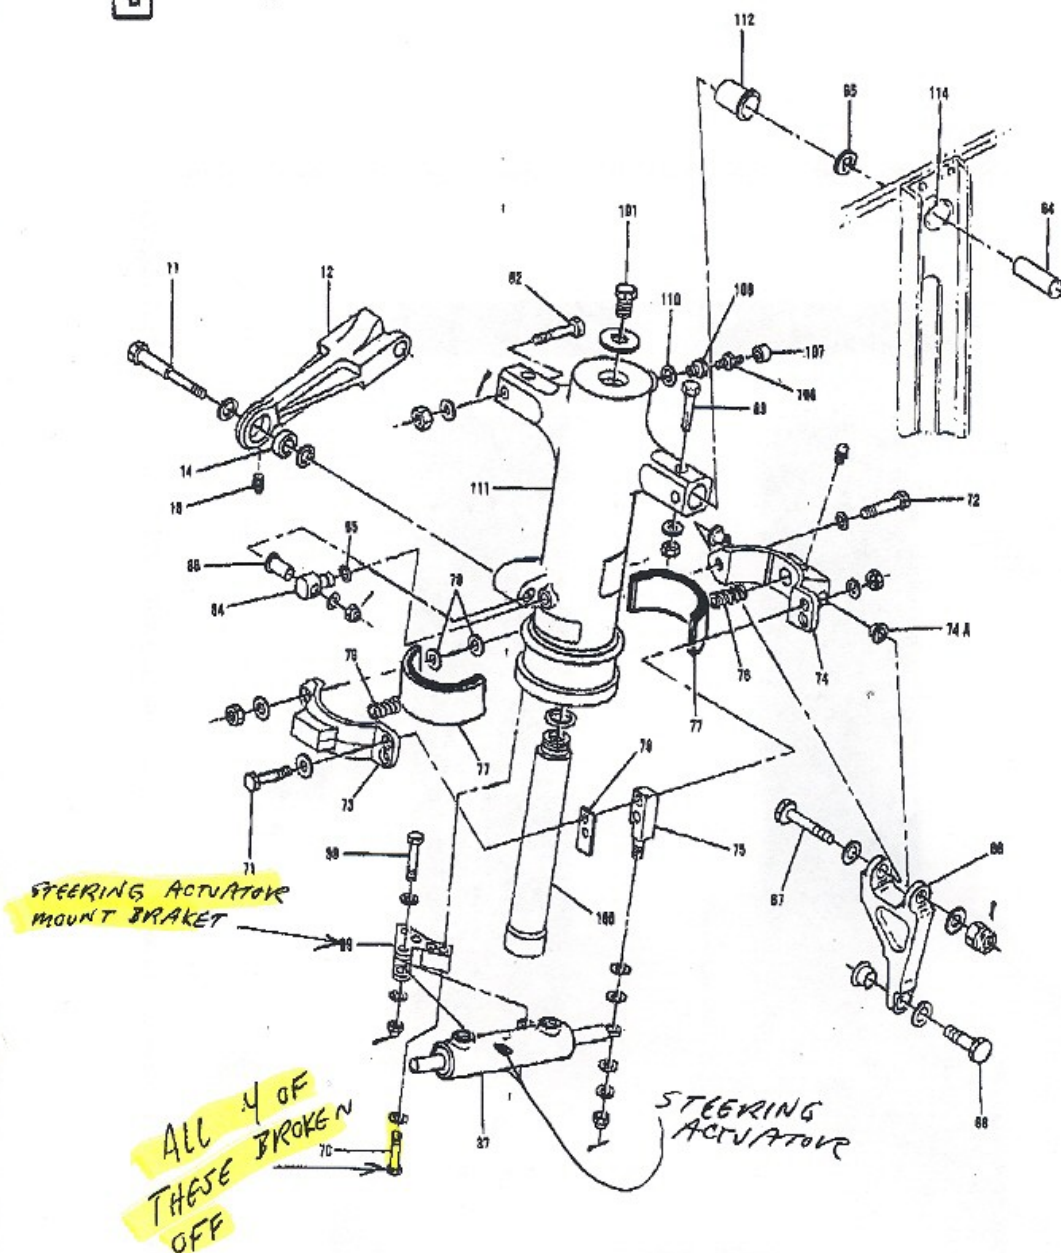
Figure 2-18. Nose Landing Gear Installation (Sheet 2 of 5)

Inspection revealed the four AN3 bolts (used to secure the hydraulic steering actuator to the nose landing gear oleo strut) sheared, resulting in the steering actuator hanging only by its hydraulic lines. The unsecured steering actuator had possibly jammed between the nose landing gear strut and the Radome, preventing full extension of the nose landing gear. Some Radome damage was evident, though we did not find any other damage.

“The four broken AN3H11A bolts can be damaged by exceeding the nose landing gear turn limits during towing. It is suspected the bolts were weakened by excessive turning (while towing) sometime in the past, and failed during this flight.”
