Beech F33A, Frayed Elevator Cable, ATA 2730

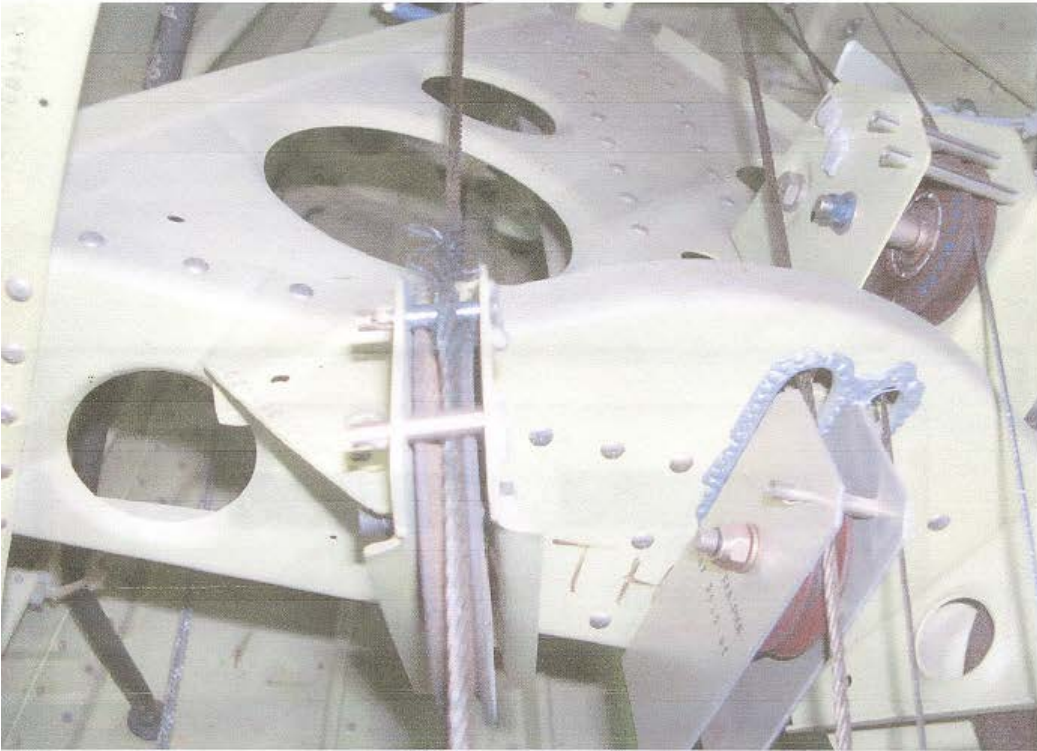
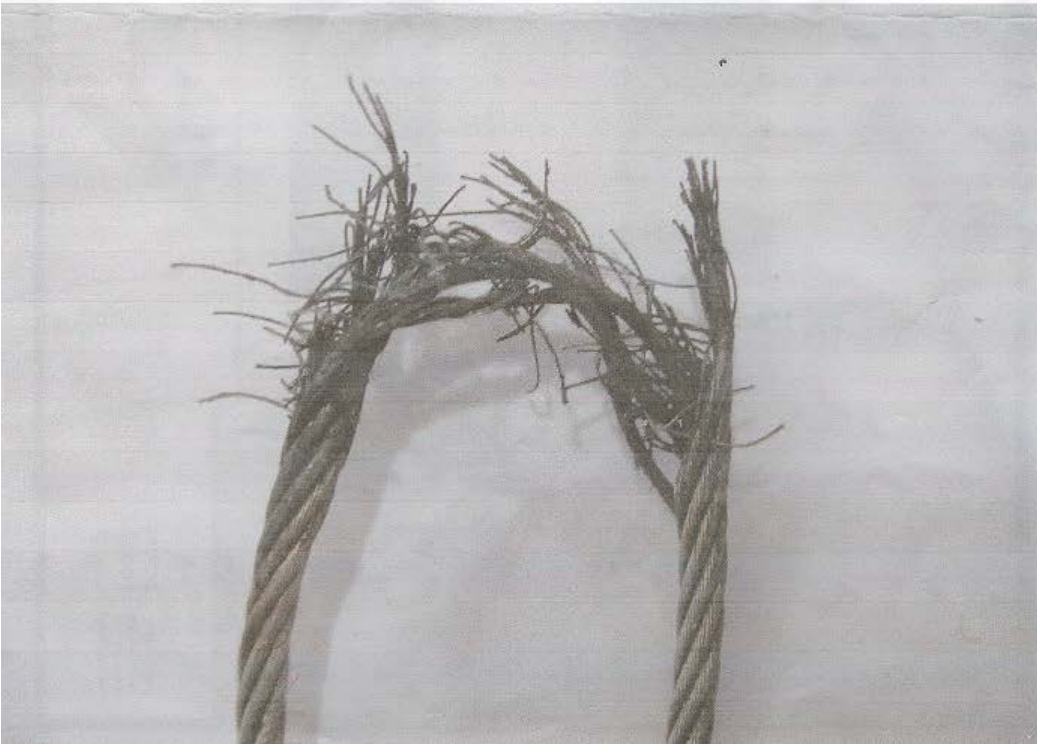
Beech F33A, Frayed Elevator Cable, ATA 2730

A repair station technician stated, “While performing an annual inspection on this aircraft, the right aft rudder cable was found frayed almost in half. We found the cable routed over the top of one cable pulley guard pin and under another in the same location in the aft tail section.

This cable appears to be the original cable installed in the aircraft at the factory. The Logbooks did not reveal any evidence the cable had ever been removed or disconnected—(an action which may have explained this improper routing, post production). Estimating from the amount the cable was frayed, it was determined that it had been rubbing on the pulley guard pin for quite some time.

“It is suspected this cable was routed incorrectly at the factory. Subsequent annual inspections might have been completed in a quick fashion, (motivated, perhaps, by the aircraft’s recent production) and low total time.
