Beech A36, Loose Auto Pilot Connecting Rod

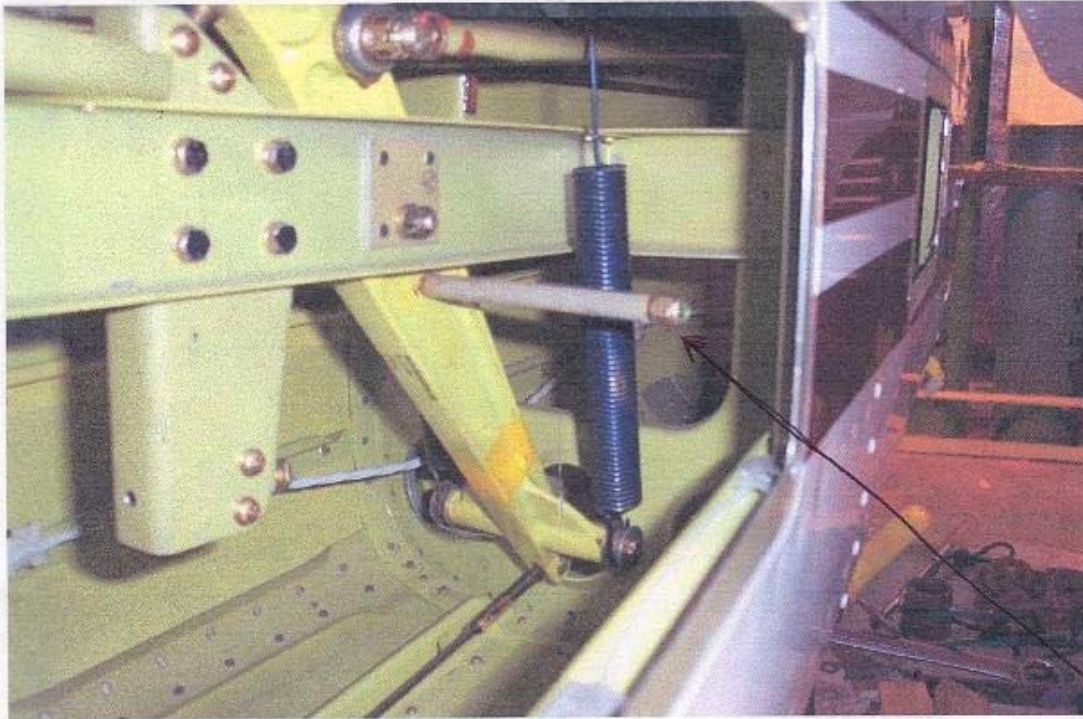
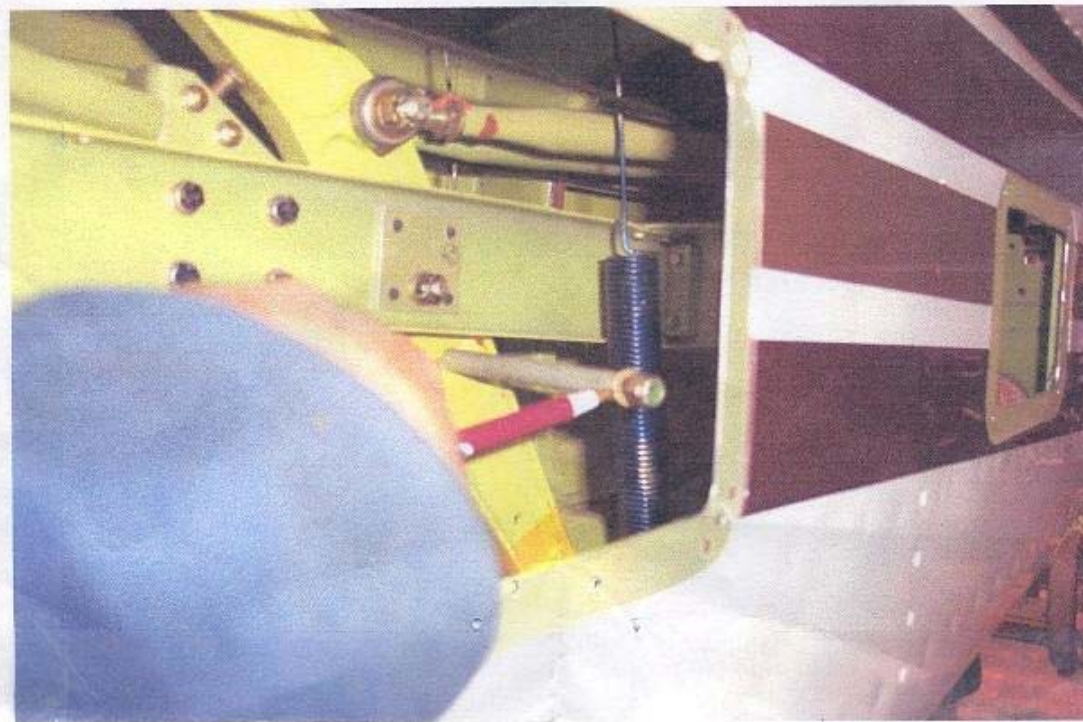
A submitter writes, "The auto-pilot hook-up rod should be tightened up or removed from the aircraft at the factory. This is the second aircraft in one week (*in which*) this rod (*and/or its attachment nuts*) has been found loose...." (*Elevator control bell crank P/N: 002-524024-51.*)

Part Total Time: 140.0 hours.
