Piper PA34-200, Worn Landing Gear Mount Holes, ATA 3211

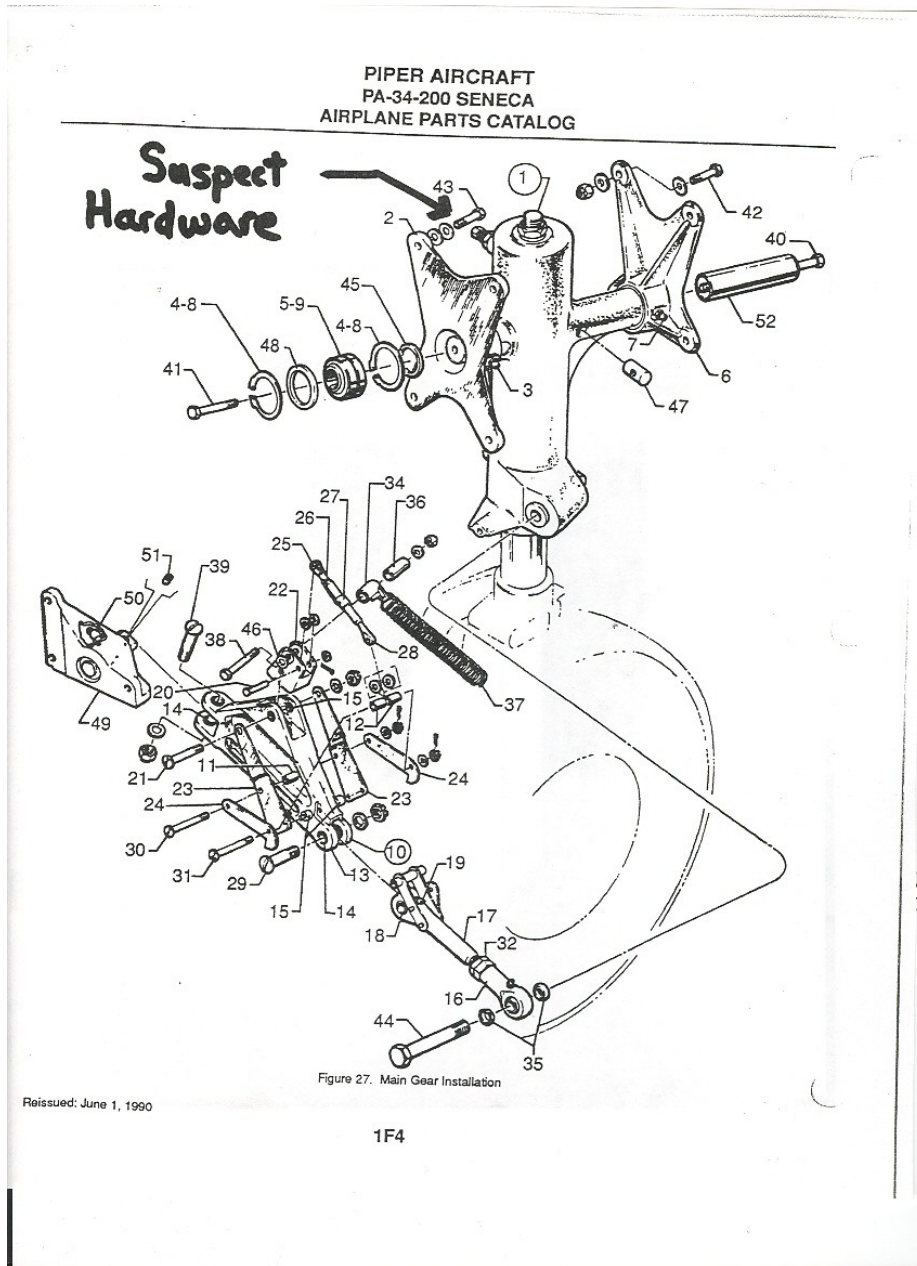
Piper PA34-200, Worn Landing Gear Mount Holes, ATA 3211

He reported that the main landing gear pivot casting (forward trunnion fitting assembly) attached hardware continually comes loose, allowing chaffing between the casting and the wing spar, and enlarging the attach bolt holes in (both) the casting and the spar.

The attachment holes in the casting and spar were reamed to accept AN5 bolts rather than the original AN4. The original nut-plates on the forward side of the wing spar (MS21047) do not seem to adequately accept the imposed stress on them and it is likely to be the leading factor in the continual loosening of the casting.

The nut plates were replaced with MS21078-5 nut-plates which provide more strength and (apparently) prevent the attach bolts from loosening. We operate a fleet of PA34-200, -200T, and -220T Seneca. The -200 and -200T (aircraft) have exhibited the same tendency regarding the loosening of the forward pivot casting attach hardware. (I) suggest inspecting the pivot casting attach hardware regularly and replacing hardware as stated above."
