Beech V35B, Cracked Flap Leading Edge Nose Rib, ATA 5753

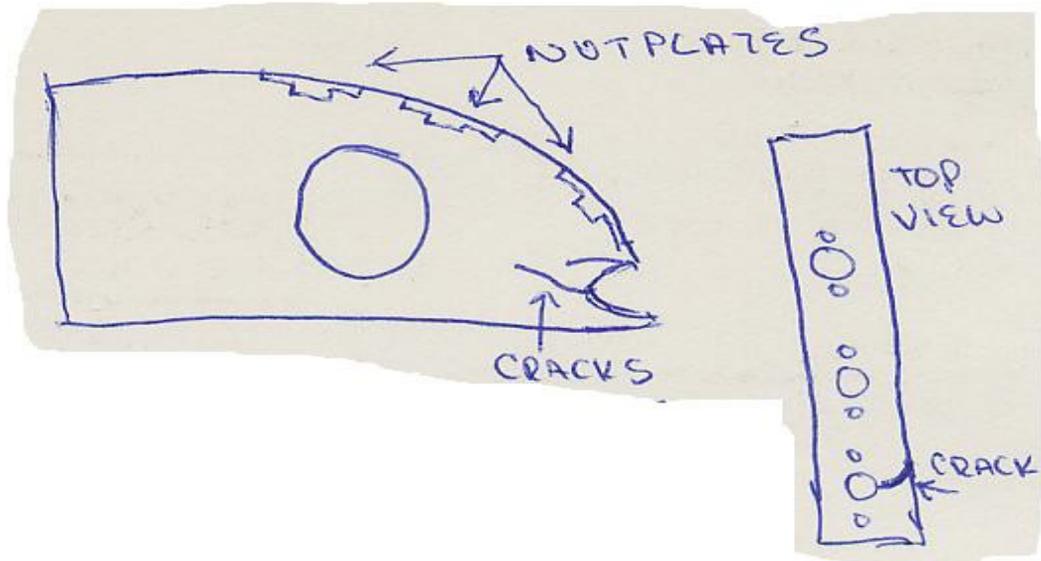
An annual inspection found the R/H flap rod attach point rib cracked.”(Rib P/N 35-165050-84; R/H flap P/N 35-165050-606).

(This technician also includes another such report of a cracked attach point for the flap actuating rod on a Beech 55 having 4,552.7 hours. Of these six referenced Beech aircraft, the time ranged from 3,144.9—to 5,255.1 hours yielding 2,110.2 hours difference. This is awfully good anecdotal evidence arguing for close attention to these actuation attach points after a couple thousand hours.)

Part Total Time: 4,288.19 Hours.
