## **Piper PA44-180, Failed Nose Gear Drag Link Bolt, ATA 3222**

**SUBJECT:** NOSE LANDING GEAR BOLT FAILURE

Type AC: PA44-180      AC Number:      AC Total Time: 4146.0  
Part Failure: NLG FWD bolt in drag link assembly      PN: 400-191  
Bolt Specification: AN5-51      FAST Report Number: F5429

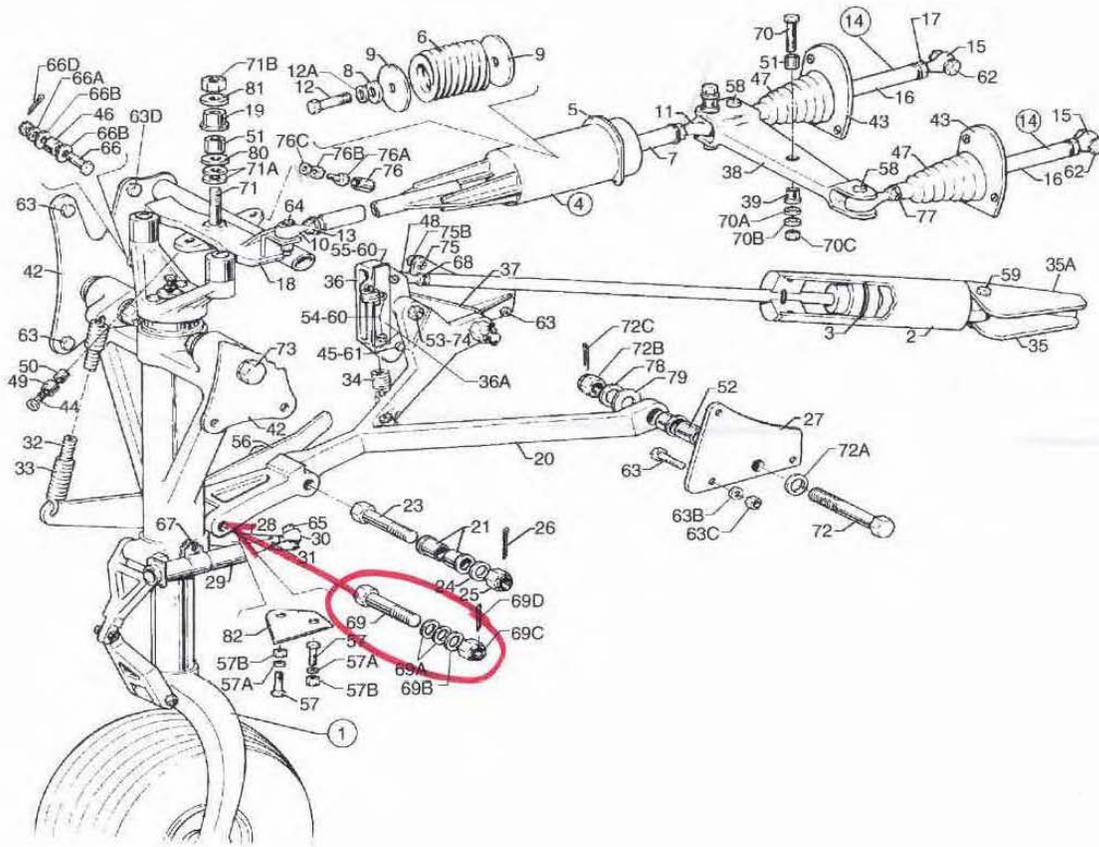
Figure 1 Figure item #69 is the bolt that failed. It is PN 400-191, an AN5-51 bolt.

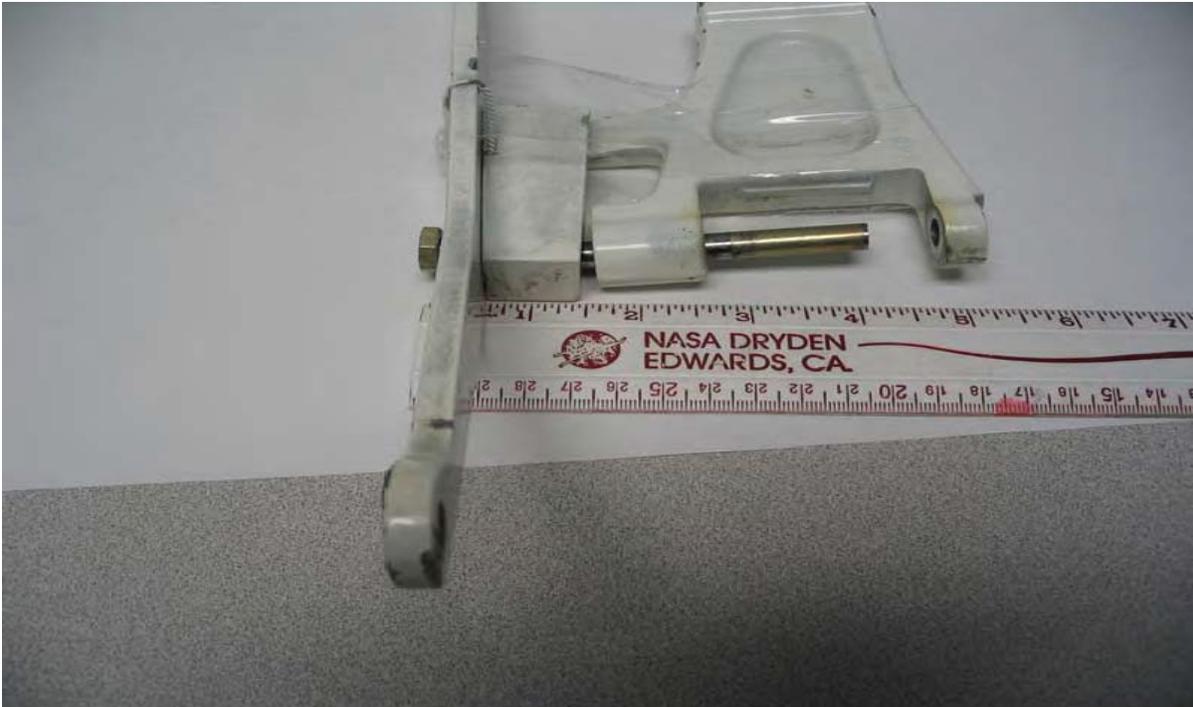
The NLG diagram from Piper’s Airplane Parts Catalog is shown in Figure 1 for reference. Post failure, the fractured bolt, Figure item #69 was stuck in the NLG drag link assembly, Figure item #20, which is shown “as received” by FAST in Figures 2 & 3. The bolt was stuck in the drag link assembly due to the bending in the bolt shaft. The bolt could not be rotated in the assembly using finger force only. Another view of the fracture surface of the bolt is shown looking through the drag link assembly hole, Figure 4. There are significant fracture features visible at this level of magnification. There is a dark narrow band running through the center of the bolt from the 8 o’clock to 2 o’clock position. There is a semi-circle at the outer edge of the bolt at the 11 o’clock position, and on the opposite edge at the 4 o’clock position is a roughened edge. It was necessary for FAST personnel to cut the bolt so that the fracture surface could be examined in detail under the scanning electron microscope (SEM). The mating surface of the bolt was never found.

*Figure 2 This photo shows the bolt still stuck in the drag link assembly, Figure item 20 in Figure 1.*

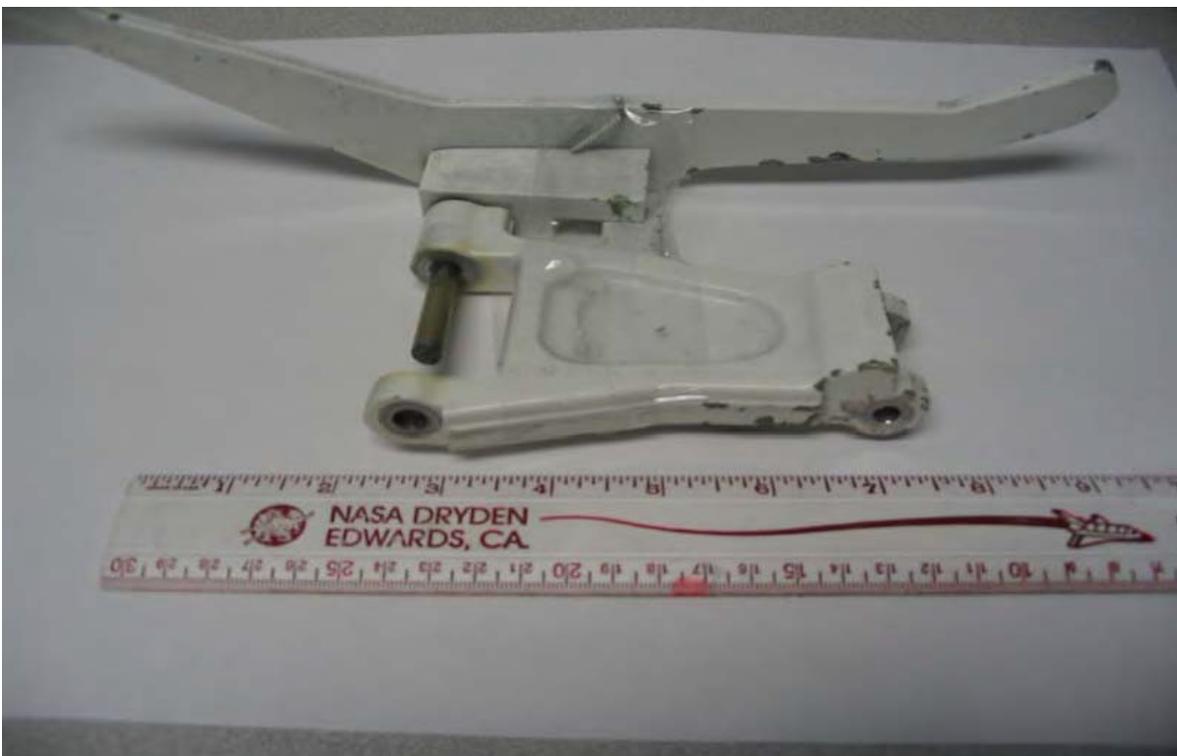
*Figure 3 A side view of the bolt and drag assembly shown as received.*

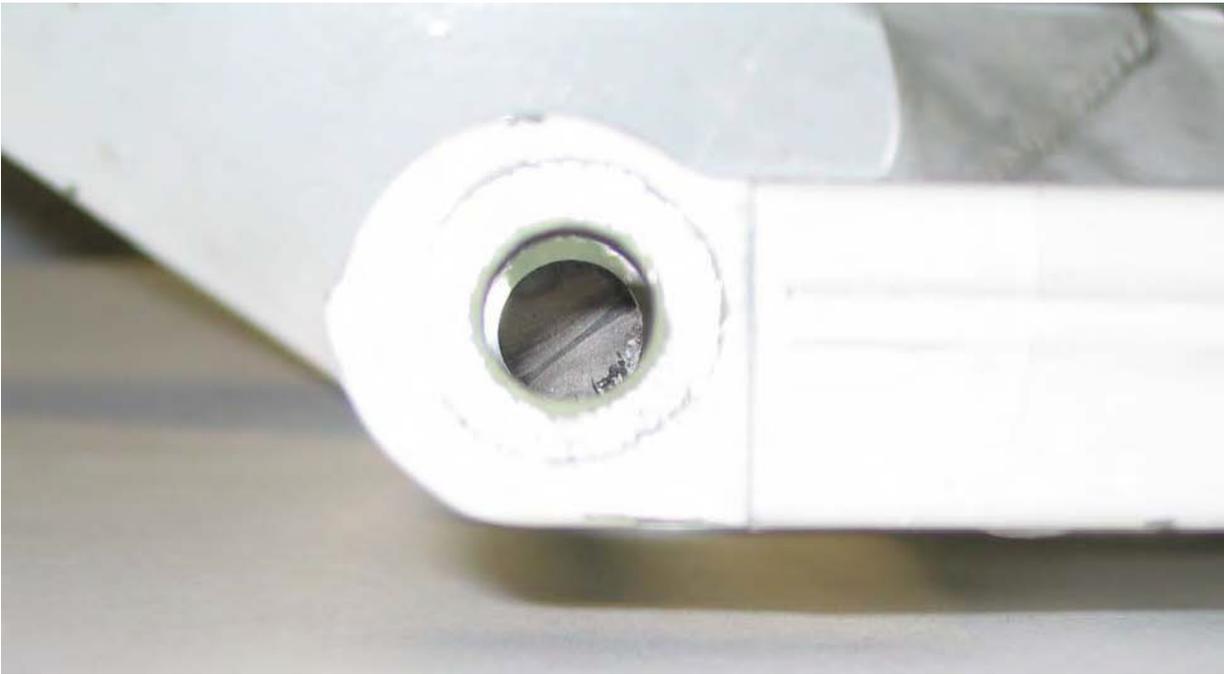
Figure 4 This photo is looking through the drag link assembly hole that reveals a dark narrow band running diagonally through the center of the bolt fracture surface from 8 o'clock to 2 o'clock. There is a semi-circle at the 11 o'clock position and rough edge at the four o'clock

position. These fracture features are shown in detail in subsequent photos.

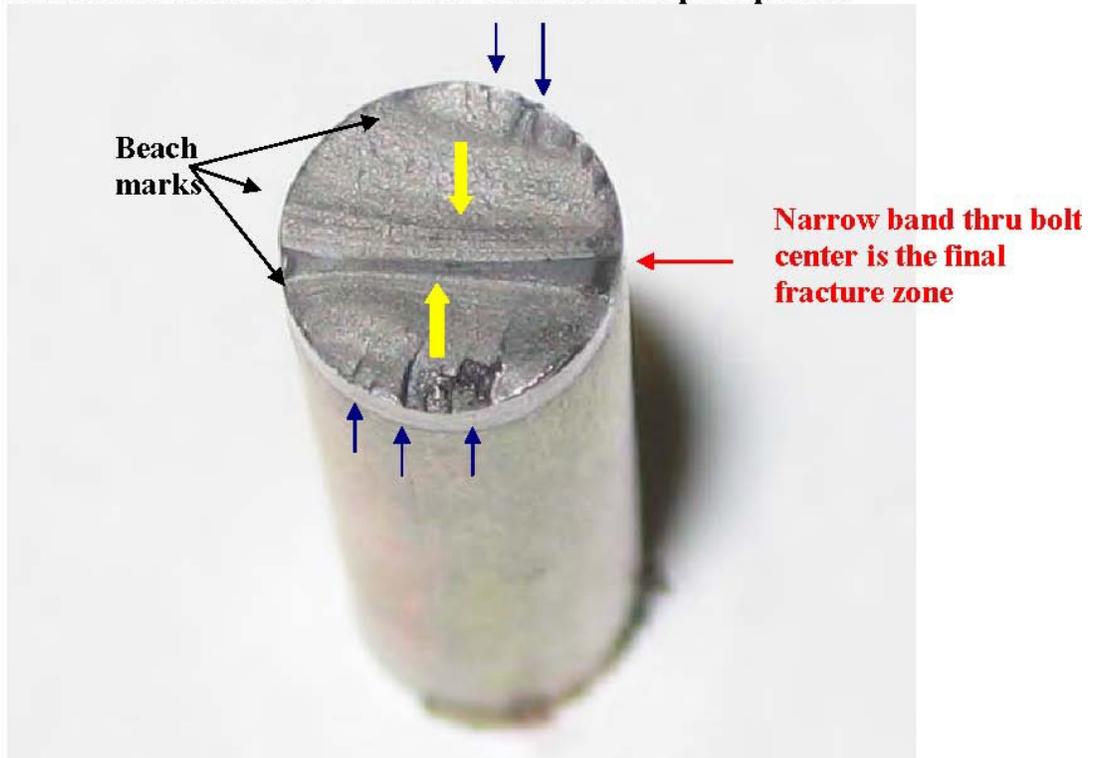
A macro photo of the bolt fracture surface after the shaft was cut by FAST personnel is shown in Figure 5. There are numerous fracture origins at both the top and bottom, indicated by the blue arrows, Figure 5. The yellow arrows indicate crack growth direction that progressed by fatigue from the fracture origins. The bolt finally failed instantaneously at the narrow dark zone traveling through the center of the bolt. A number of beach marks, which look like ripples in a pond emanating from the point where a thrown stone enters the water, emanate from the fracture origins at both the top and bottom edges. Each of these fracture features were examined in detail in the SEM.

Figure 5 This photo shows the bolt fracture surface with appropriate areas labeled. Blue arrows are fracture origins. Large yellow arrows indicate crack growth direction by fatigue.

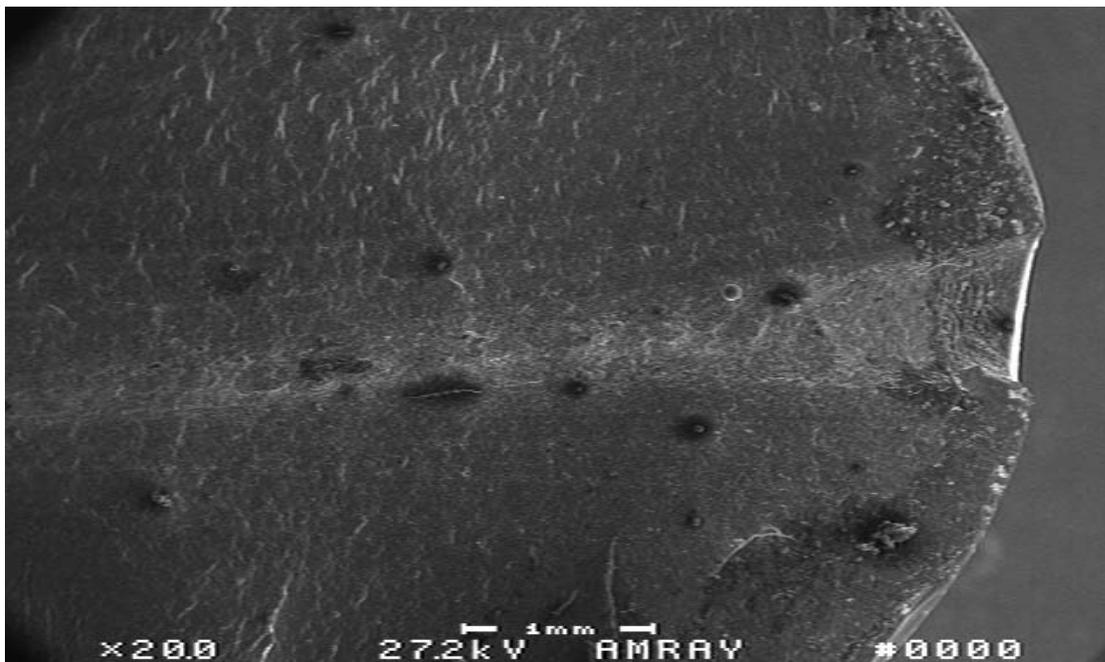
A 20X SEM photo of the narrow band running through the center of the bolt is shown in Figures 6 & 7. A number of beach marks can be seen in each of these photos. Notice that the marks above the center band are concaved upwards toward the fracture origin at the top. The beach marks below the center band are concaved downward toward the fracture origin at the bottom. Each beach mark represents crack growth stoppage from a landing and taxiing operation. The presence of numerous beach marks is proof that this bolt did not fail in one landing operation, but instead failed over many operations over a long period of time.

Figure 6 A 20X SEM photo of the right side of the narrow dark band running through the center of the bolt. Notice that the beach marks above the center band are concaved upwards, and those below the center band are concaved downwards.

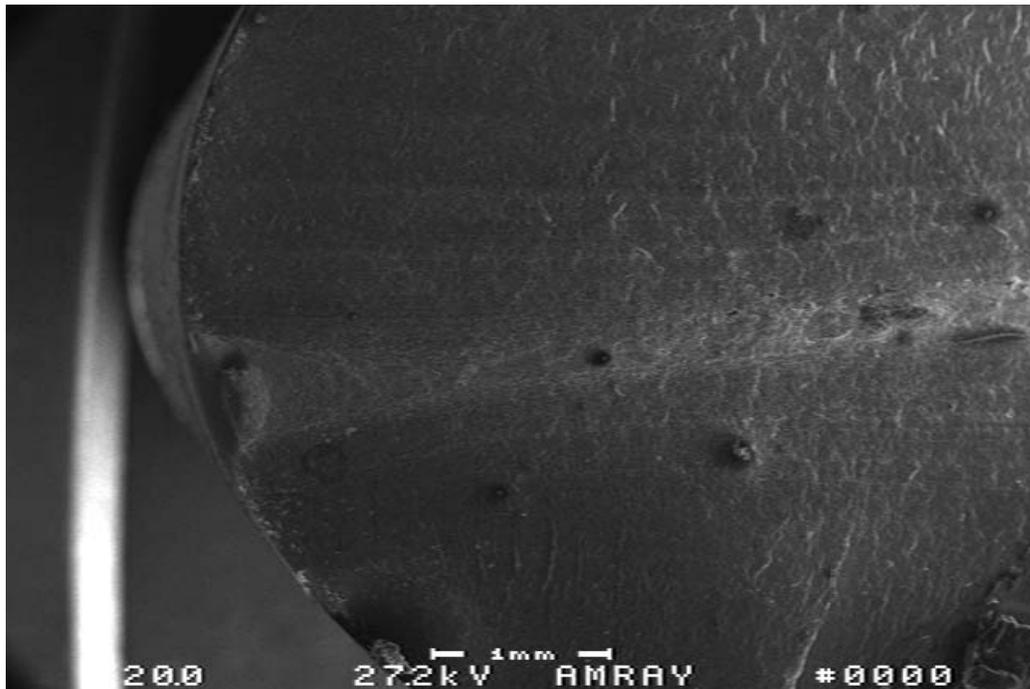
Figure 7 A 20X SEM photo of the left side of the narrow center band. The description of the beach marks discussed in Figure 6 also applies here

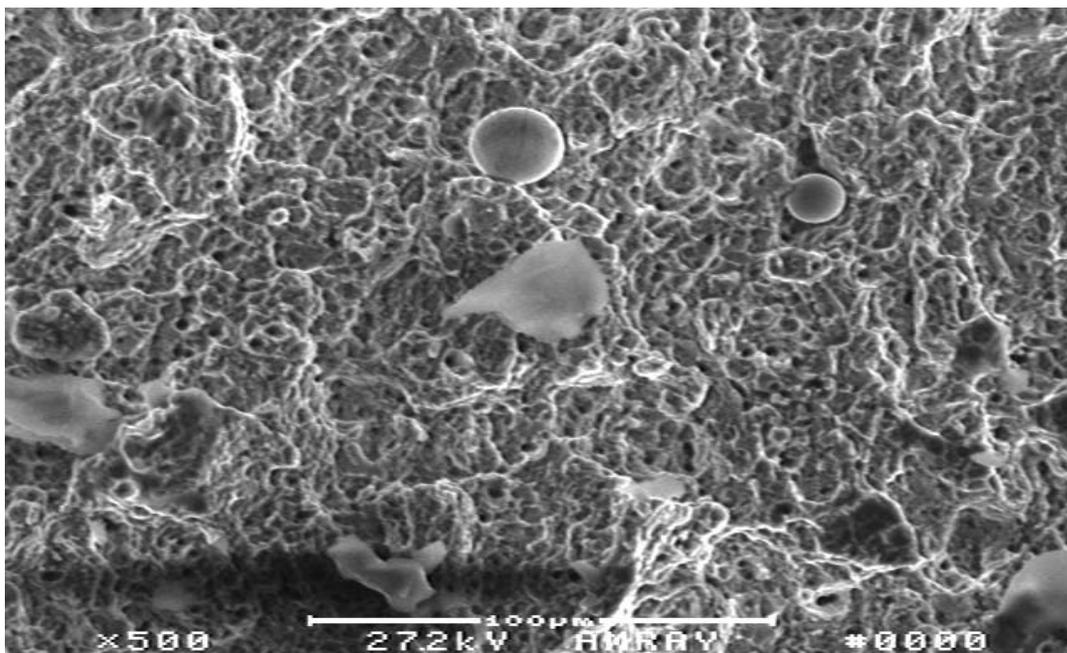
Higher SEM magnifications of the narrow center band are shown in the SEM photos, Figures 8 - 10. Each shows the characteristic ductile dimple fracture features of instantaneous overload. In other the words, this narrow center band represents the amount of metal holding the bolt together when it finally failed during the last gear retraction. There wasn’t much.

Figure 8 A 500X SEM photo of the right side of the narrow band thru the center of the bolt reveals ductile dimple fracture features characteristic of instantaneous final fracture.

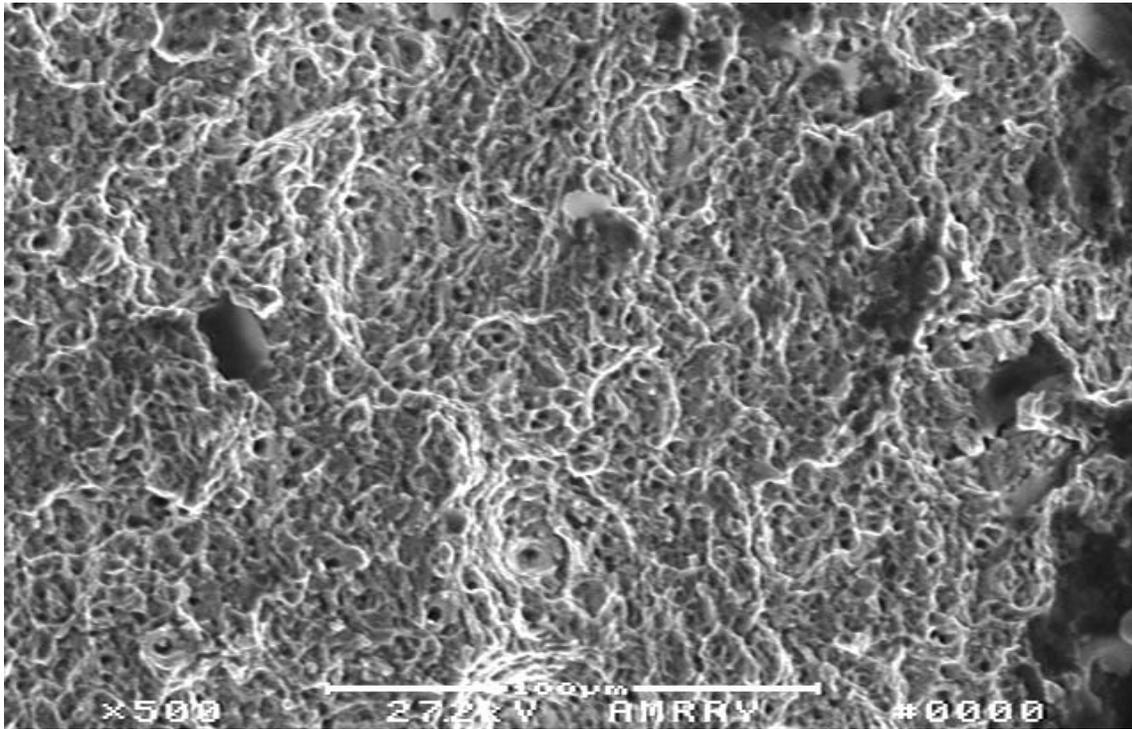
Figure 9 A 500X SEM photo of the center section of the narrow band reveals similar fracture features characteristic of overload.

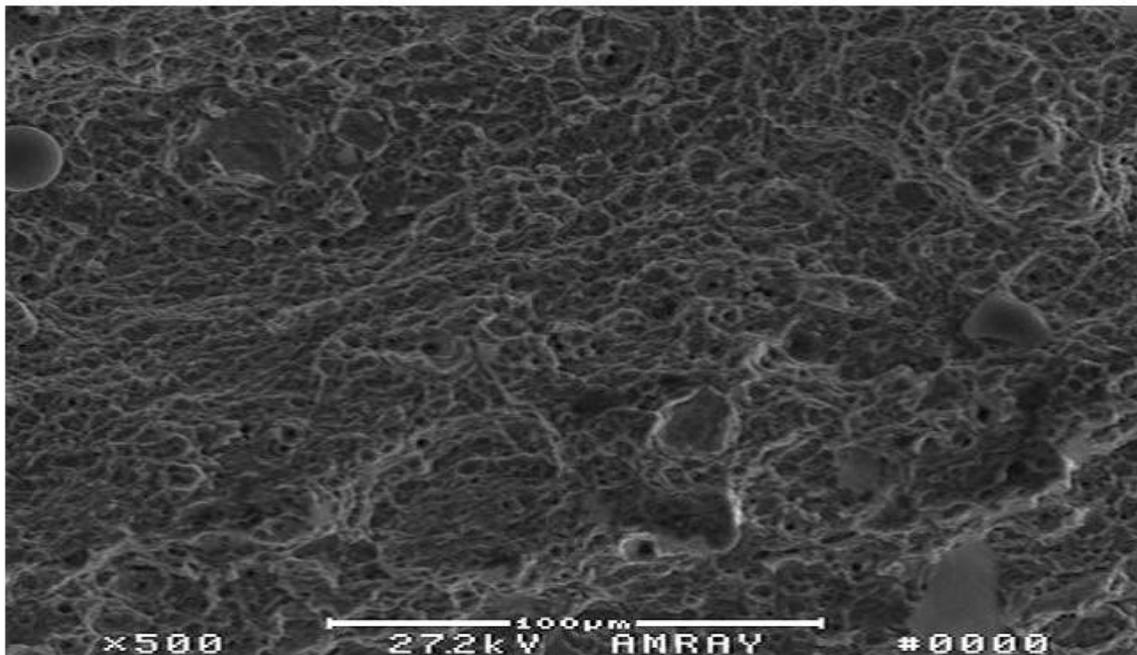
Figure 10 A 500X SEM photo of the left side of the narrow band in the center of the bolt also reveals the ductile dimple fracture features characteristic of instantaneous overload.

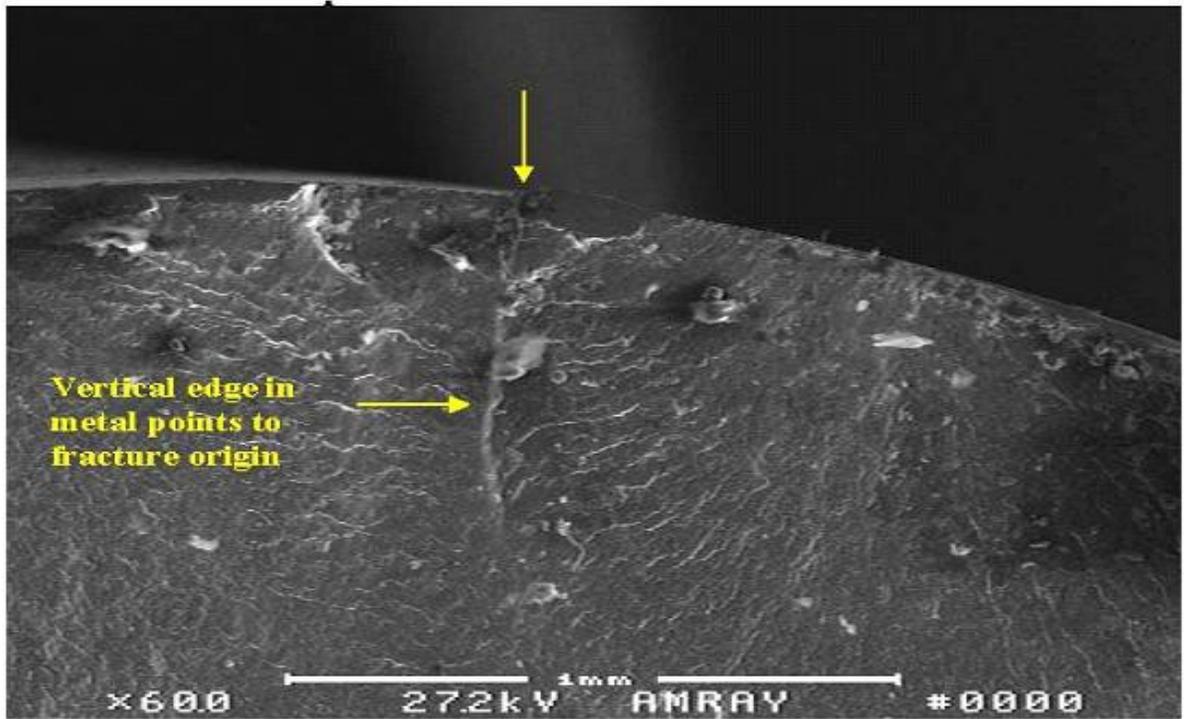
While the bolt finally failed in the narrow center band, the outer edges are where the fracture initiated. Progressive SEM magnification of the top edge shown in Figure 5, is shown in the SEM photos, Figures 11 – 13. The origin is indicated by the arrow in Figure 11. Notice that there is a vertical feature in the metal that also points to the origin. The 1000X SEM photo of the top origin shows a very smooth surface from rubbing of the mating surface of the bolt after the initial crack was formed. This photo also shows wear deformation at the outer edge of the bolt. A 1000X SEM photo of the area just below the origin reveals closely spaced parallel striations that are characteristic of fatigue crack growth, Figure 14. The striations are widened slightly

Figure 11 A 60X SEM photo showing the semi-circular shaped area at the bolt's top edge in figure 5. The origin is at the outer surface and indicated by the arrow. Note the vertical feature in the metal that also points to this edge

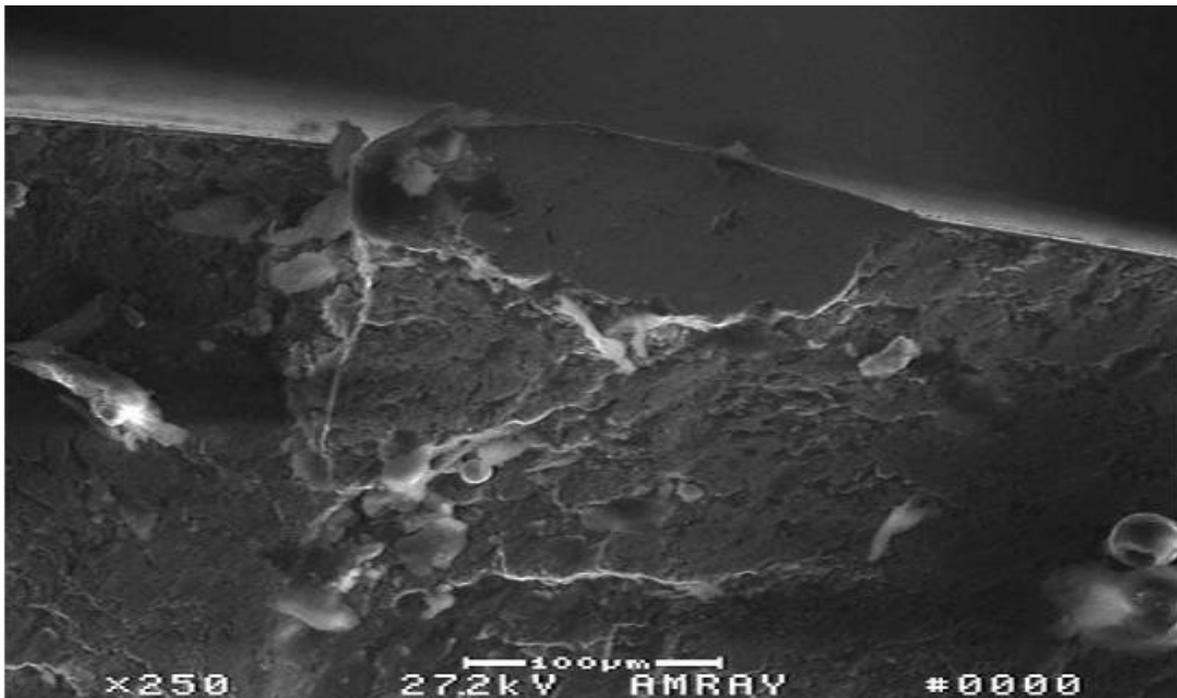
Figure 12 A 250X SEM photo of the origin shown in Figure 11.

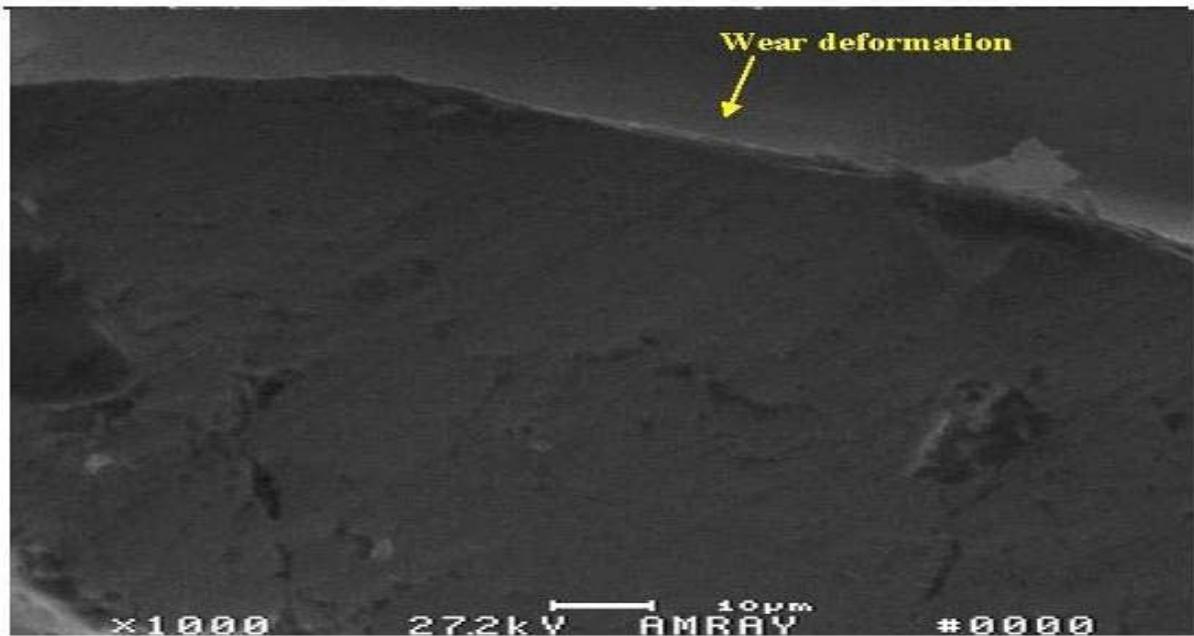
Figure 13 A 1000X SEM photo of the top fracture origin shows wear deformation at the outer edge. Notice the smooth fracture surface from rubbing with the mating surface after initial cracking.

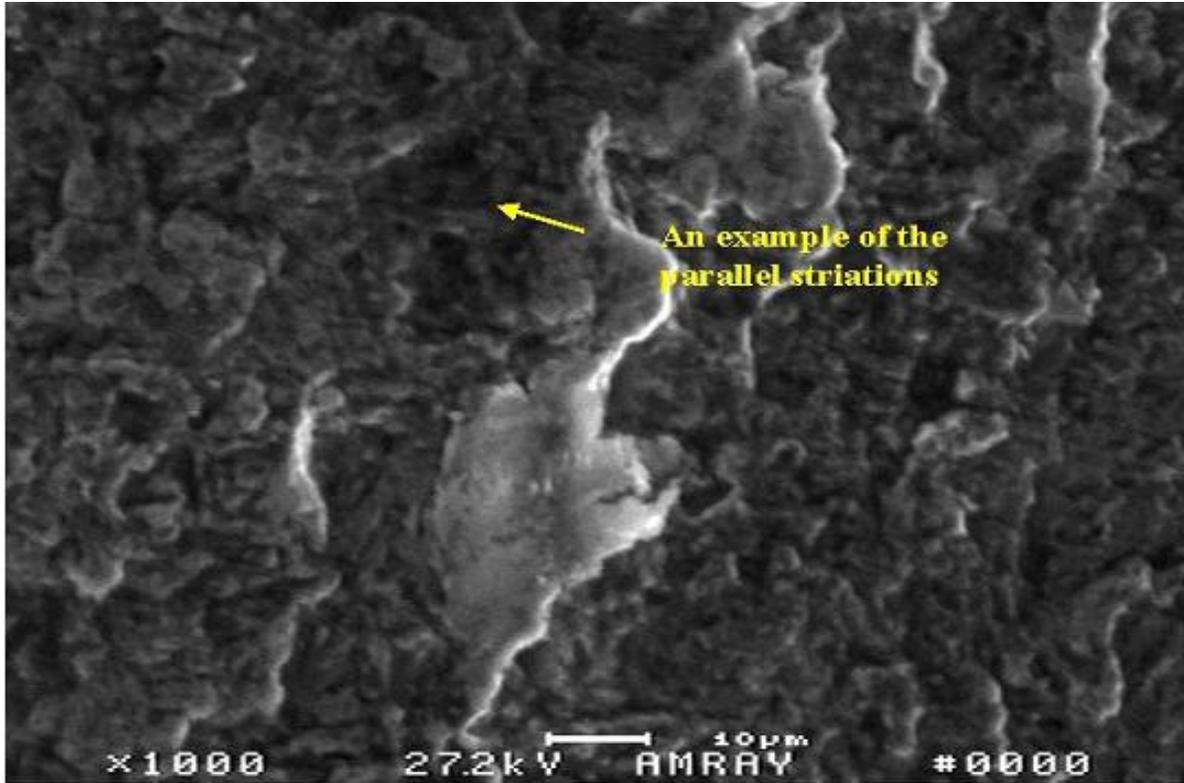
Figure 14 A 1000X SEM photo of an area just below the top origin shows parallel striations characteristic of fatigue crack growth

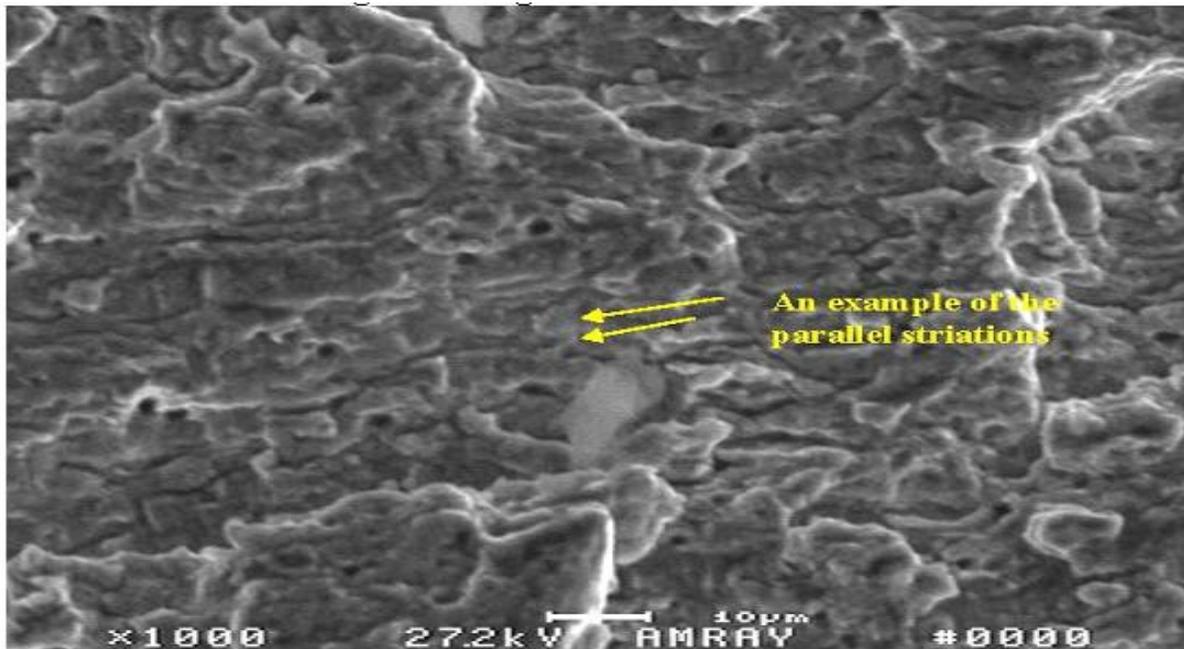
near the final fracture zone on the top half of the bolt due to less metal being able to sustain a landing and taxiing operation, Figure 15. So crack growth was accelerating.

Figure 15 A 1000X SEM photo of an area below the top origin and above the final fracture at the center of the bolt shows parallel striations characteristic of fatigue crack growth. Crack growth direction runs from top to bottom.

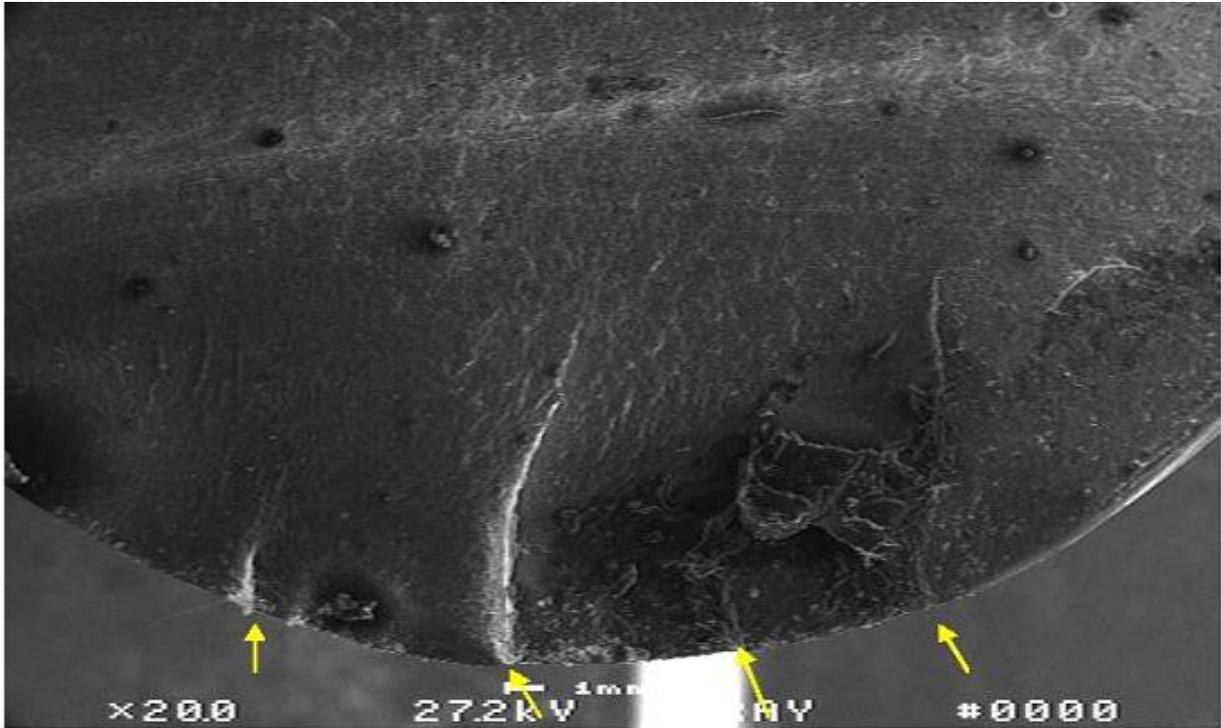
Similar fracture features are shown in the SEM photos for the bottom of the bolt, Figures 16 - 18. A 20X SEM photo of the bottom edge reveals multiple fracture origins at the outer edge. A 60X SEM photo of the origin at the 6 o'clock position is shown in Figure 17. A 500X SEM photo of the fracture surface just above this origin reveals fatigue crack growth features, Figure 18.

Figure 16 A 20X SEM photo of the bottom edge of the bolt from Figure 5 shows multiple origins (arrows) at the edge

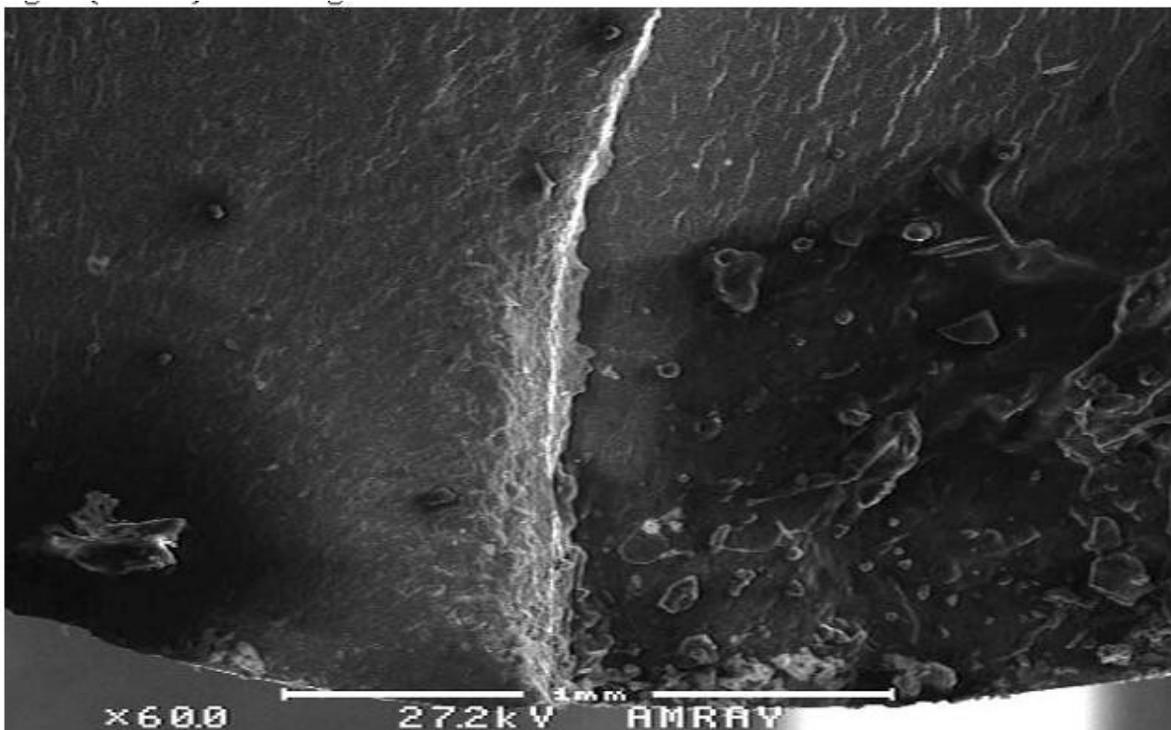
Figure 17 A 60X SEM photo of the bottom origin at the 6 o'clock position as shown in Figure 16.

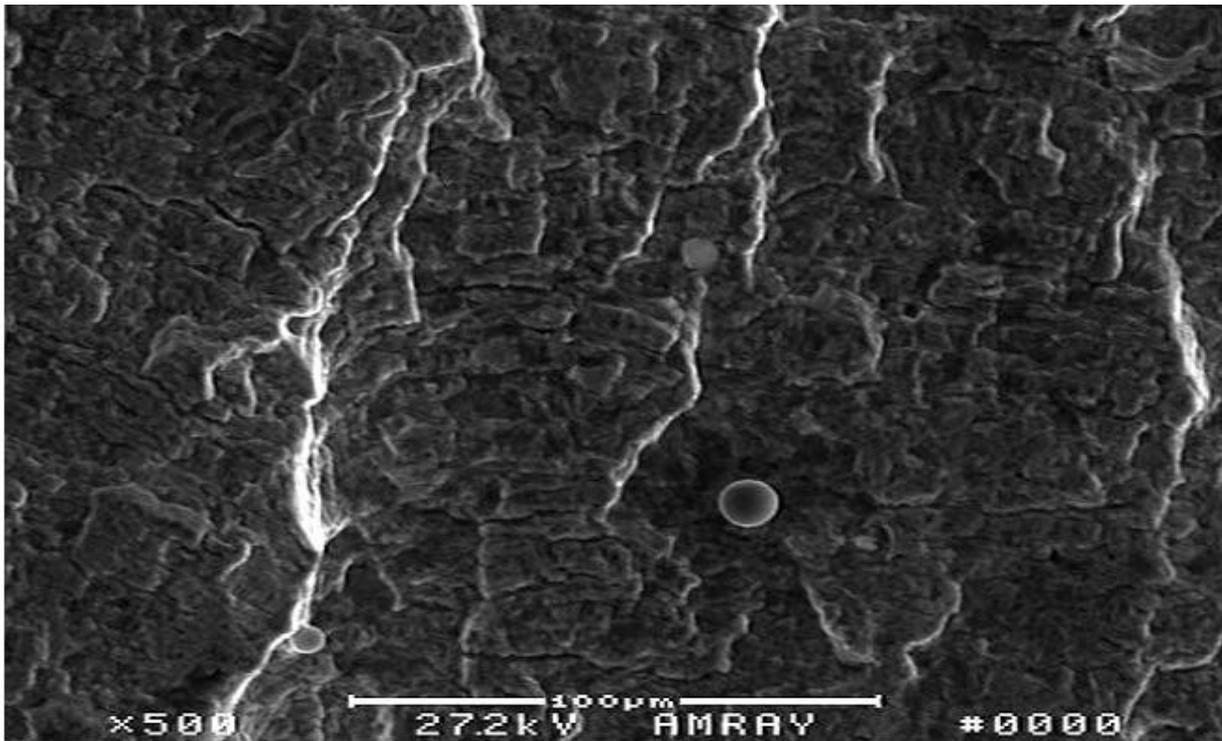
Figure 18 A 500X SEM photo of the area just above the origin shown in Figure 17 reveals fatigue fracture features

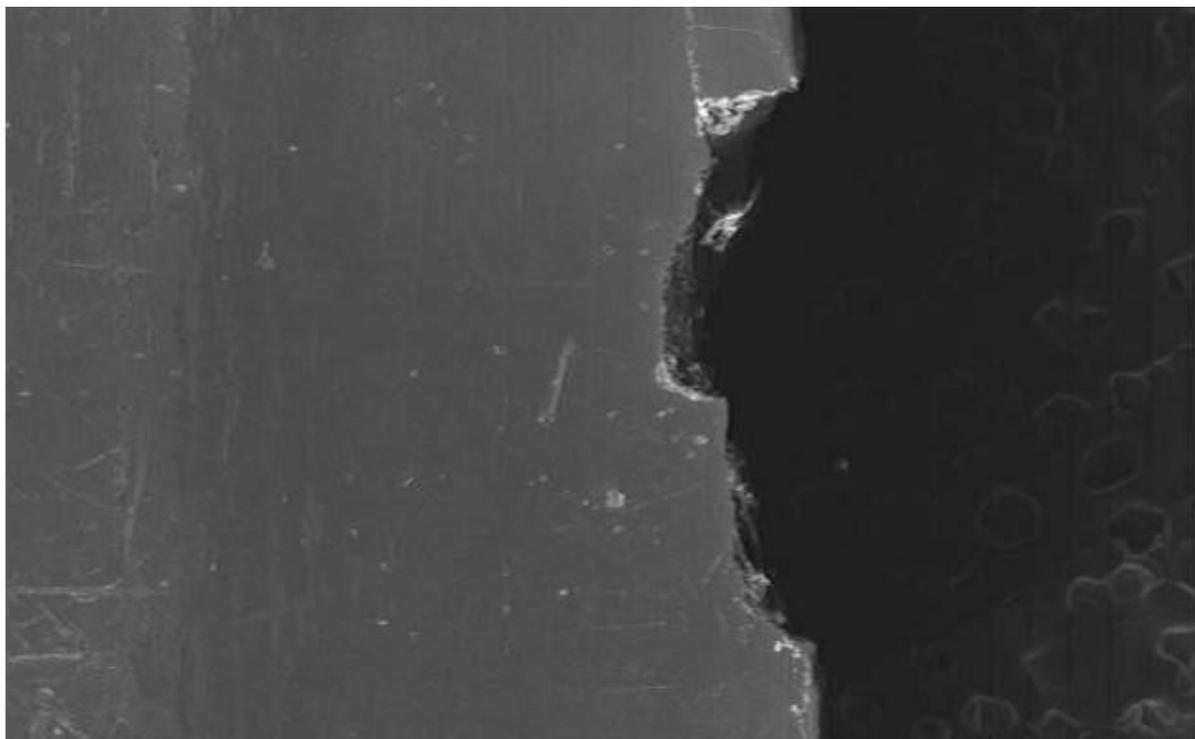
A side profile of the bolt at the 6 o'clock edge shown in Figure 5 is shown in the 30X SEM photo, Figure 19. Progressive SEM magnifications of this area show a crack in the edge and wear, Figures 20 – 22. These photos reveal that the source of the stress concentration from which crack growth proceeded by fatigue is from wear with in the mating NLG bushing. The wear is very close to the edge of the bushing. Notice the gold color is worn from the bolt right at the edge of the fracture, Figure 23.

Figure 19 A 30X SEM photo of the side of the bolt at the 6 o'clock area from Figure 5 shows some wear and a crack

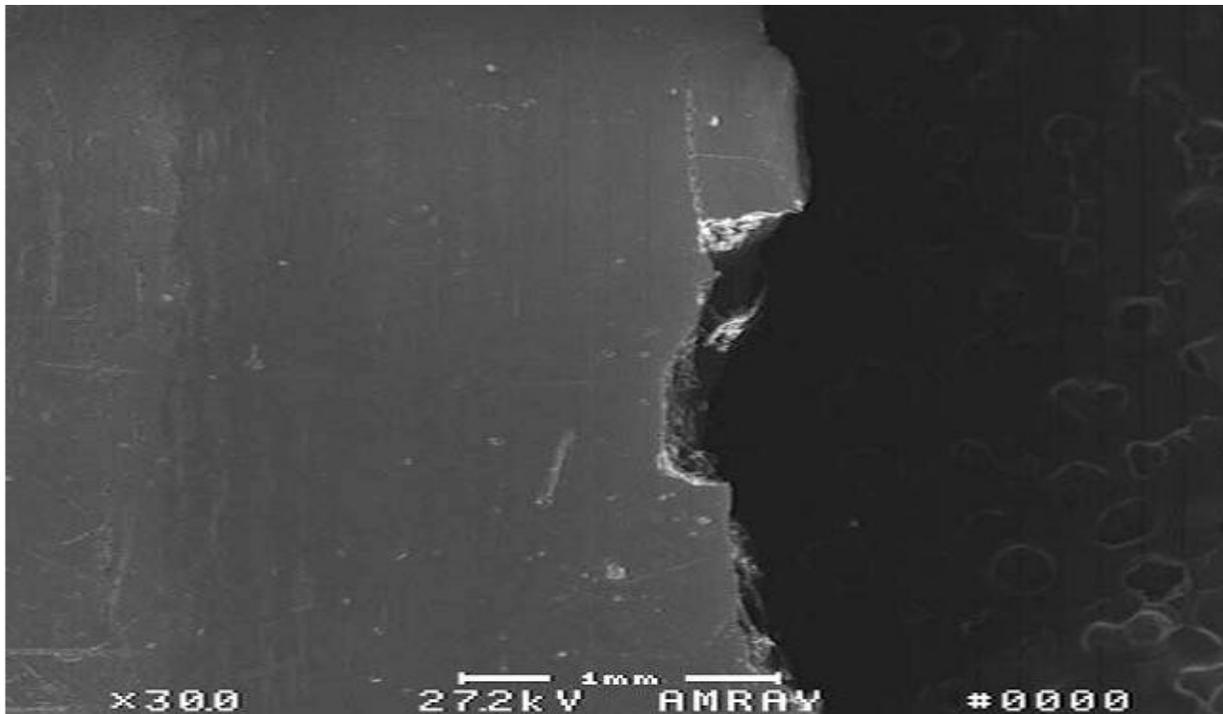
Figure 20 A 30X SEM photo of the side at the 6 o'clock fracture origin shows a crack on the surface.

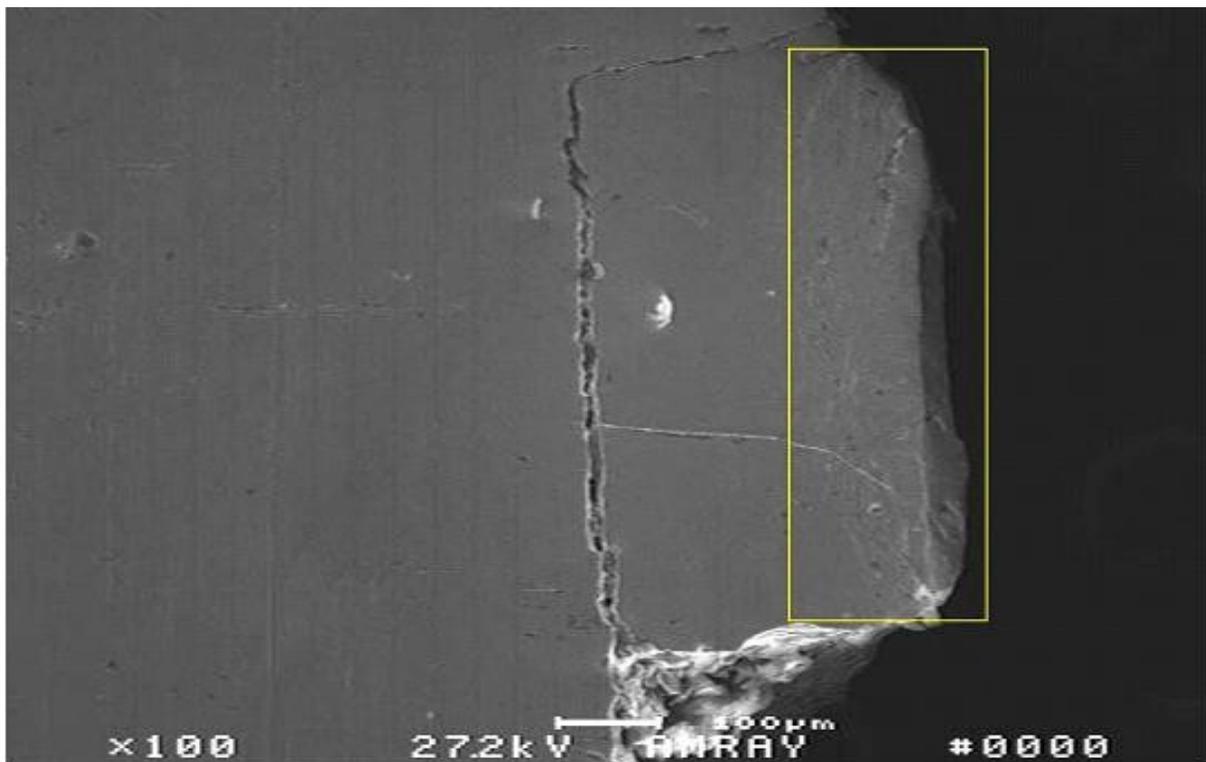
Figure 21 A 100X SEM photo of the cracked area from Figure 20. Notice the wear area outlined by the box

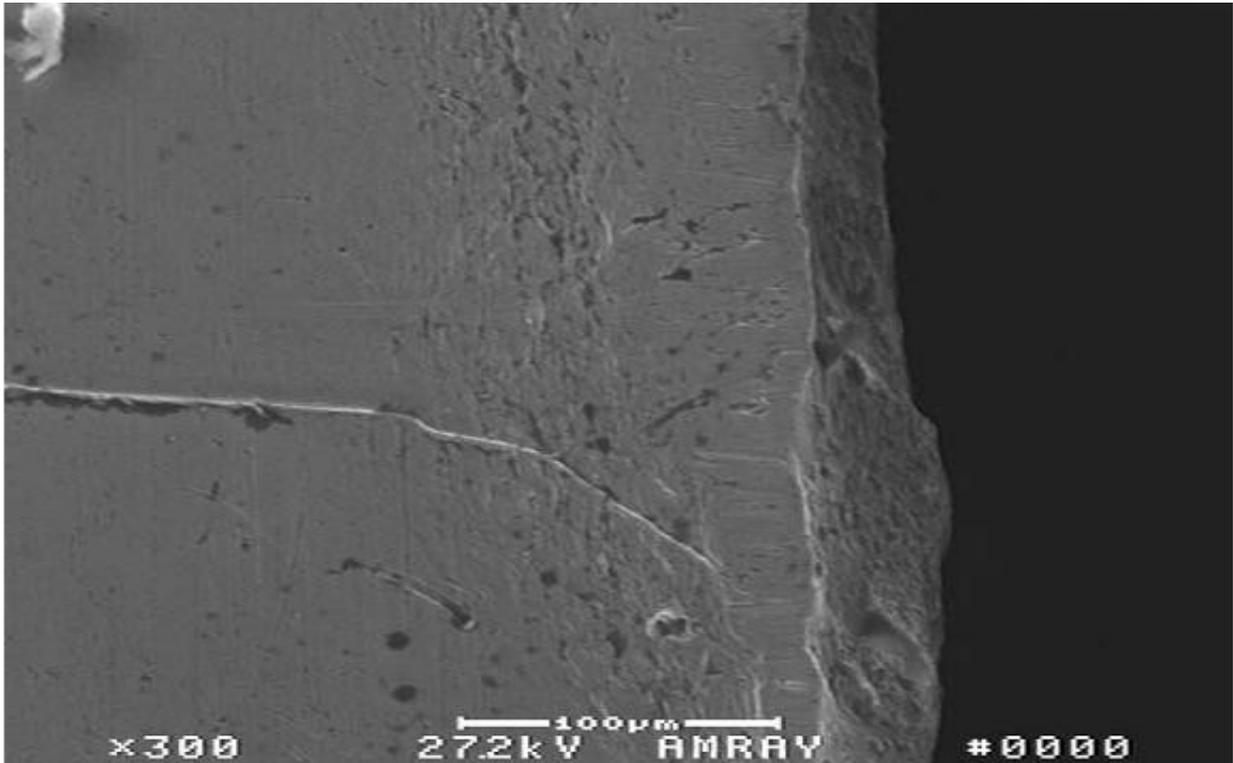
Figure 22 A 300X SEM photo of the outlined area in Figure 21 shows the wear.

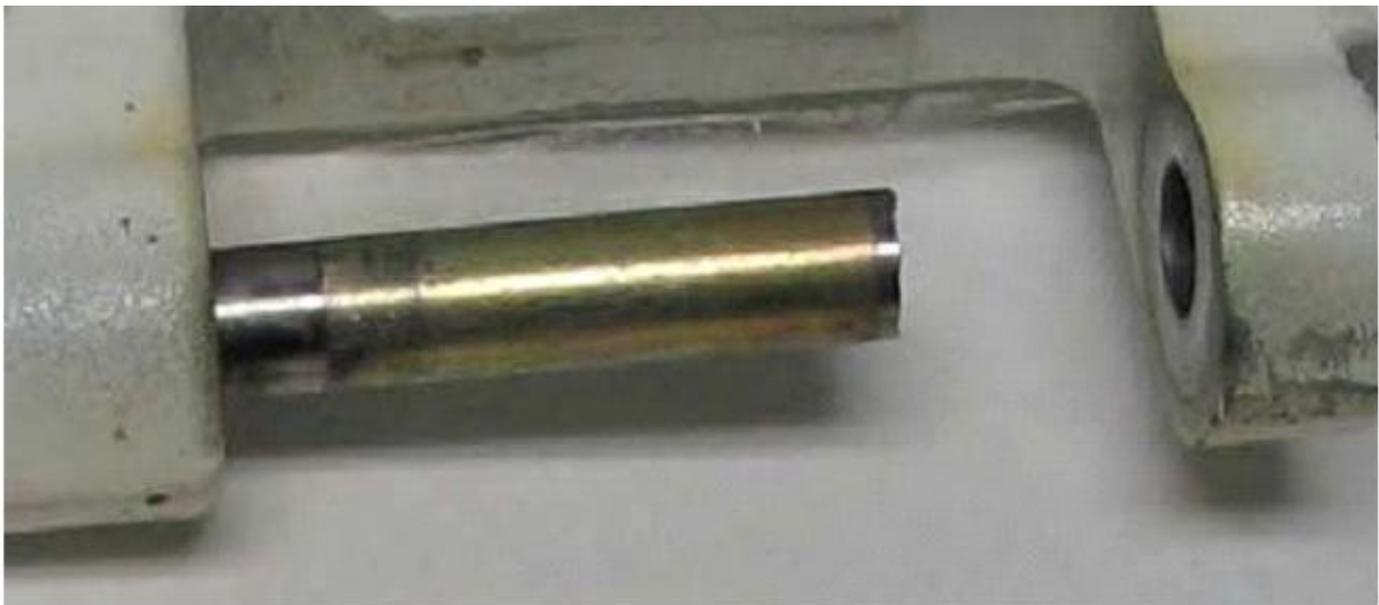
Figure 23 The gold color is removed from the bolt very near the fracture zone.

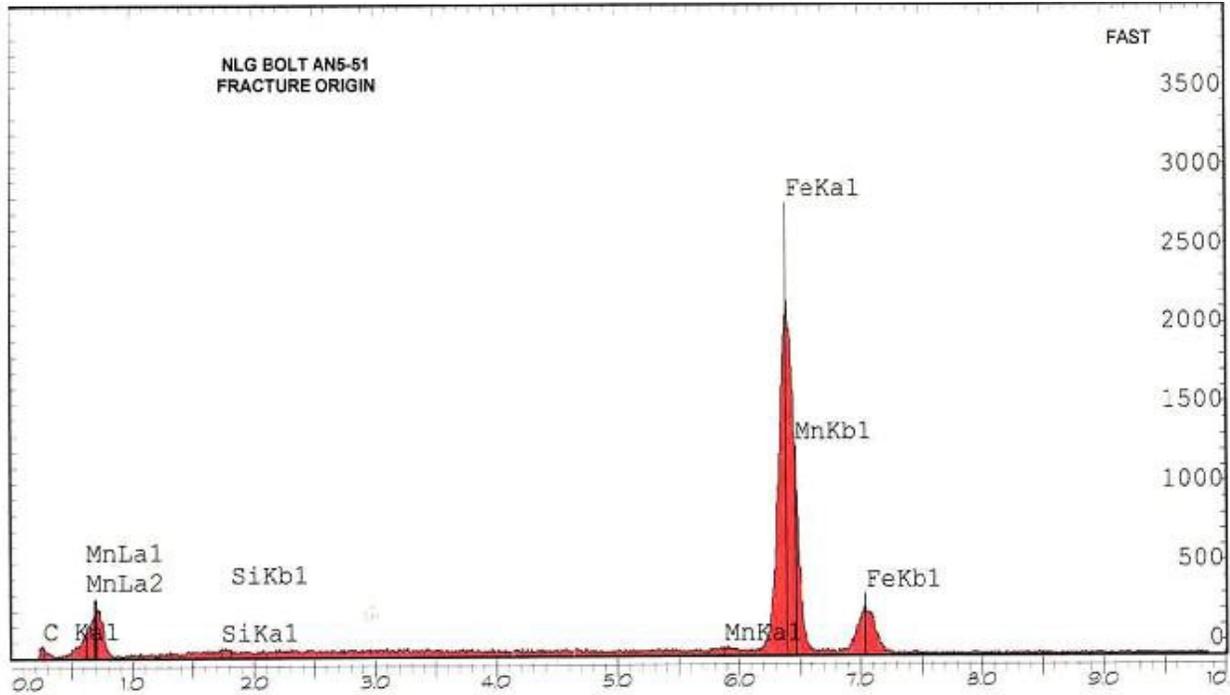
The bolt was found to be made of a non-corrosion resistant steel in accordance with the AN5-51 bolt specification, Figure 24. The outer surface was plated with cadmium and a chromate conversion coating, Figure 25.

Figure 24 The base metal of the bolt is low alloy carbon steel.
