## **Piper PA44-180, Failed Nose Gear Drag Link Bolt, ATA 3222**

**SUBJECT:** NOSE LANDING GEAR BOLT FAILURE

Type AC: PA44-180      AC Number:      AC Total Time: 4146.0  
Part Failure: NLG FWD bolt in drag link assembly      PN: 400-191  
Bolt Specification: AN5-51      FAST Report Number: F5429

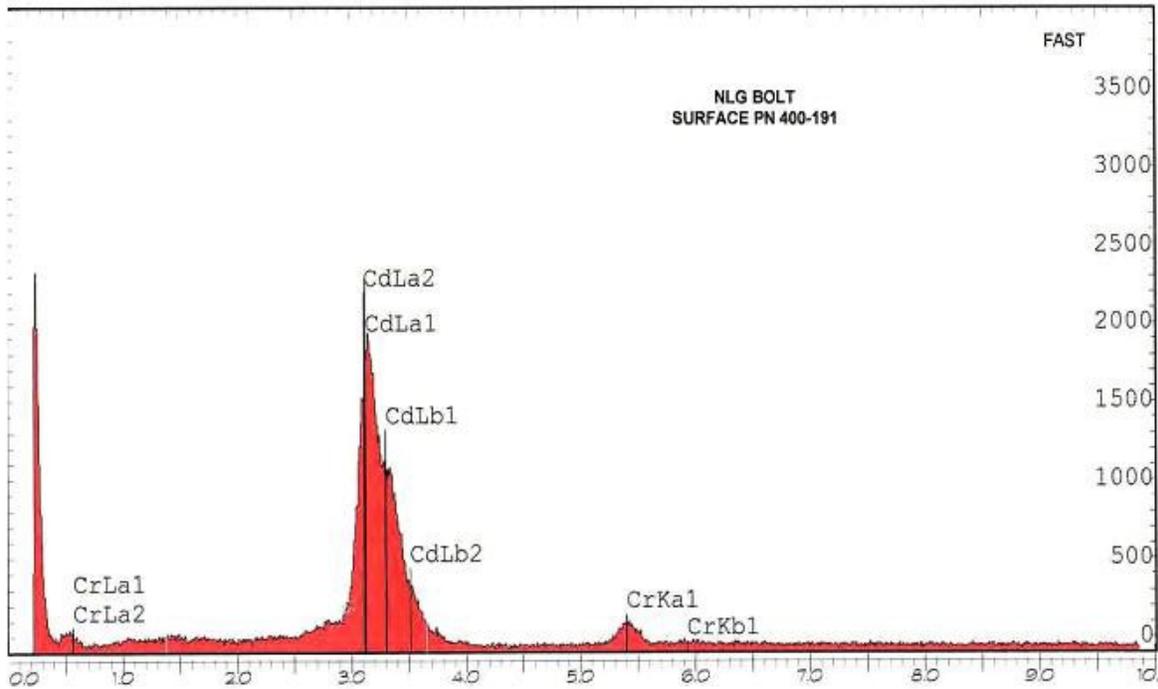
Figure 25 The bolt outer surface is plated with cadmium and a chromate conversion coating.
