Beech F33A, Cracked Leading Edge Nose Rib, ATA 5753

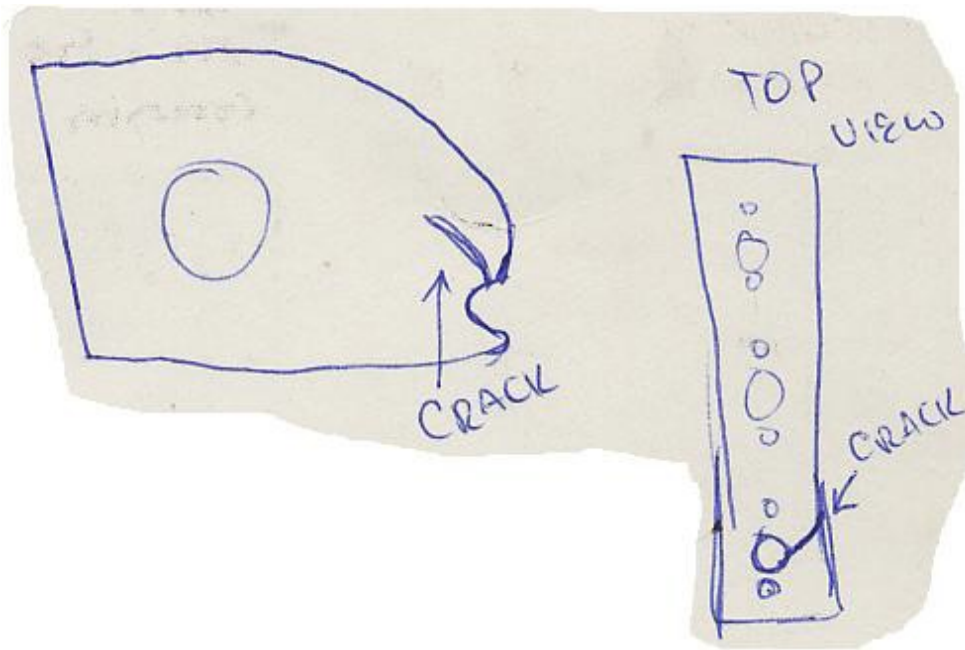
An annual inspection found the R/H flap rod attach point rib cracked." (Rib P/N 35-165050-84; Flap P/N 35-165050-606: both the flange and web were found to be cracked.)

Part Total Time: 5,255.1 Hours.
