REMOVE OMEGA PMA BOLT NUMBER GYS186C21-OAA FROM SERVICE

Beech Jet 400, Wheel Tie Bolts Maintenance Alert

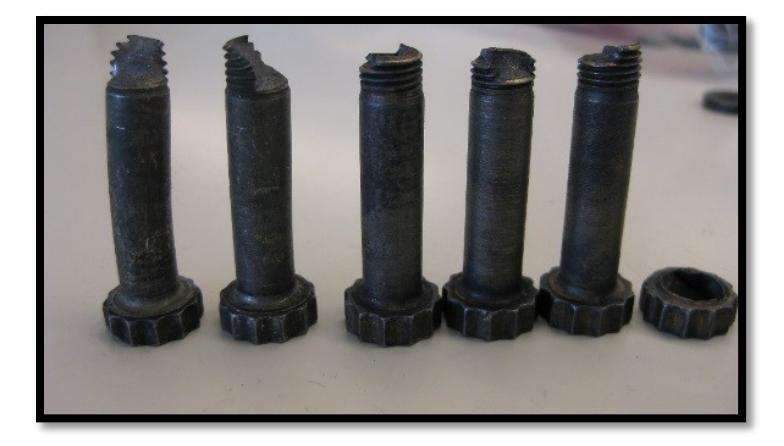
- FAA Airworthiness Inspectors from the Lincoln Nebraska Flight Standards District Office examined a number of failed Beech Jet 400A Omega PMA Wheel Bolts. Inspectors found bolt heads and shanks sheared. Inspectors also noted several bolt heads cracked in the radius between the shank and the head (see Figures 1, 2, and 3).

Figure 1 OMEGA Head Bolt and Shank Failures (1)

The Omega PMA bolts, part number GYS186C21-OAA, can be identified by its head marking (Figure 5). If found, these Bolts should be **immediately removed from service and discarded.**

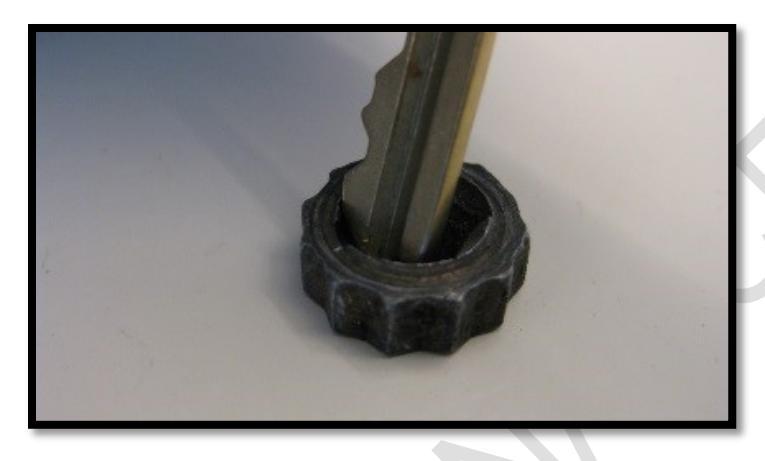
Figure 2 OMEGA Head Bolt and Shank Failures (2)

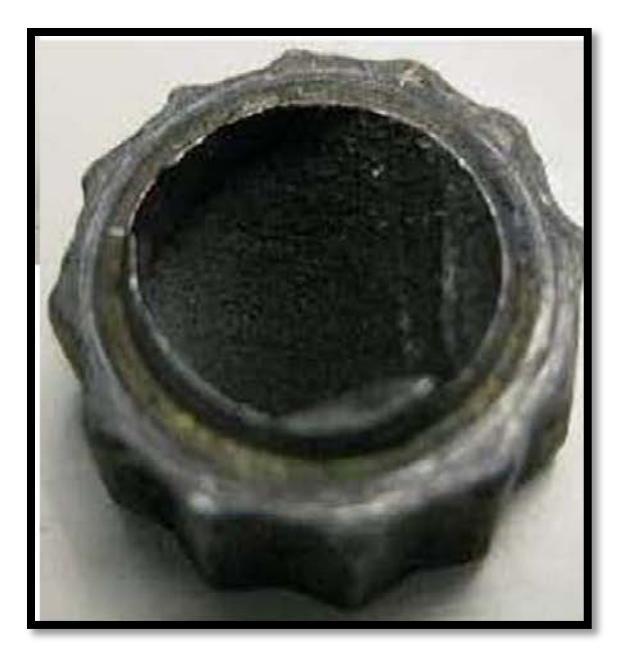
Figure 3 OMEGA Head Bolt and Shank Failures (3)

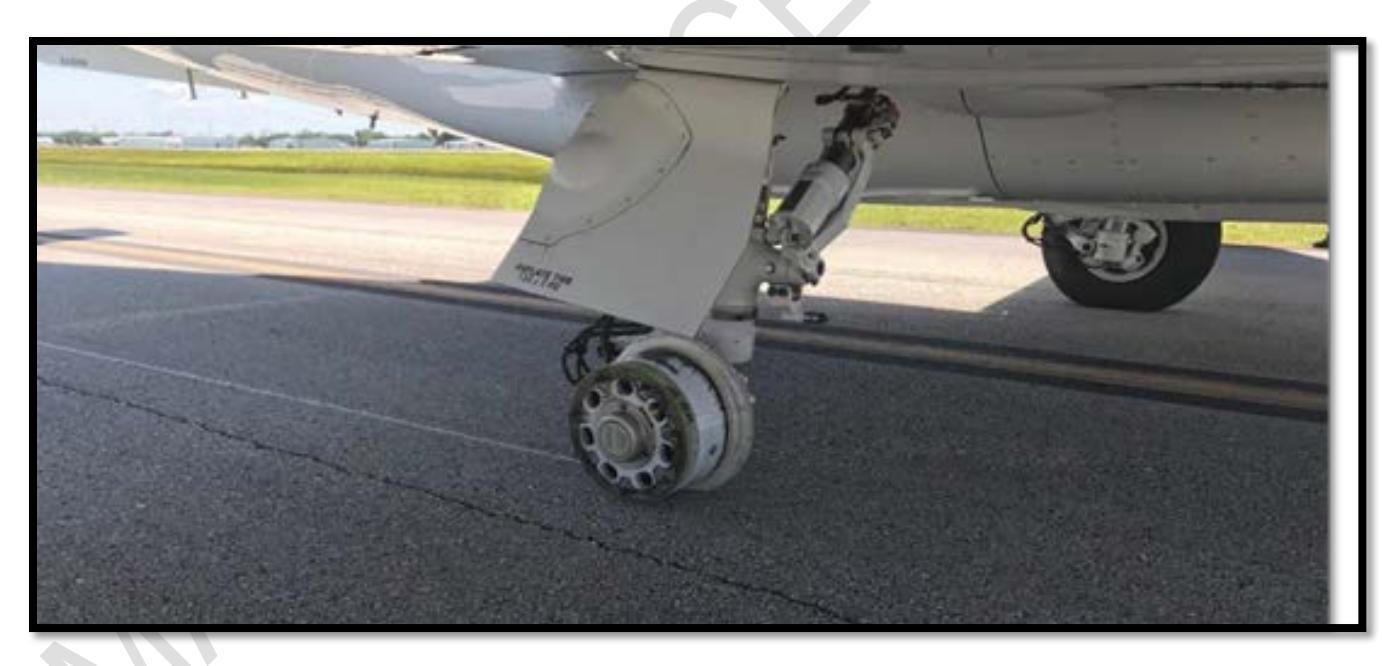
- In May of 2018, a Beech Jet 400A experienced a wheel separation failure just after a landing roll while exiting the runway and entering the taxiway. The outer half of the wheel had separated and departed the aircraft due to <u>all seven (7)</u> of the main Wheel Bolts failing. During the event, the main tire deflated and departed the wheel, causing an impact to the underside of the aircraft wing. Further investigation revealed five of the seven failed main Wheel Bolts were Omega PMA bolts (see Figure 4).

Figure 4 Beech Jet 400A, Service Wheel Separation

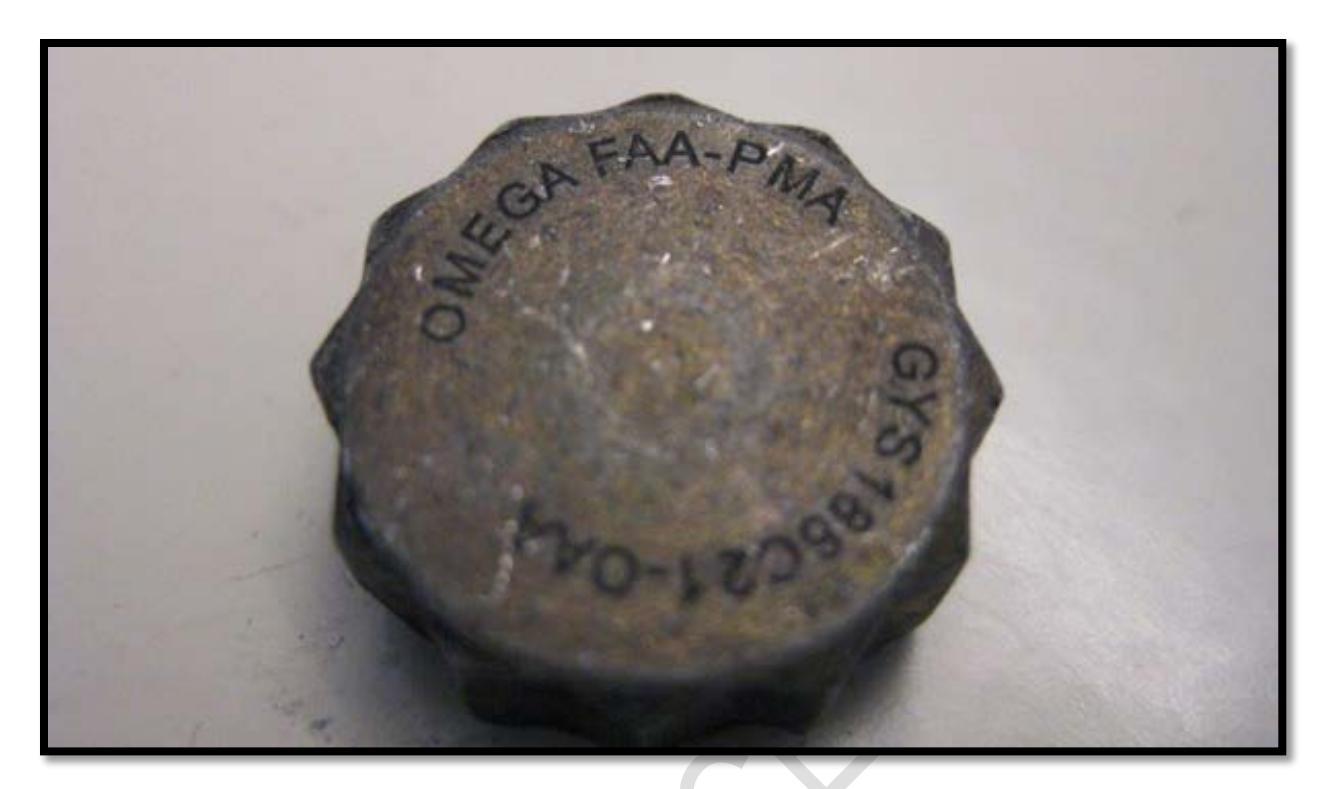
Figure 5 REMOVE FROM SERVICE
