## Univar 415-C, Sheared Brake Clevis, ATA 3240

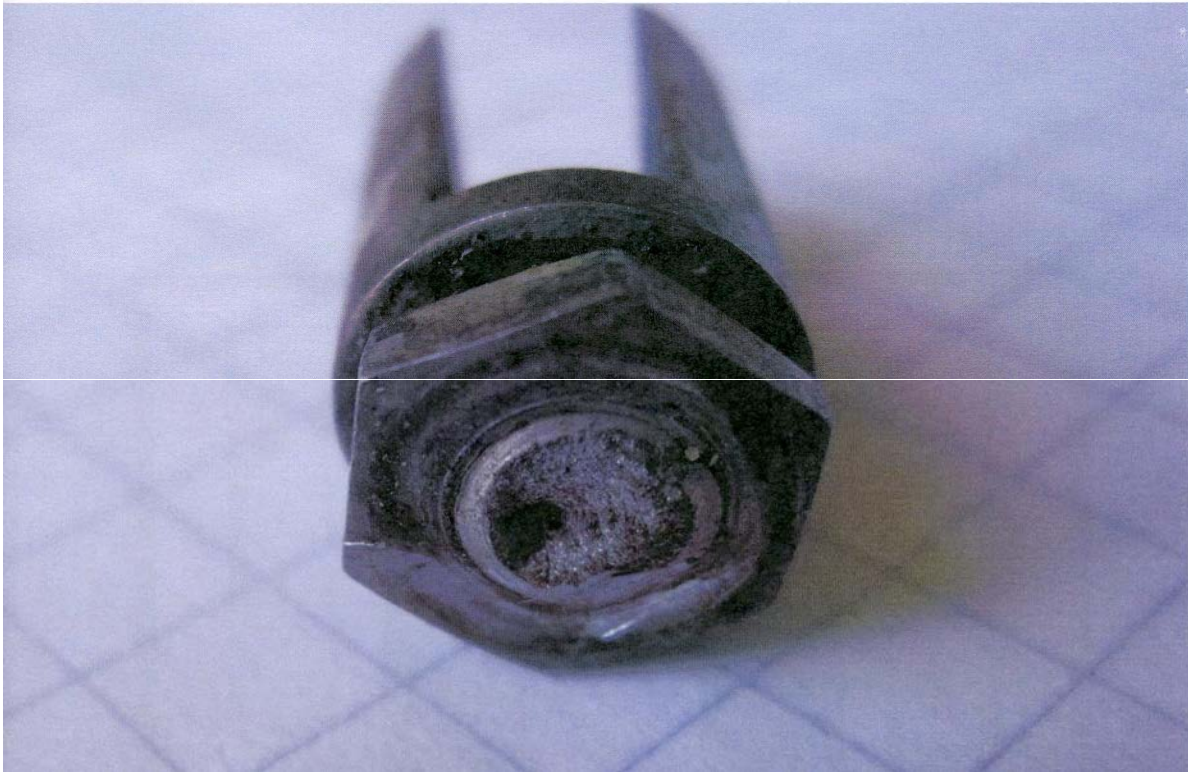
"On landing," says this general aviation technician, "*(this aircraft)* lost braking action. An investigation found the brake piston clevis rod—between the brake pedal arm and the master cylinder—had sheared below the lock nut."

*(Piston clevis rod P/N: 4008. Component name and P/N: Brake Arm; 41533458. See photo below.)*
