Alerts: Cessna 185A, Broken Alternator Bracket, ATA 2410

Cessna: 185A; Broken Alternator Bracket; ATA 2410

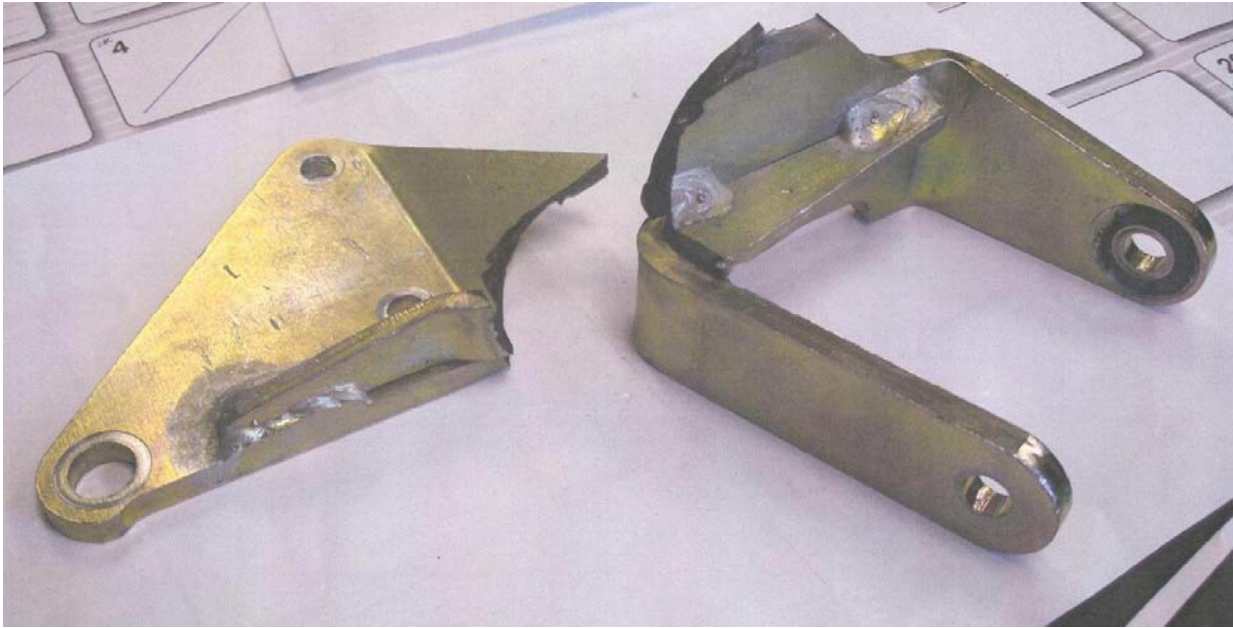
A mechanic states that at an earlier date, he installed a Plane Power Alternator Conversion Kit (STC SA10682SC) on this aircraft. During an oil change, the mechanic found the alternator bracket (*Plane Power P/N 10-9003*) cracked totally in half. This alternator had only been in use for three weeks at approximately 45 hours."

Figure 1 Broken Alternator Bracket

Part Total Time: 45.0 hours.
