## Beechcraft 200, Cracked Spar Shear Fitting, ATA 5740

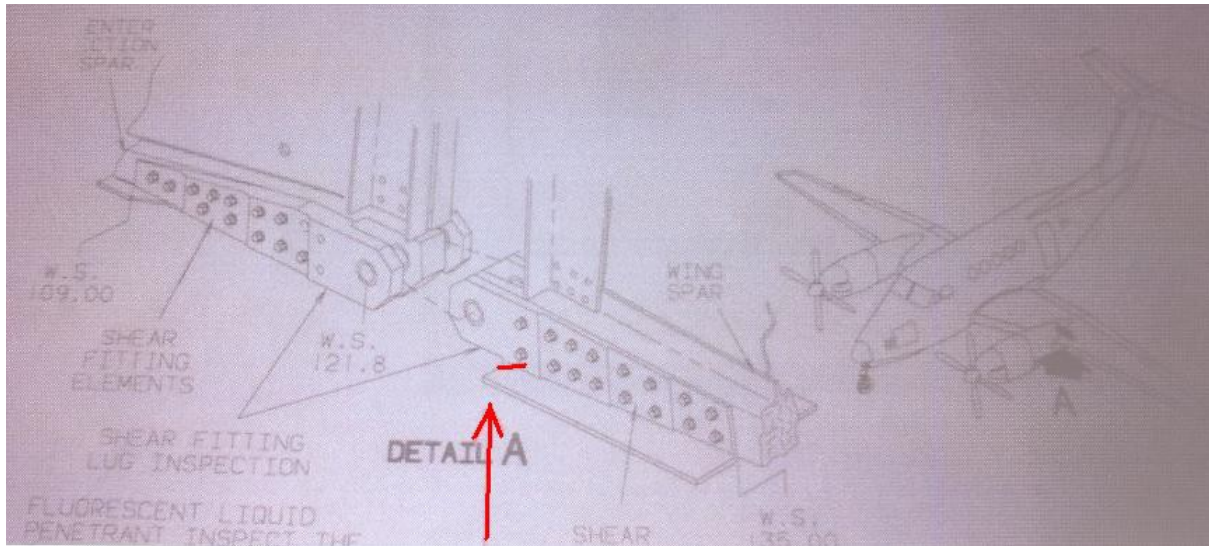
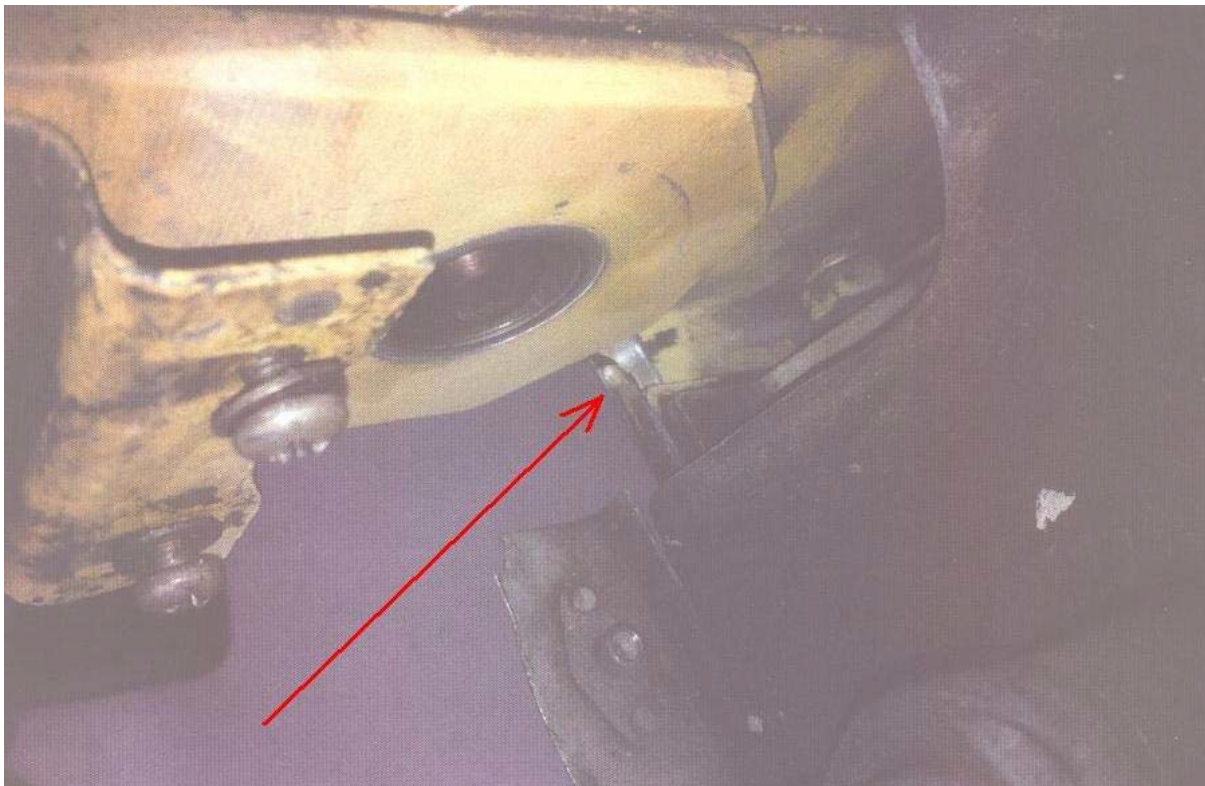
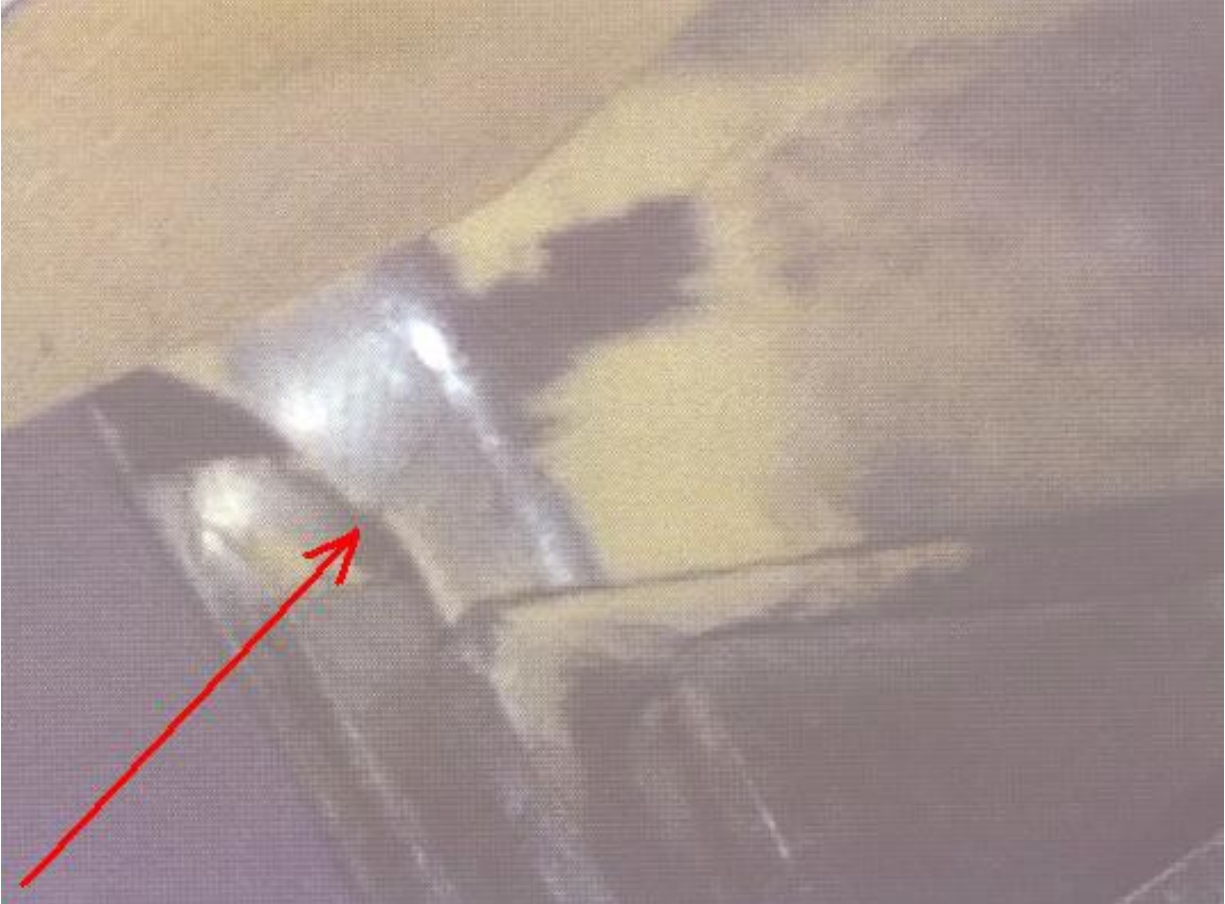
**Beechcraft 200, Cracked Spar Shear Fitting, ATA 5740**

"While accomplishing a wing bolt inspection," says this unidentified technician, "the L/H lower wing spar attach shear fitting was found cracked (P/N 1011100731). This crack is approximately 0.75 inches long and is located in the forward flange area."

Part Total Time: 13,141.0 Hours
