Turbomeca, Arriel 2B1, Cracked Turbine Guide Vane, ATA 7250

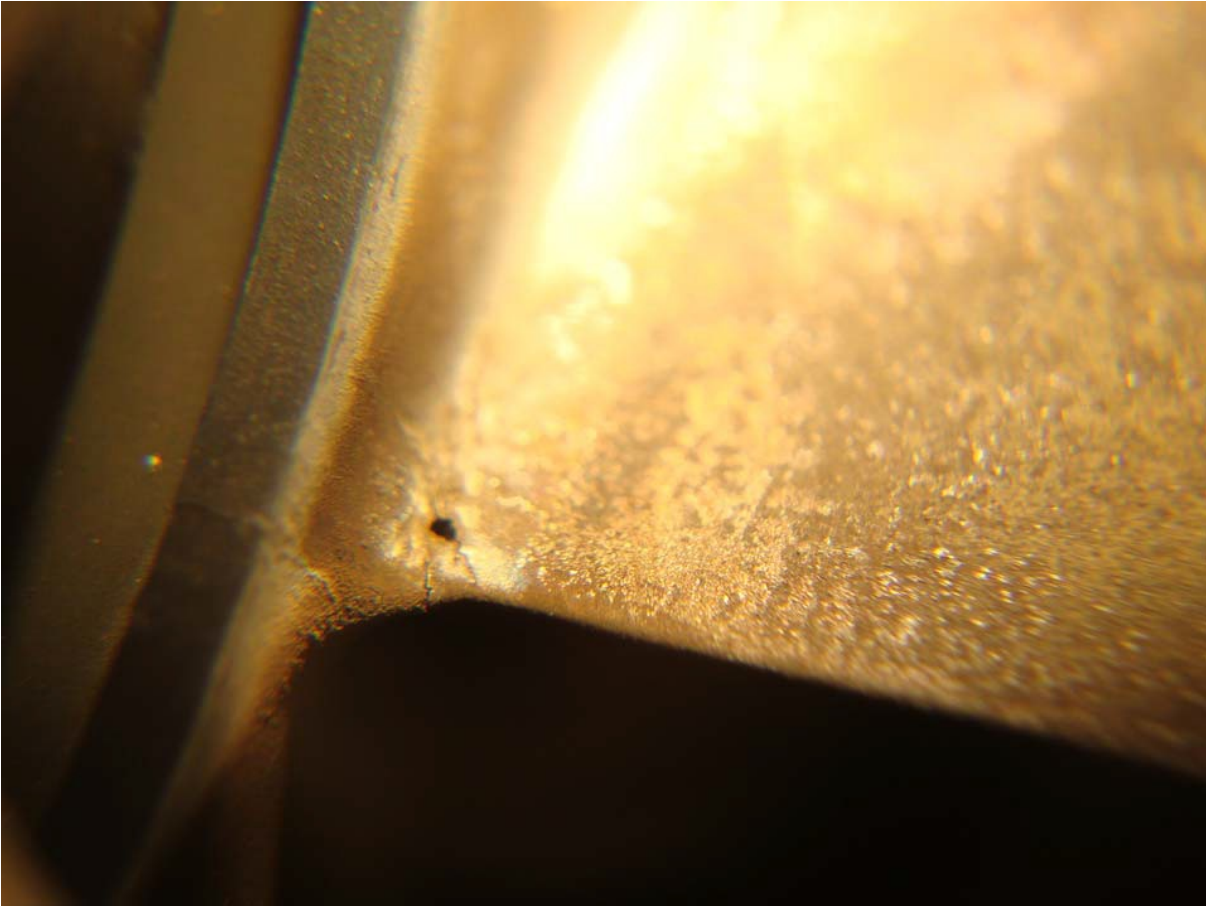
An AS350B3 helicopter operator writes, "While disassembling the engine to perform modification TU166, (I) found the power turbine nozzle guide vane cracked (P/N 0292517060). The 'Module 3' (P/N 70BM032020) must be returned to the manufacturer for repair."

Part Total Time: 2,590.0 Hours
