**Beechcraft B200, Cracked Spar Attach Fitting, ATA 5740**

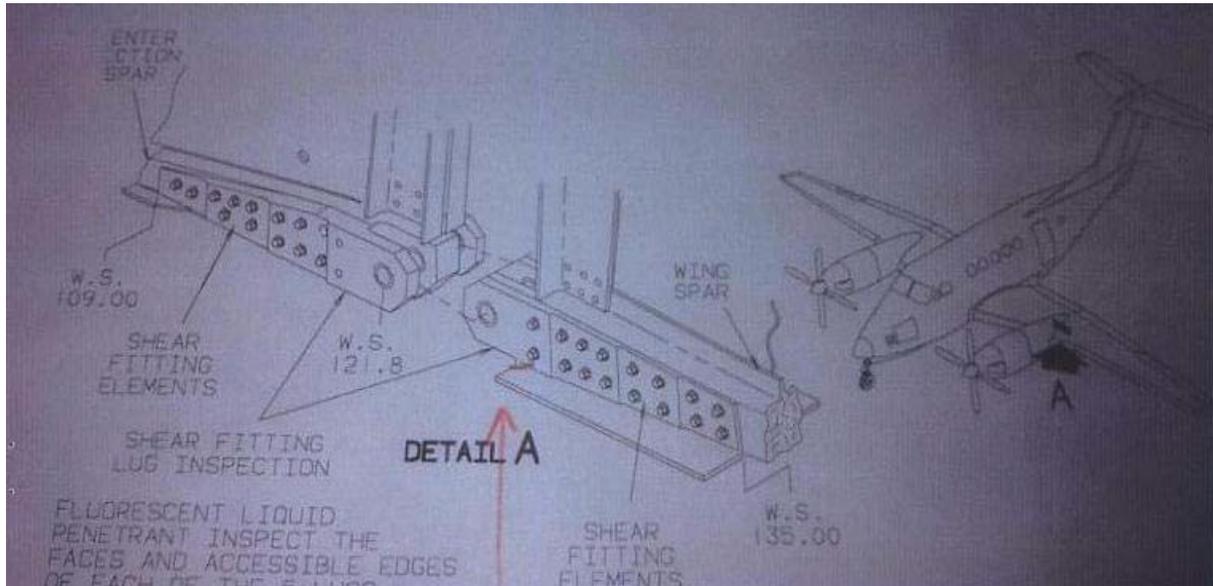
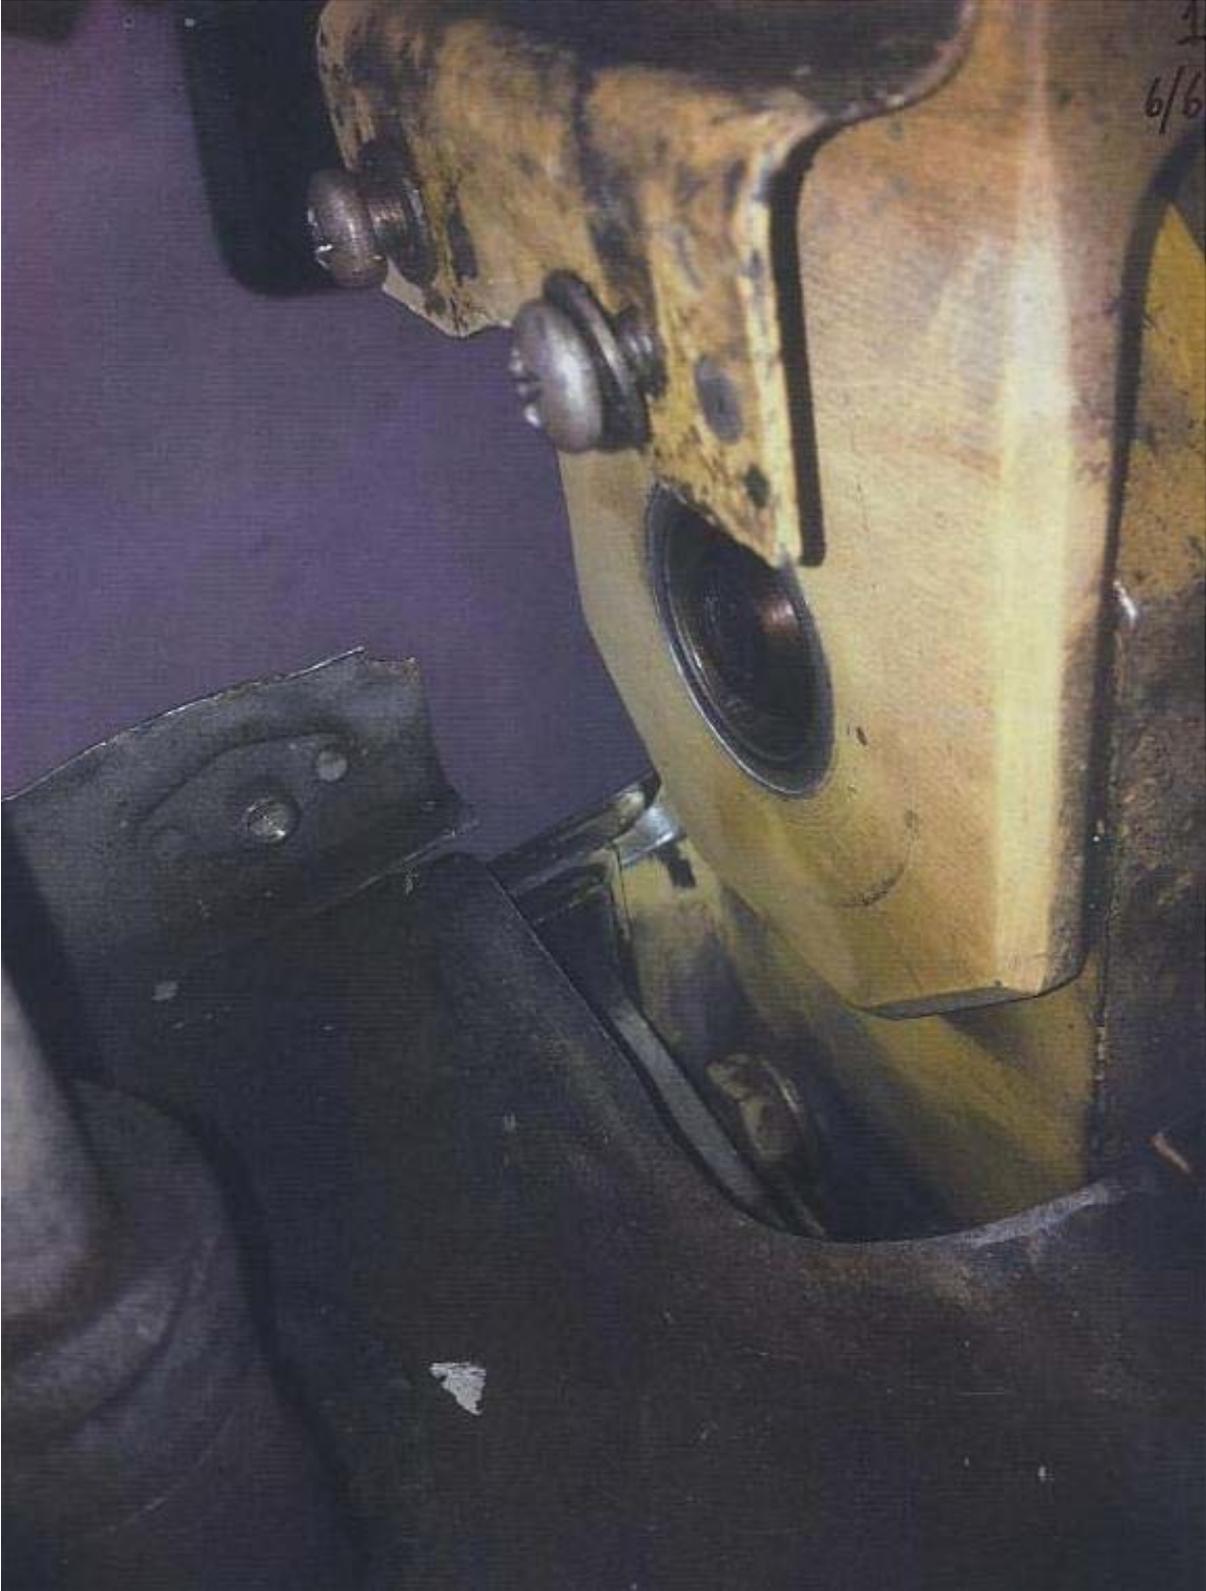
A general aviation submitter states, "While accomplishing a wing bolt inspection, the L/H lower wing spar attach shear fitting was found cracked (P/N 1011100731). This crack is approximately 0.75 inches long—located in the forward flange area."

Part Total Time: 13,141.0 Hours
