Powerplant, Continental TSIO 550C1B, Broken Crankshaft, ATA 8520

(The following description involving a Piper PA46-310P doesn't provide speculation or detective work, it does not provide much discussion at all. However, it does include one dramatic photo—Ed.)

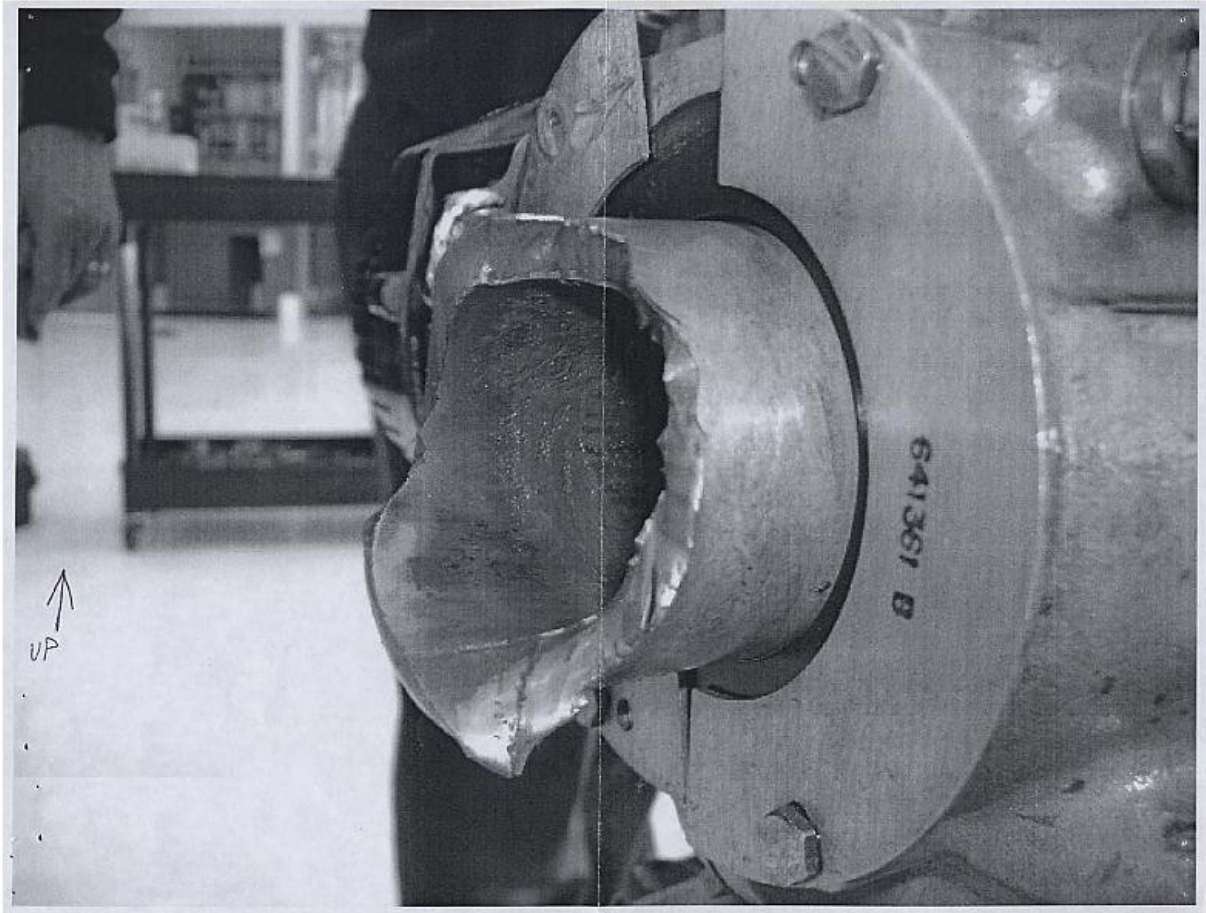
"The crankshaft broke," says this mechanic, "just aft of the propeller mounting flange"
(Crankshaft P/N: 649900).

Part Total Time: (unknown).
