## AEC Piston AEC646263, Blown Piston, ATA 8530

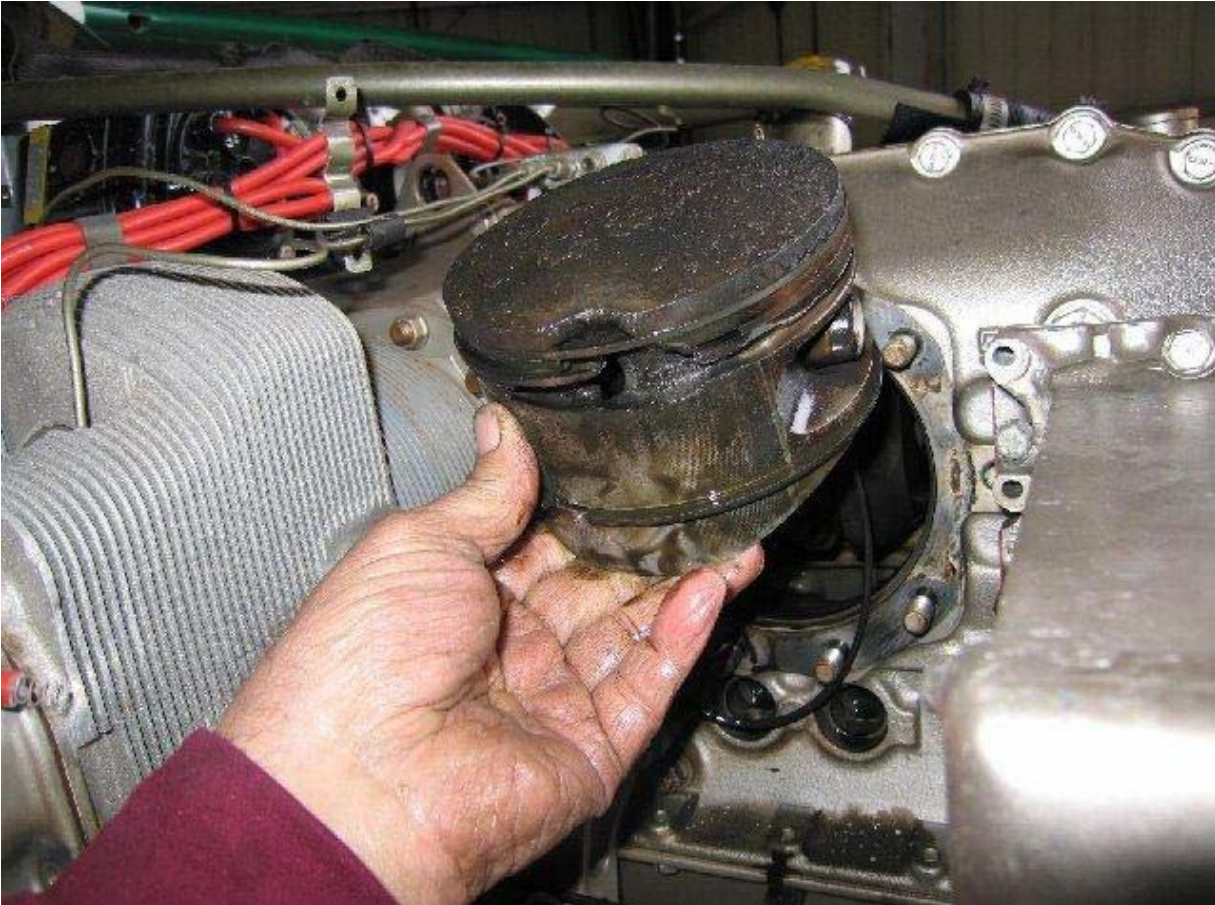
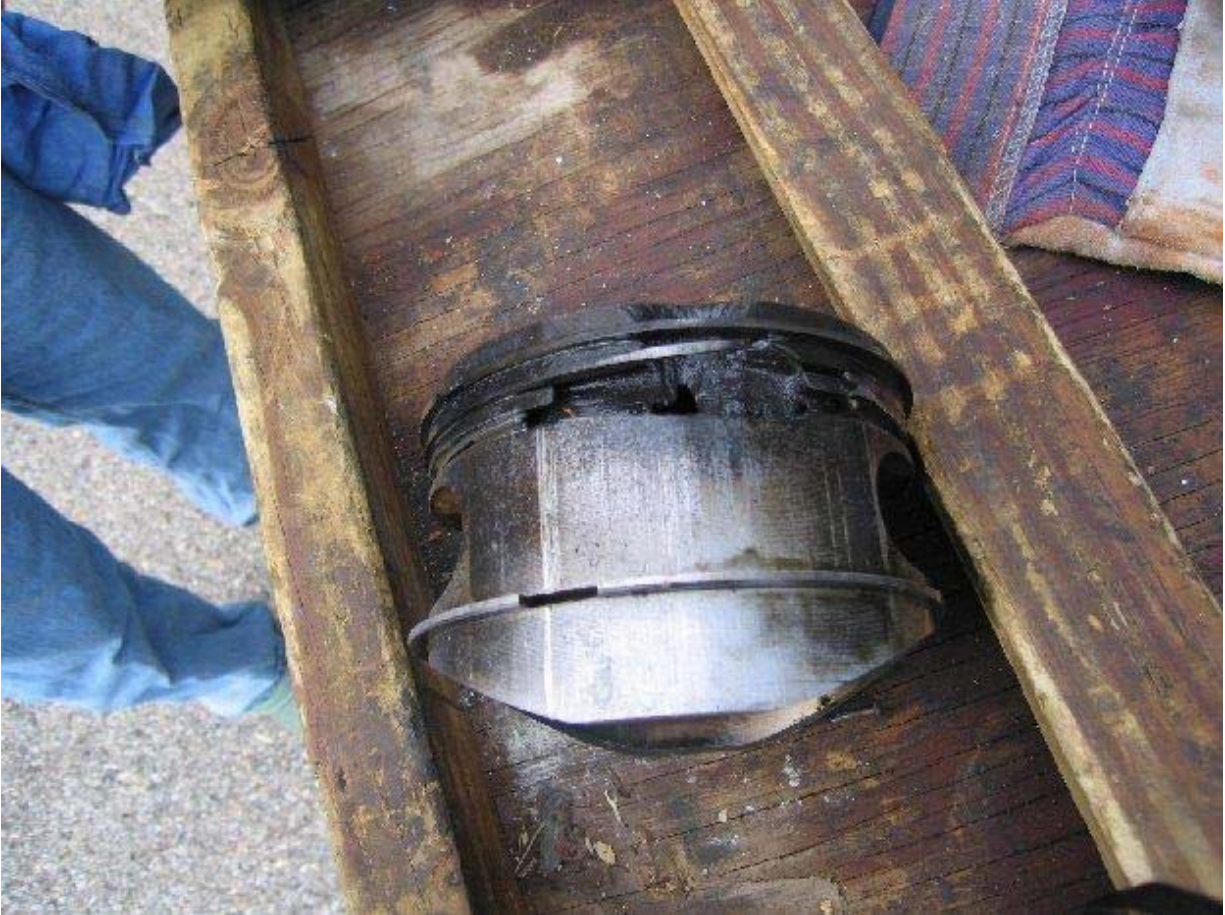
**AEC Piston AEC646263, Blown Piston, ATA 8530**

An engine mechanic states, "After approximately 300 hours of operation, the number five cylinder on this Continental O-470R engine experienced piston failure—appearing at first impression to be caused by detonation. However, the mechanic s this piston (P/N AEC646263) failed due to a flaw in its manufacture, or it may have experienced damage (such as a fall to the floor) prior to installation in the engine. It is my belief this failure occurred over a period of several hours by combustion gasses slowly eroding the edge of the piston."

Part Total Time: 300.0 hours (approximate)
